## **T/V *Margara* Emergency Restoration Inspection October 19-21, 2006**

A site inspection of the emergency restoration efforts led by Continental Shelf Associates and supported by Trustee staff at the impact sites of the T/V *Margara* was conducted from October 19-21, 2006 by the Trustees. The goal of the inspection was to determine if any additional work was required. The inspection team consisted of Craig Lilyestrom and Edwin Rodriguez (Puerto Rico Department of Natural & Environmental Resources), Michael Nemeth and Sean Griffin (Lighthouse Technical Consultants, Inc.), and Tom Moore and Kevin Kirsch (National Oceanic & Atmospheric Administration).

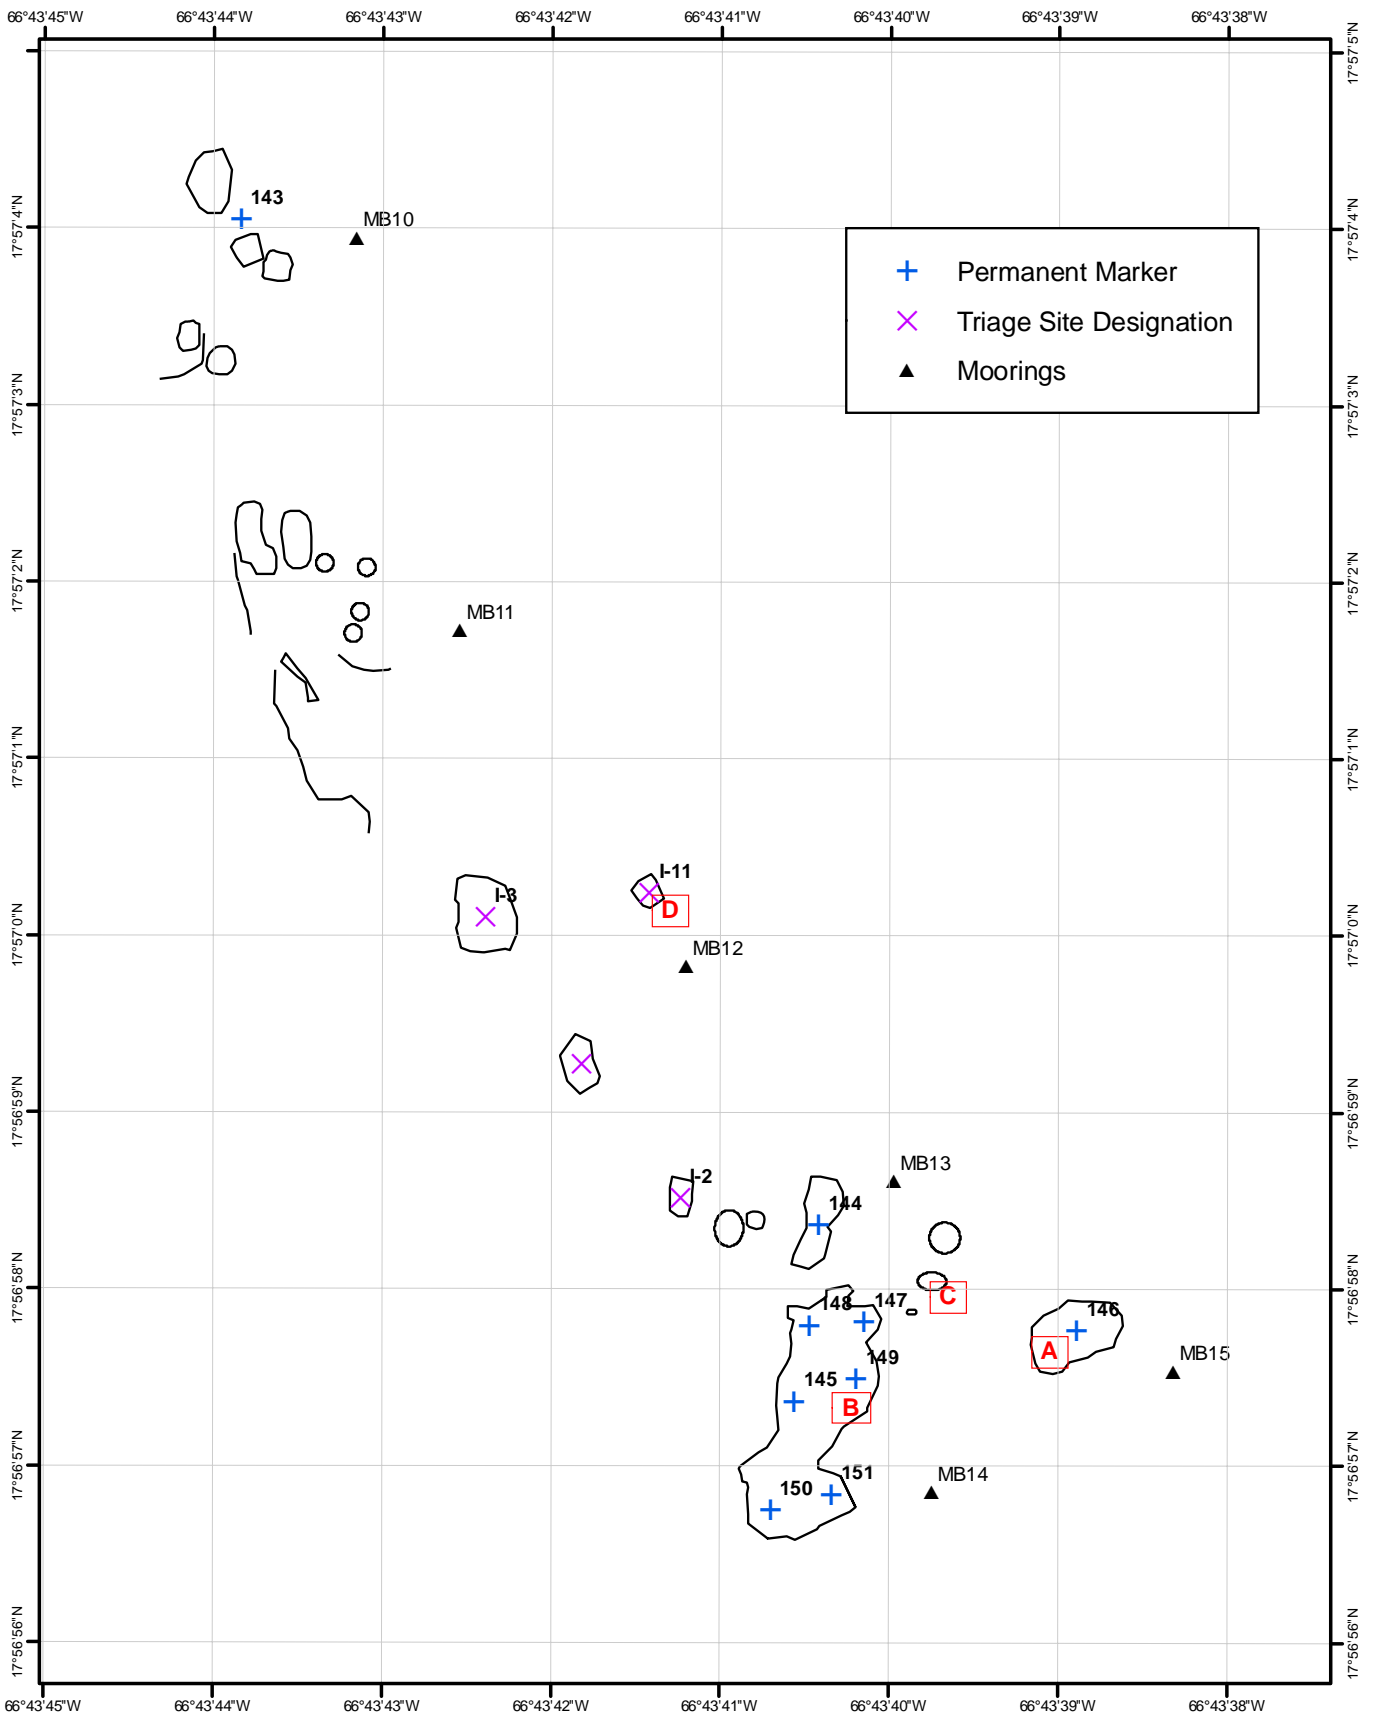
Figure 1. Southern injury, red letters indicate areas where additional emergency restoration work is needed

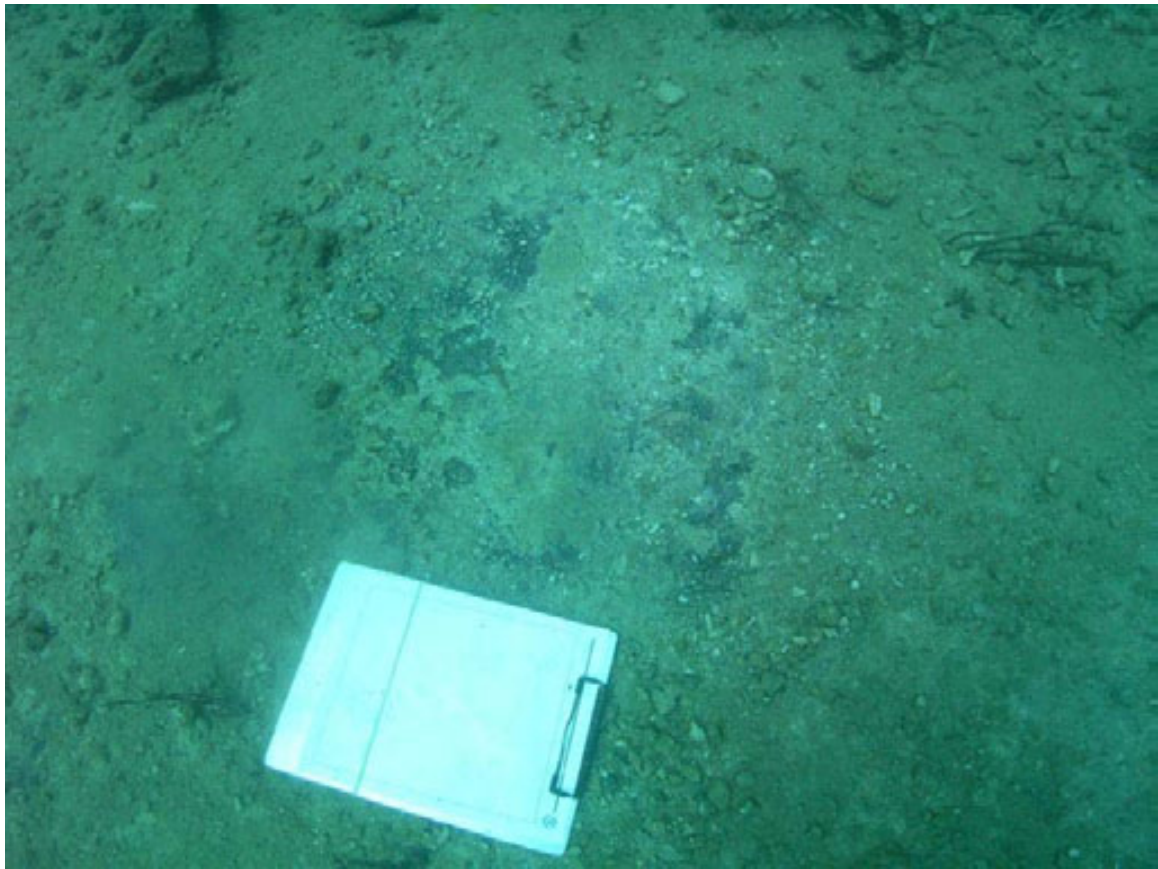
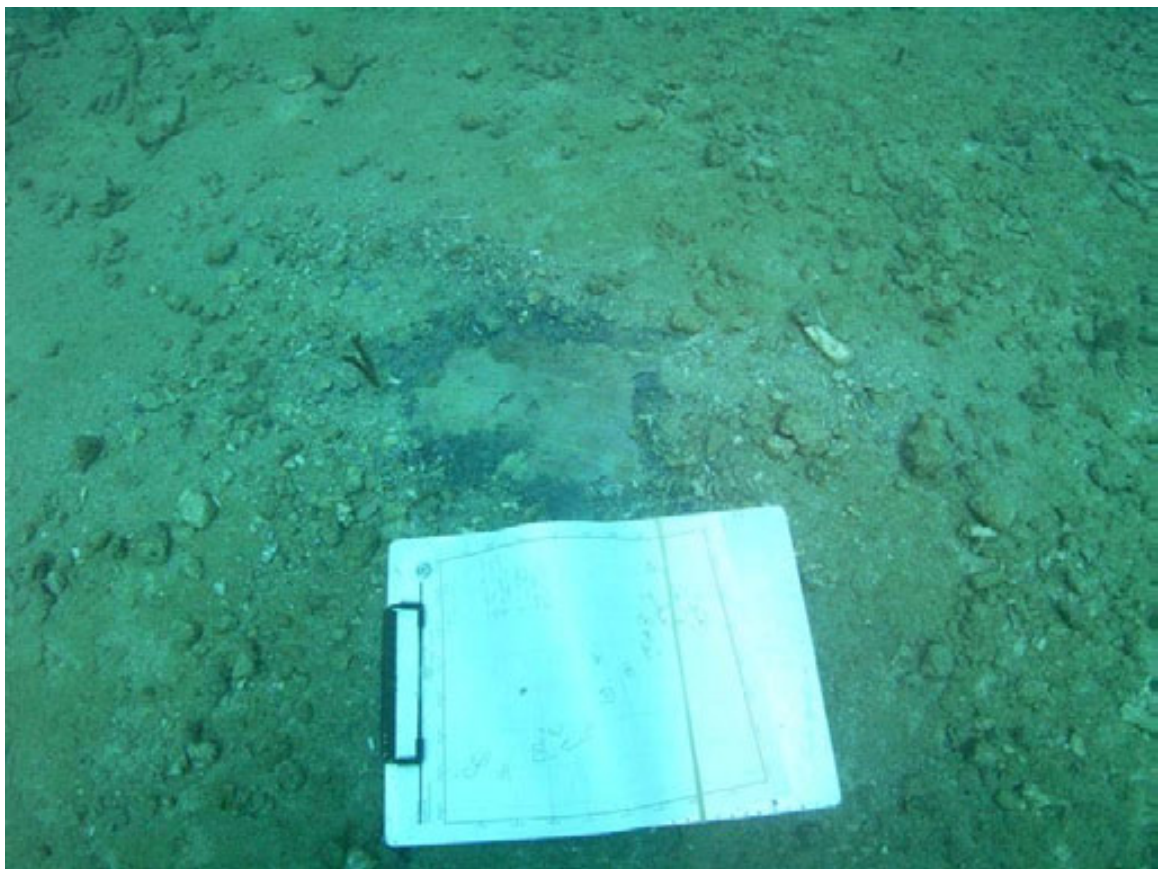
There are at least 5 areas where anti-fouling paint needs to be removed (see Figure 2a & b).

Figure 2a. Representative photos of remaining areas of anti-fouling paint at Site 146

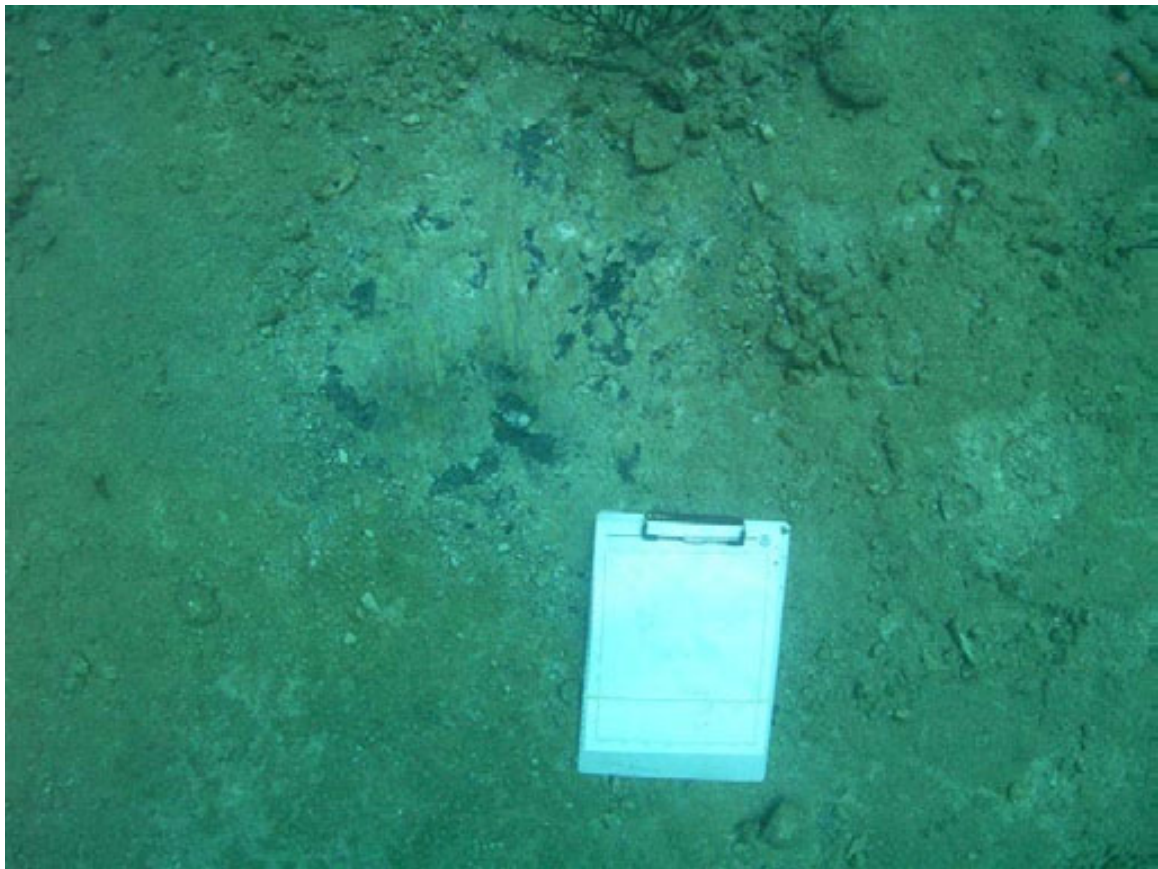
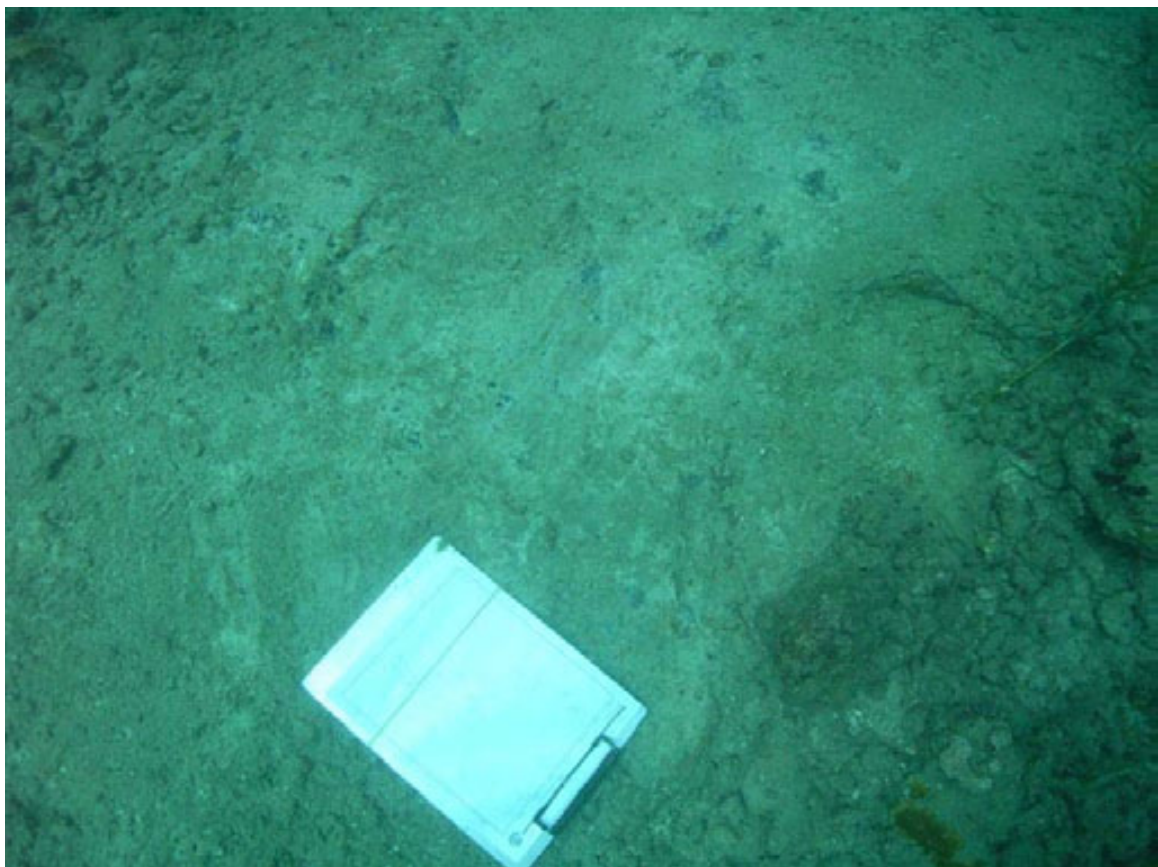
Figure 2b. Representative photos of remaining areas of anti-fouling paint at Site 146

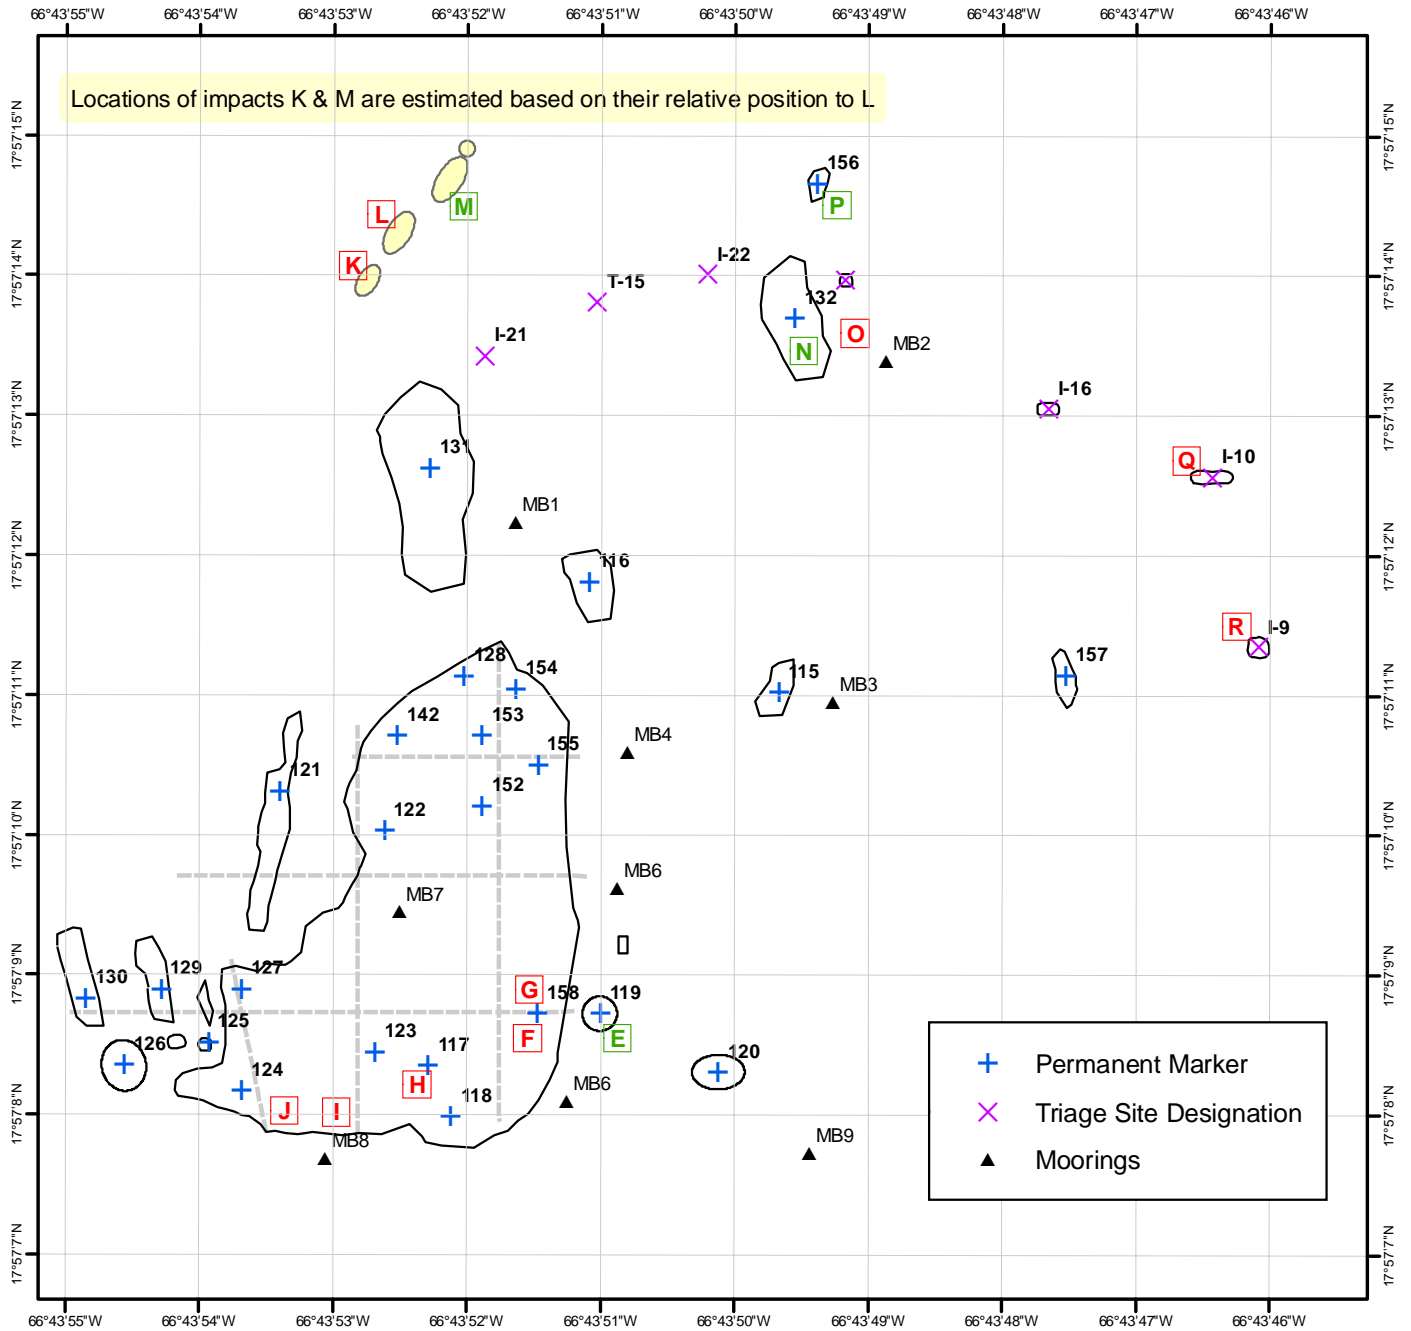
Figure 3. Northern injury; red letters indicate areas where additional emergency restoration work is needed; green letters indicate areas of note within the text.

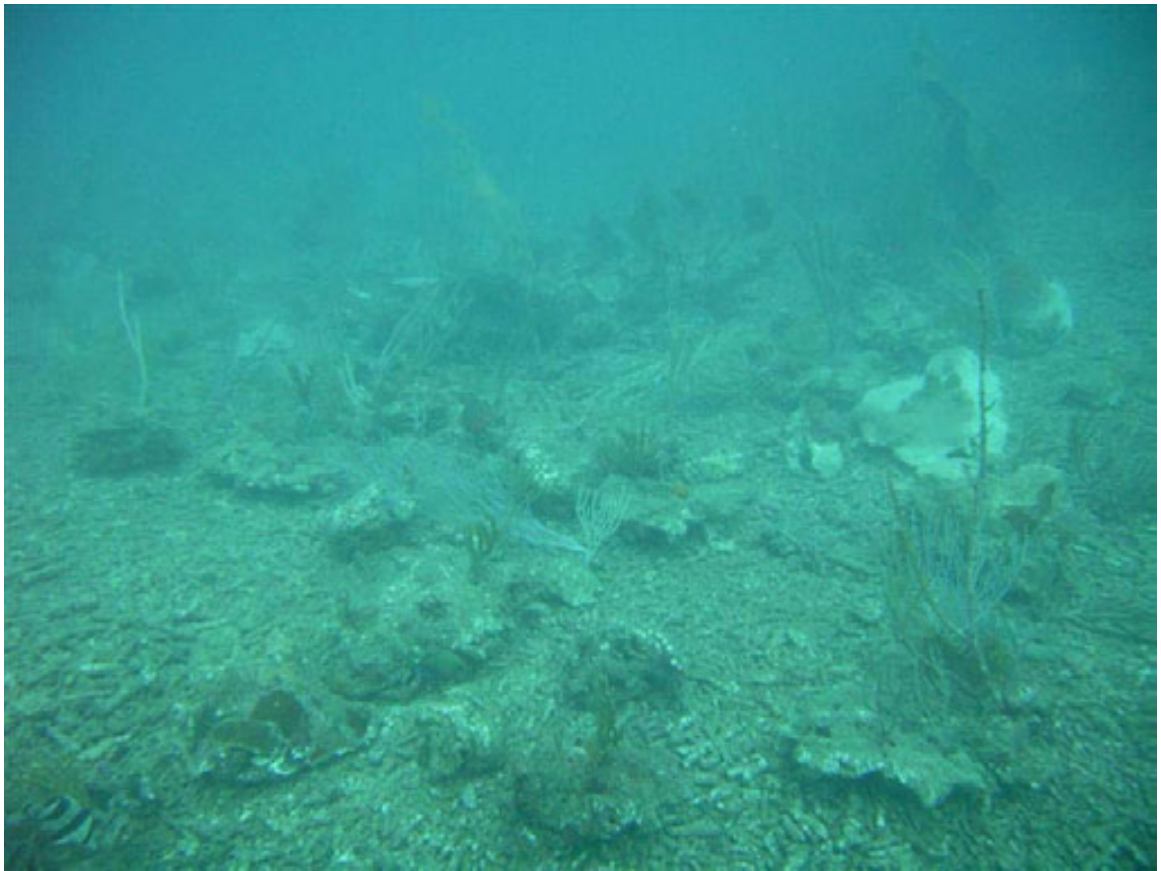
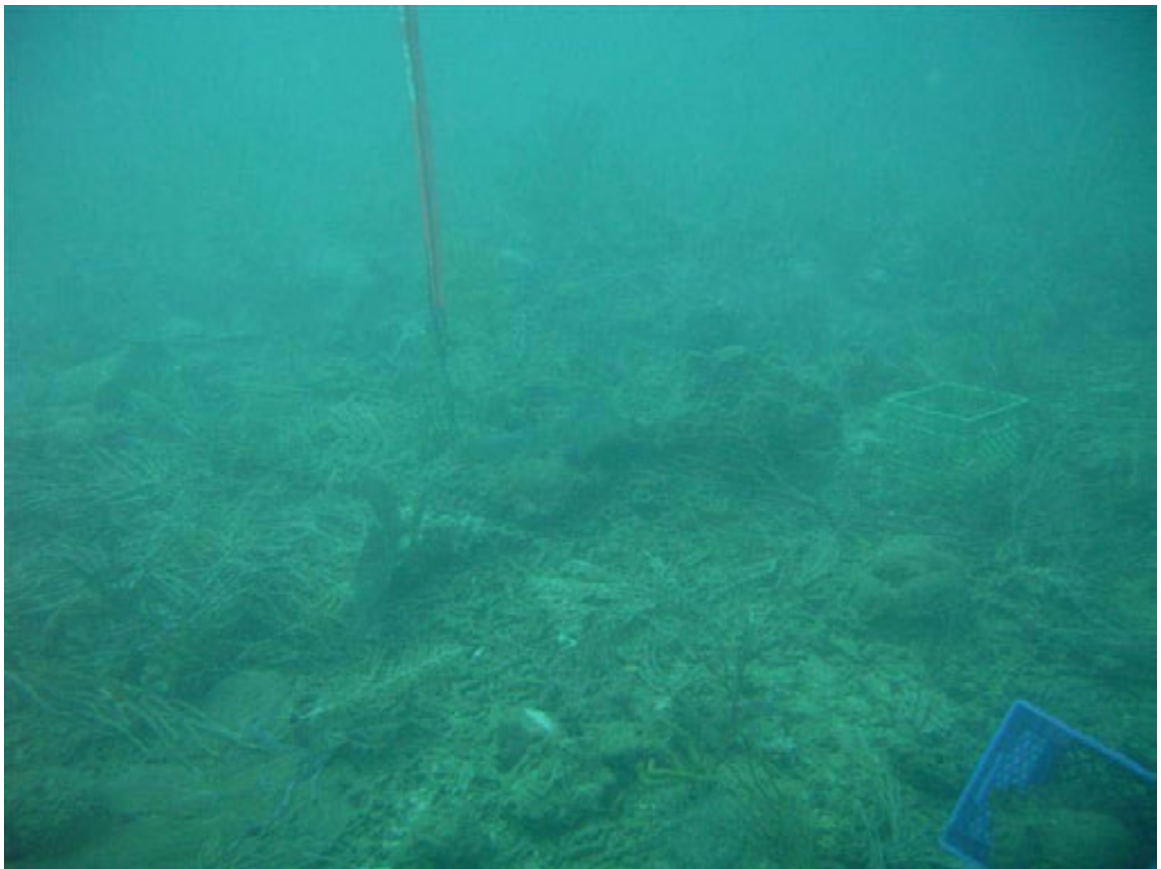
Approximately 150 hard coral pieces and 200-250 soft corals were cached that need to be reattached (see Figure 4). There is also additional anti-fouling paint that needs to be removed.

Figure 4. Photos of corals cached at Site 117.

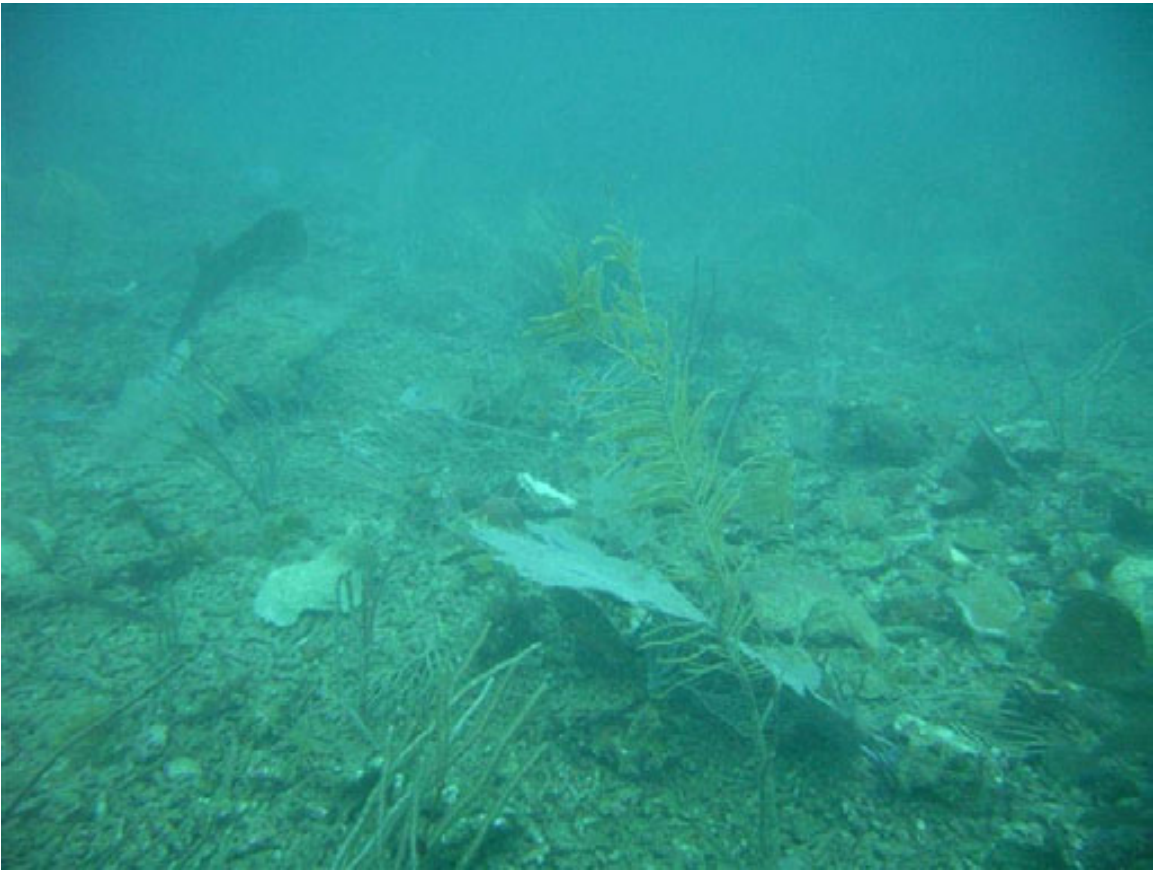
Approximately 100 hard coral pieces and 200-250 soft corals that need to be reattached were cached south of the marker (see Figure 5).

Figure 5. Corals cached south of Site 158.

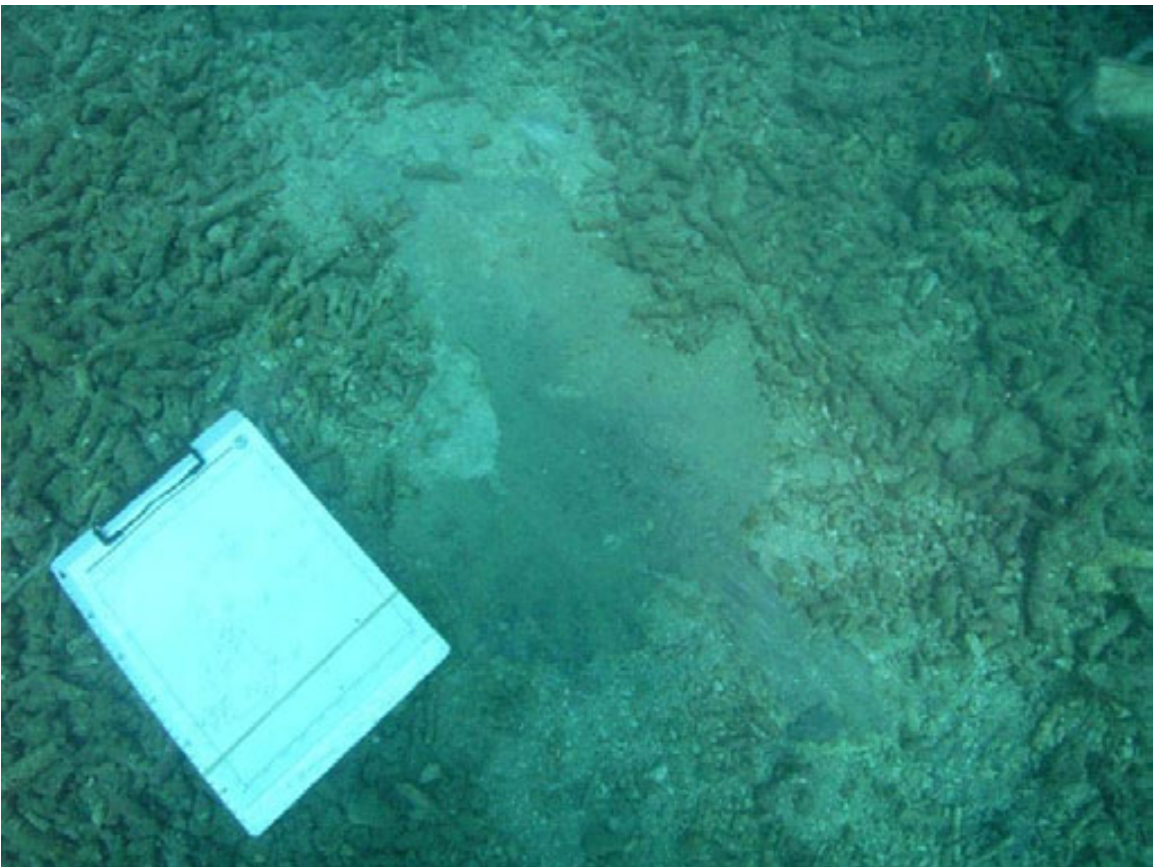
There is a 1 meter x 0.5 meter area of anti-fouling paint that needs to be removed (see Figure 6).

Figure 6. Area of anti-fouling paint that needs to be removed, at letter J in Figure 3.

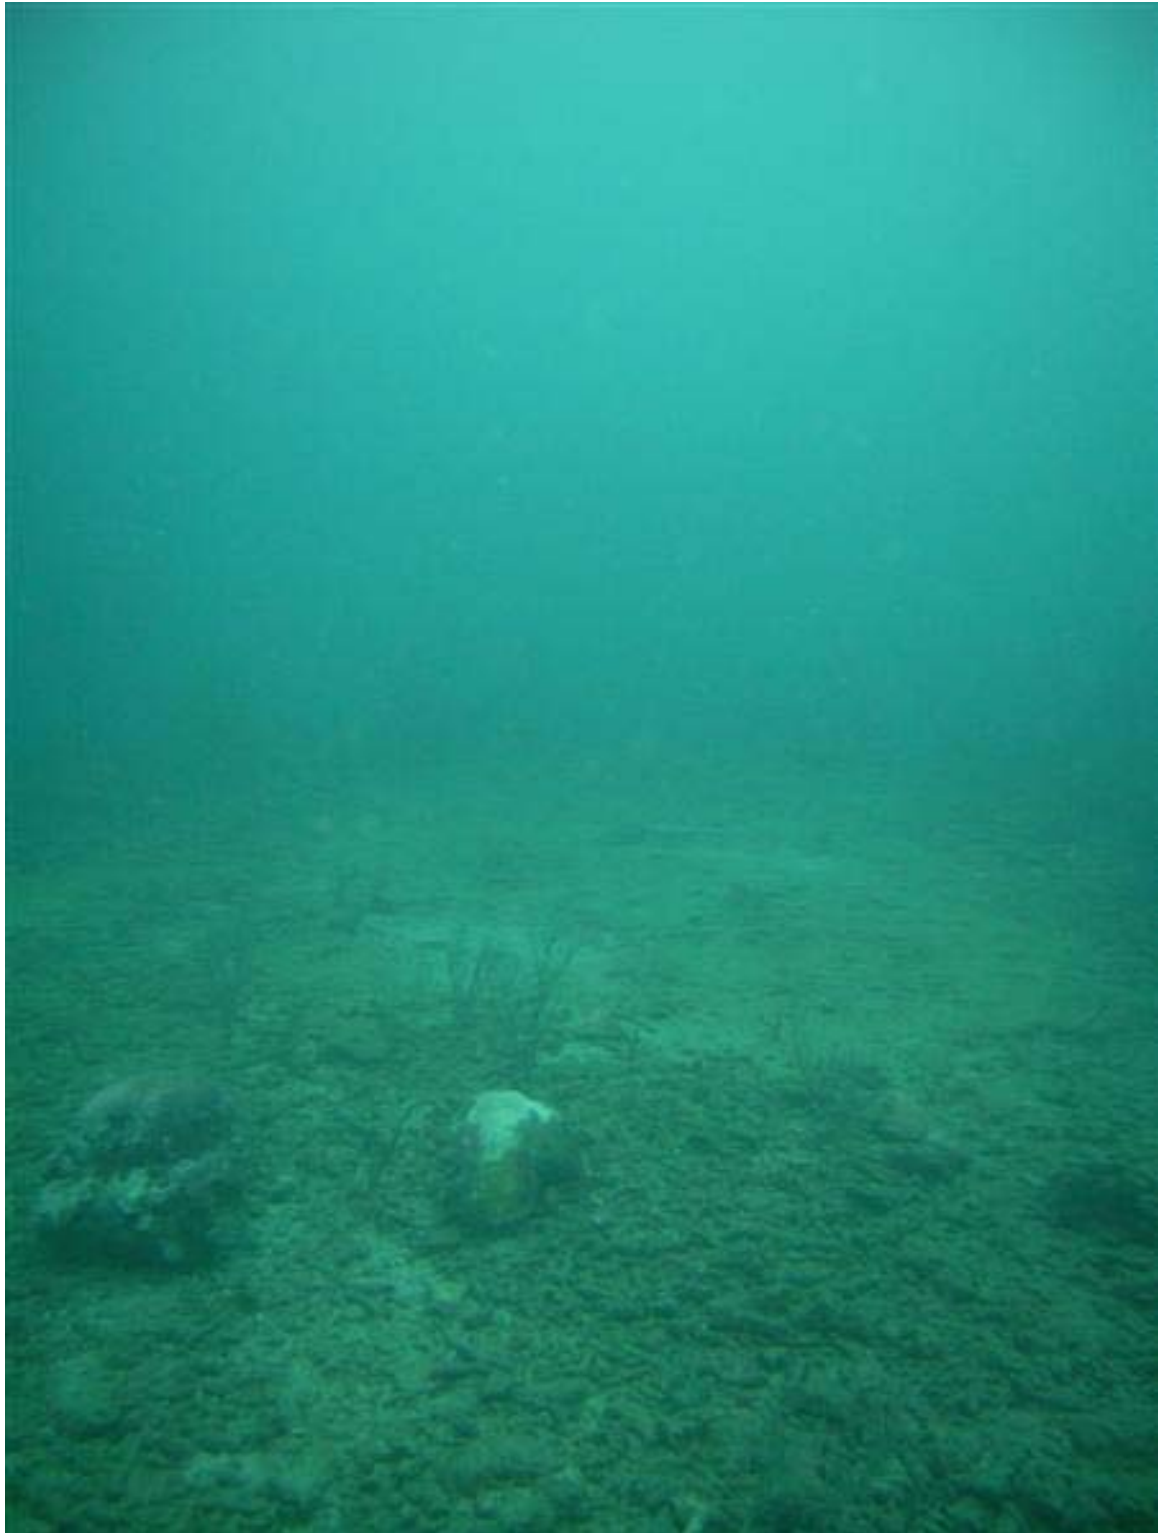
There is anti-fouling paint to be removed and coral to be reattached. The site was measured as 34' x 17' (10.4 m x 5.2 m). (see Figure 7 & 8)

Figure 7. Photo of Site T-15.

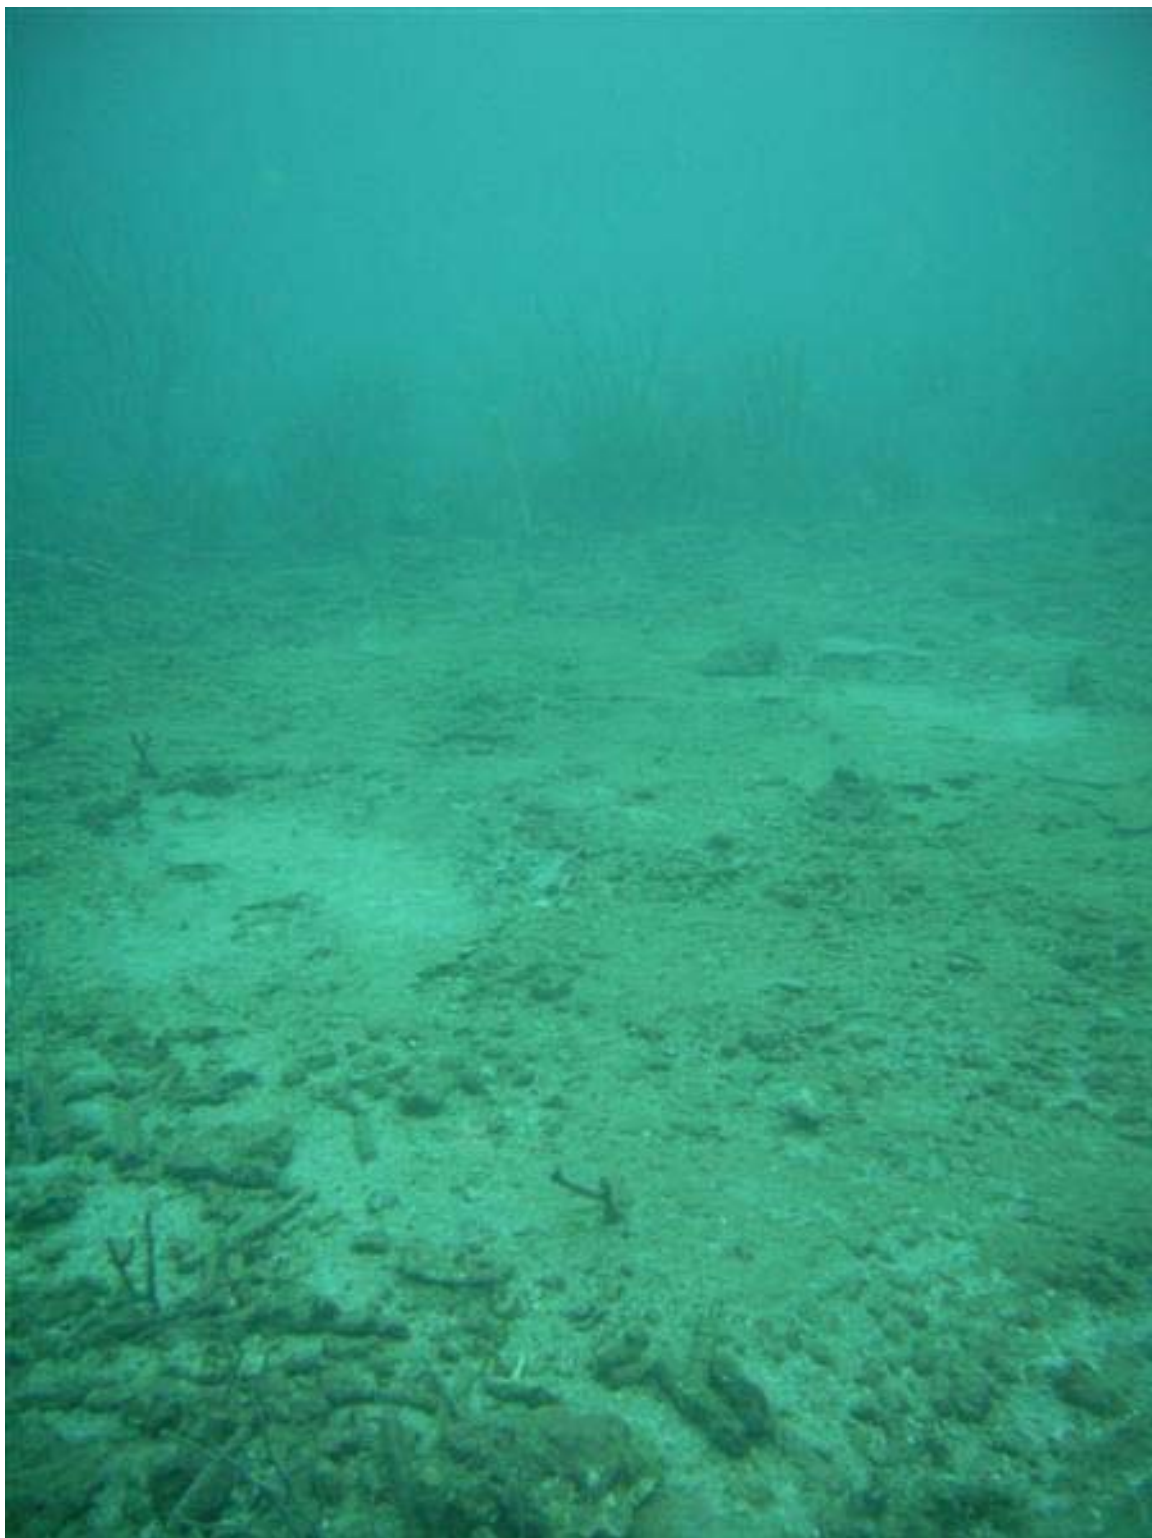
Figure 8. Close-up of Site T-15 showing areas of anti-fouling paint.
