CALLAWAY MARINE TECHNOLOGIES INC.

Re: *T/V Margara* Grounding Restoration Recommendation

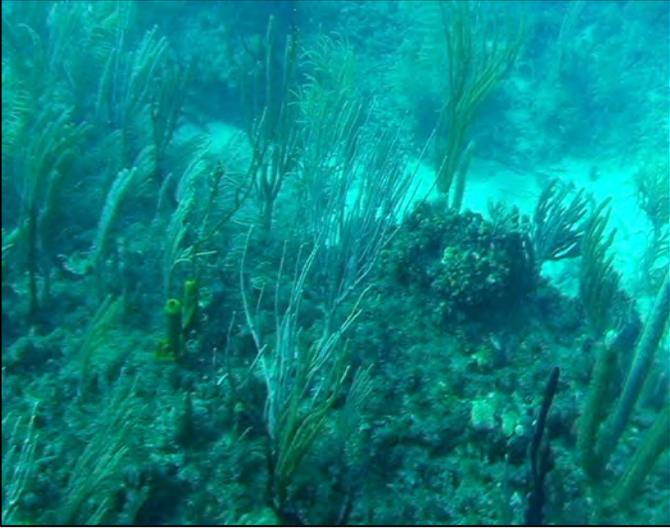
Figure 1. Natural Reef Area at the Margara Site

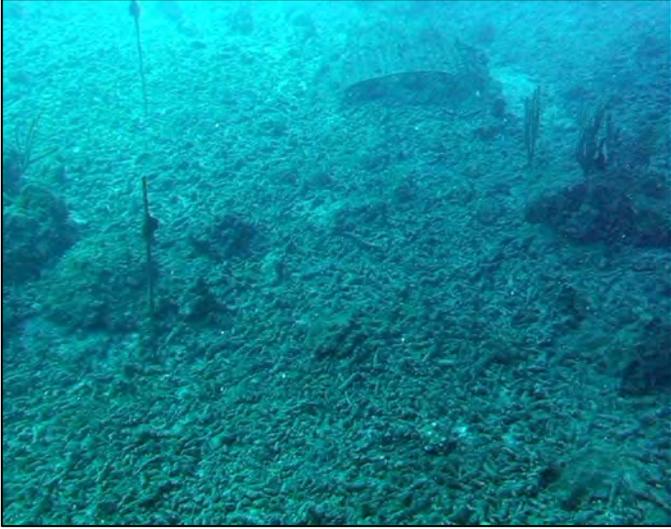
Initial restoration efforts at this site focused on stabilization and reattachment of displaced corals and substrate. The damage observed is so extensive that re-attachment of all of the available onsite material would cover only a small percentage of the impacted area. The majority of the original reef surface (or crust) has been crushed, exposing large amounts of unconsolidated rubble. Proper restoration of the site will require reconstruction of the lost topography and three dimensional complexity of reef. In addition, the restoration objective must include stabilization of the rubble to prevent further damage to the surrounding corals and expansion of the impacted areas from rubble movement. Observation and extensive documentation of other vessel grounding incidents has revealed that unstabilized, loose rubble can cause significant damage to surrounding coral, thus increasing the extent of the impacted area.

Figure 2. Impacted Area at the Margara Site

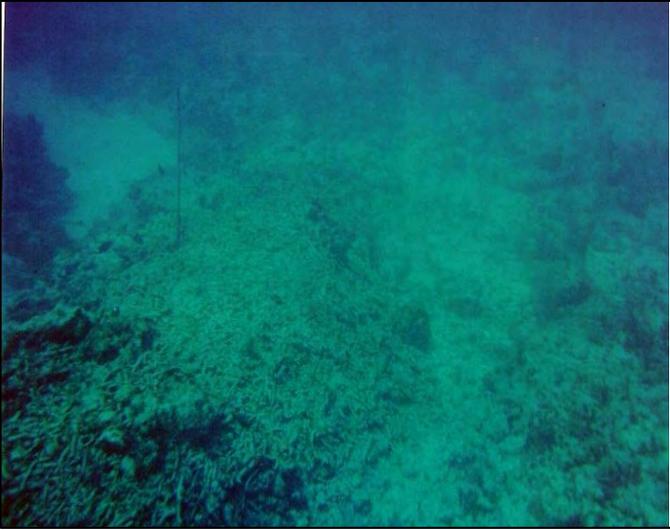
Figure 3. Columbus Iselin Grounding Site Prior to Restoration (Looe Key)

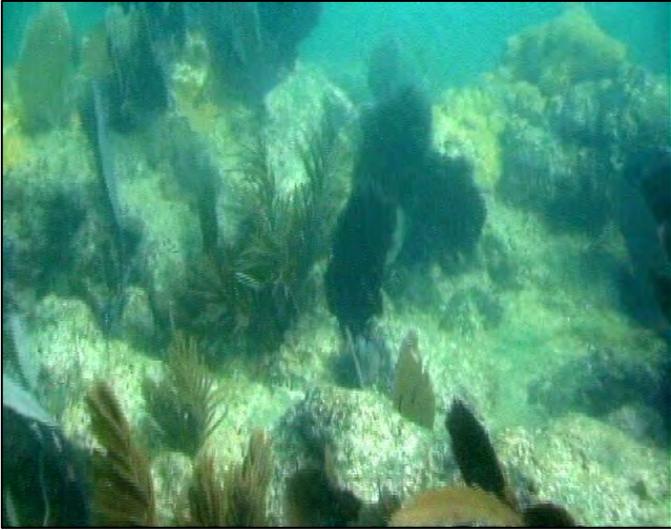
Figure 4. Columbus Iselin Grounding Site Post Restoration (Looe Key)
