**General assessment of the condition of the primary dune parallel to Road PR-187
and Parcelas Suárez both located on the municipality of Loiza, Puerto Rico**

June 6, 2018

Robert J. Mayer Ph.D.
Vida Marina: Center for Conservation and Ecological Restoration
University of Puerto Rico at Aguadilla

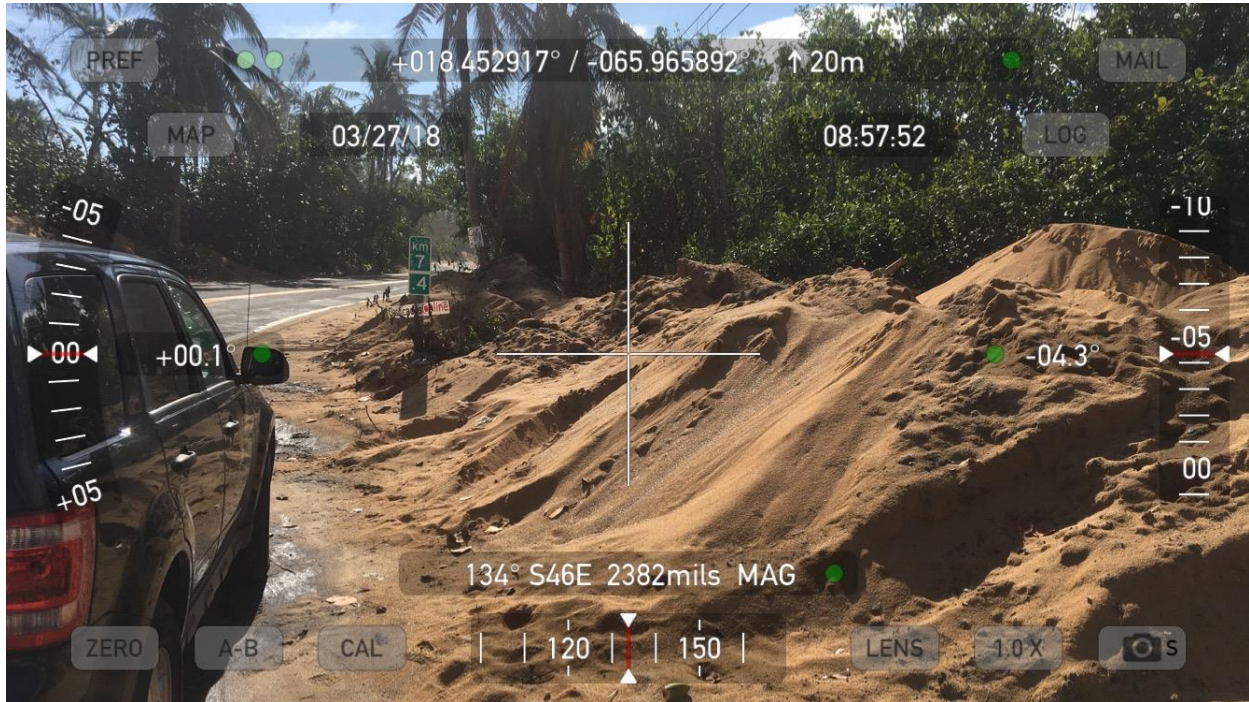
We found high volumes of **displaced sand** on both sides of road PR-187 especially on breached portions of the dune.

Figure 4. Displaced sand on the landward side of PR-187. This is very common along this route especially in areas where the dunes were breached.

A formal **sand relocation plan** for displaced sand needs to be designed and strictly implemented in this area. See figure 8 for an example of a sand relocation application form used on the mainland United States. The sand should be immediately relocated to the berm area of the beach.

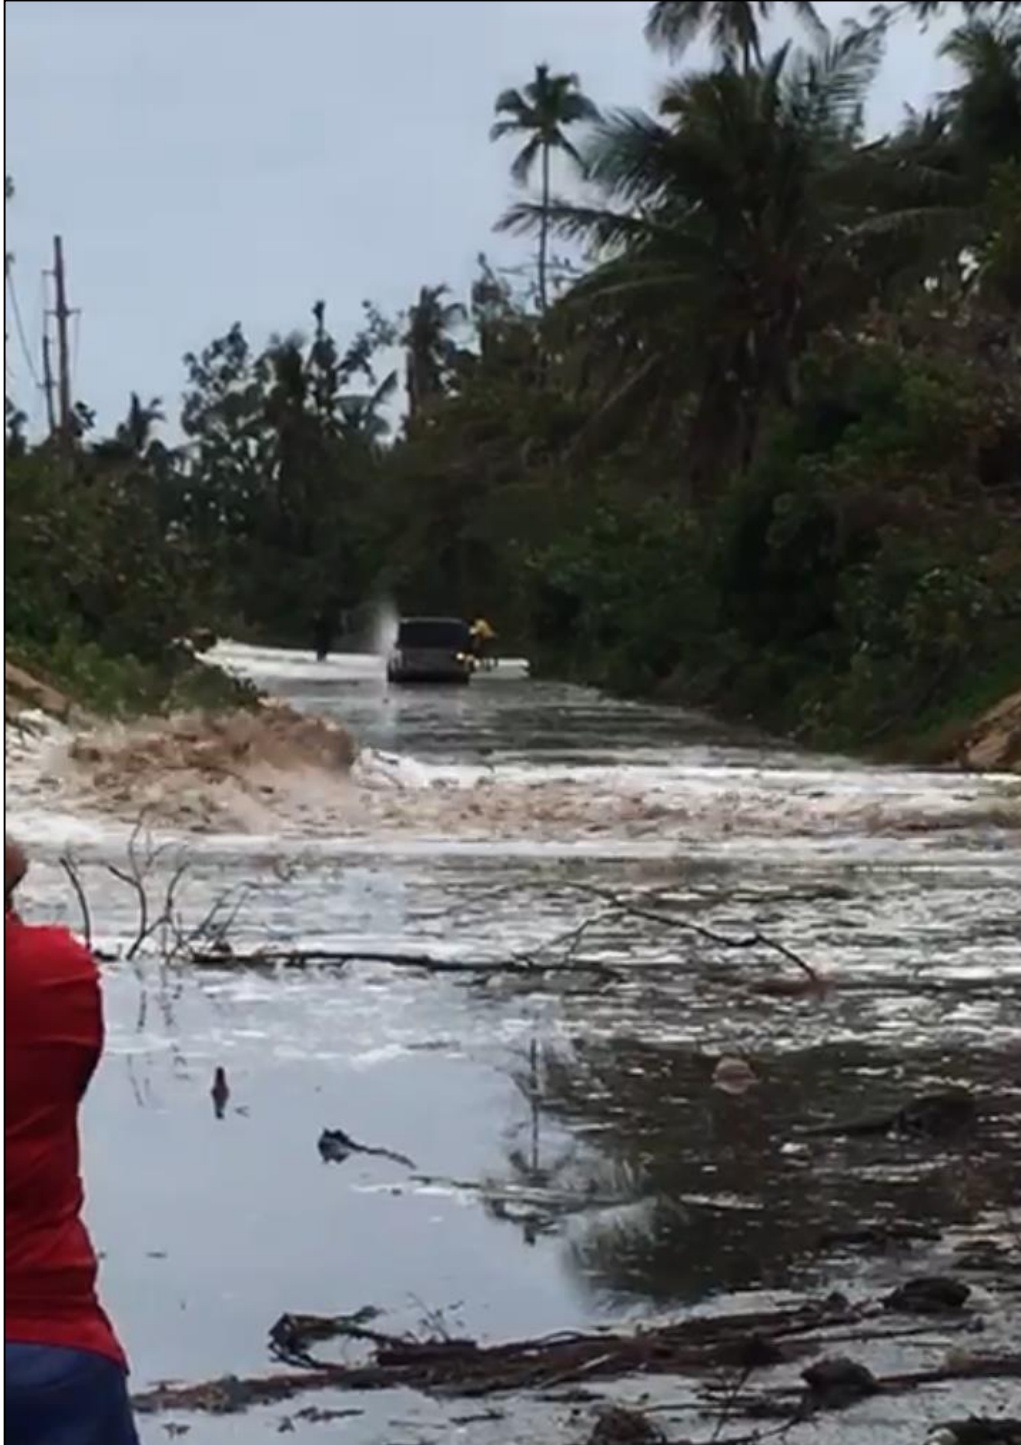
We also identified many non-vegetated and highly eroded **breaches**, used as random beach accesses, on this line of primary dune. Areas of the dune that have significant vegetation cover withstood the effects of the strong wave action of the storms while the breached areas served as inlets of large volumes of sea water that caused massive flooding on this area (figure 5).

Figure 5. Stream of seawater flowing from the beach to PR-187 through a breached beach access on the primary dune during the week that winter storm Riley affected the Puerto Rico coast.

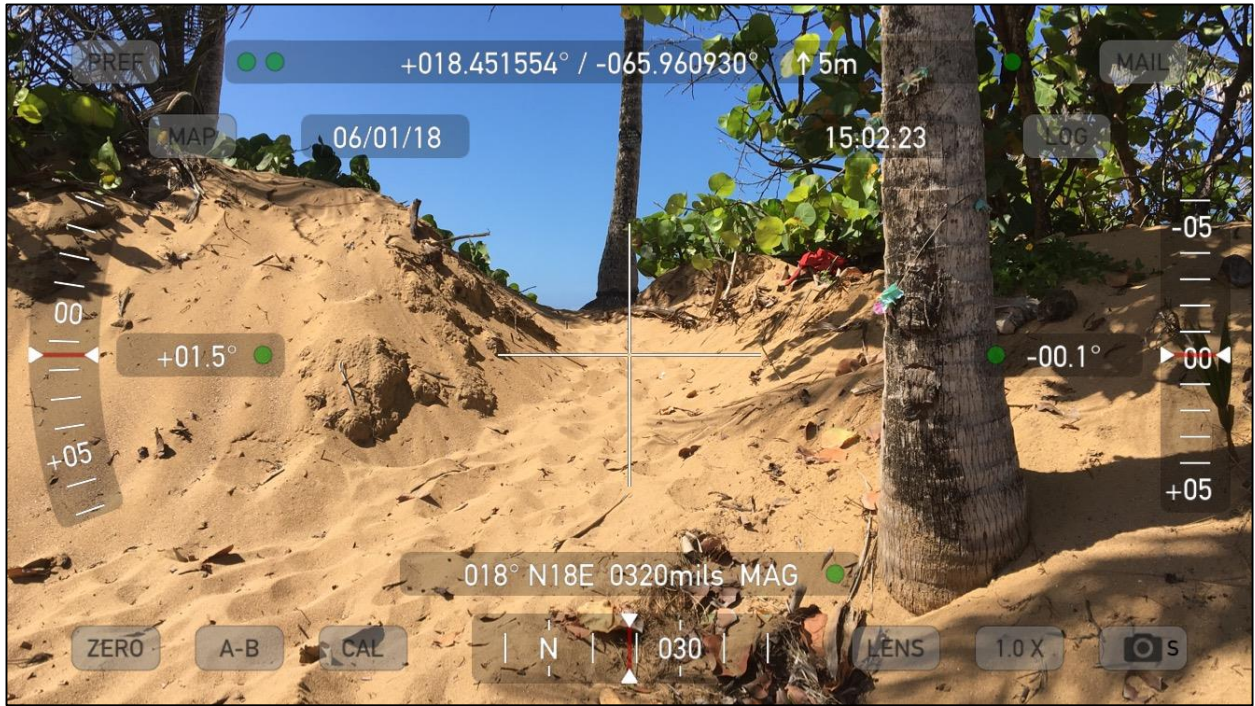
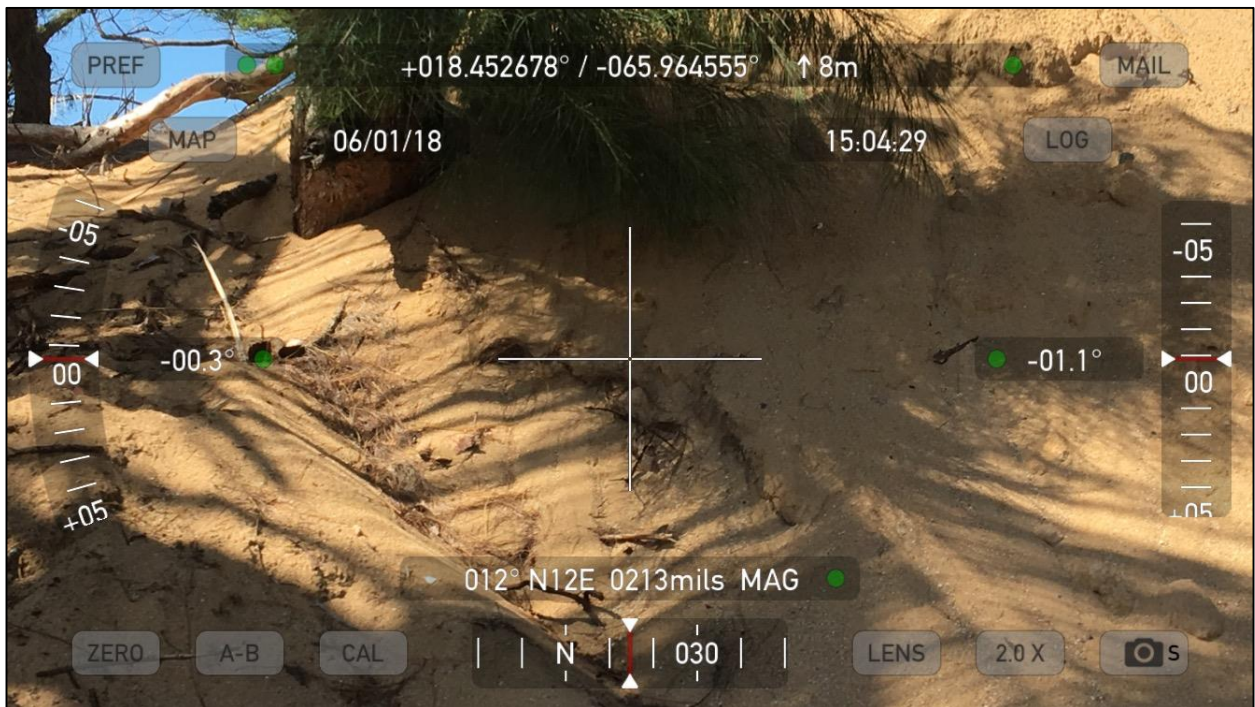
Many areas on these **random beach accesses** have no vegetation, a factor that reduces the stability of the dune (figure 6). We also found several **wooden boardwalks** that are in very bad (even dangerous) condition and should be repaired immediately. Additional better-designed and longer boardwalks should be installed along this area of dunes in order to re-direct foot traffic (which is heavy in some areas) away from vegetated areas. This simple measure would reduce flooding of this road significantly. If foot and sometimes vehicular traffic is not redirected the problem of flooding and massive sand displacement will not be resolved.

Figure 6. Two of the many random beach accesses along the primary dune parallel to PR-187.

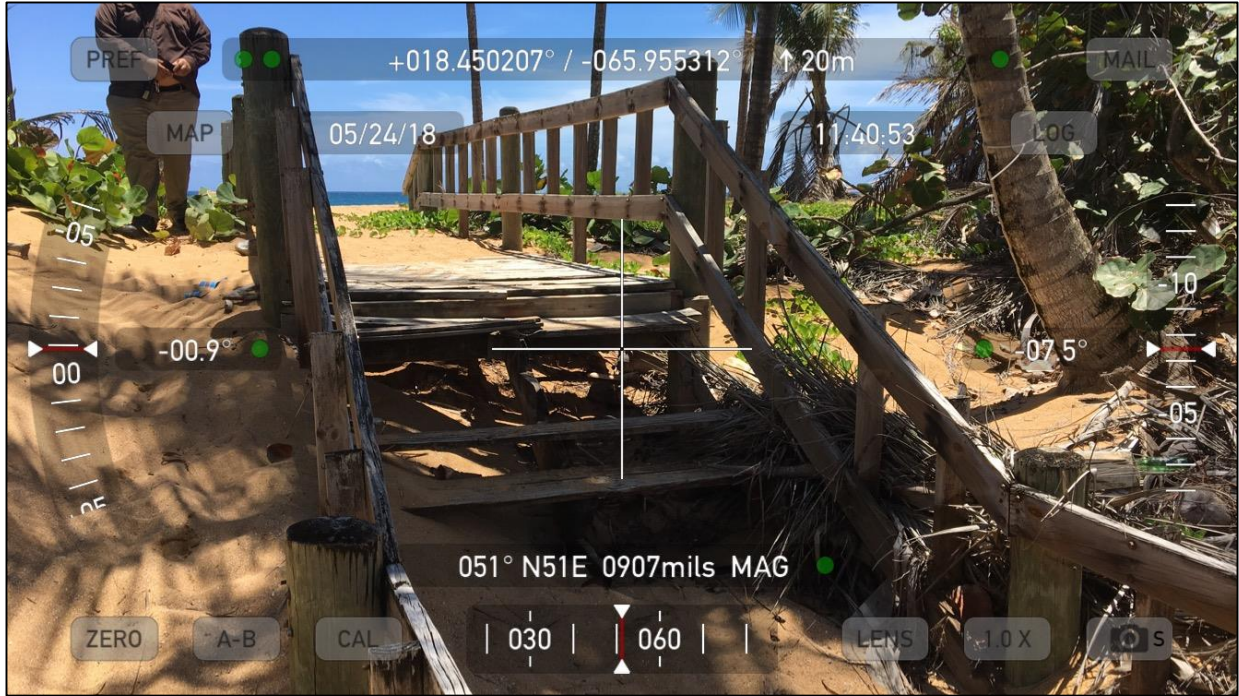
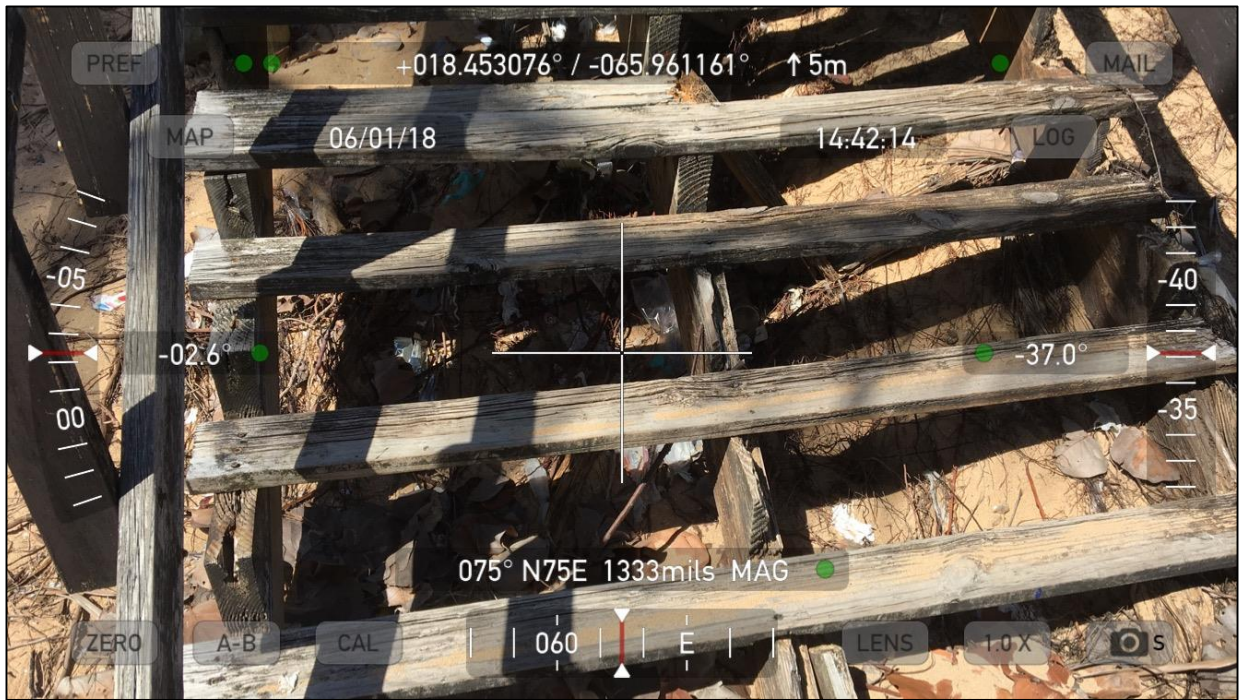
Figure 7. One of the wooden boardwalks on the primary dune along PR-187.

We have a method for the analysis of foot traffic patterns on highly visited areas allowing us to locate the new **wooden boardwalks** in the best possible locations. This integrates the use of a UAS and photogrammetry software (Pix4D and Sample Point). Our boardwalks have been very effective in redirecting foot traffic in the Isabela area and even withstood the recent storms. Our data from previous projects on the western coast of the island suggests that this is the only effective way to increase vegetation cover in areas of high foot traffic such as this one. We are recommending the installation of wooden boardwalks that will reduce the incidence of random foot traffic and plant trampling that promotes erosion of the primary dune. The **random accesses** should be closed with exclusion fencing and signs should be installed in these areas in order to make people aware of the problem that these breaches on the primary dune cause and the direction to the nearest designated beach access (walkover).

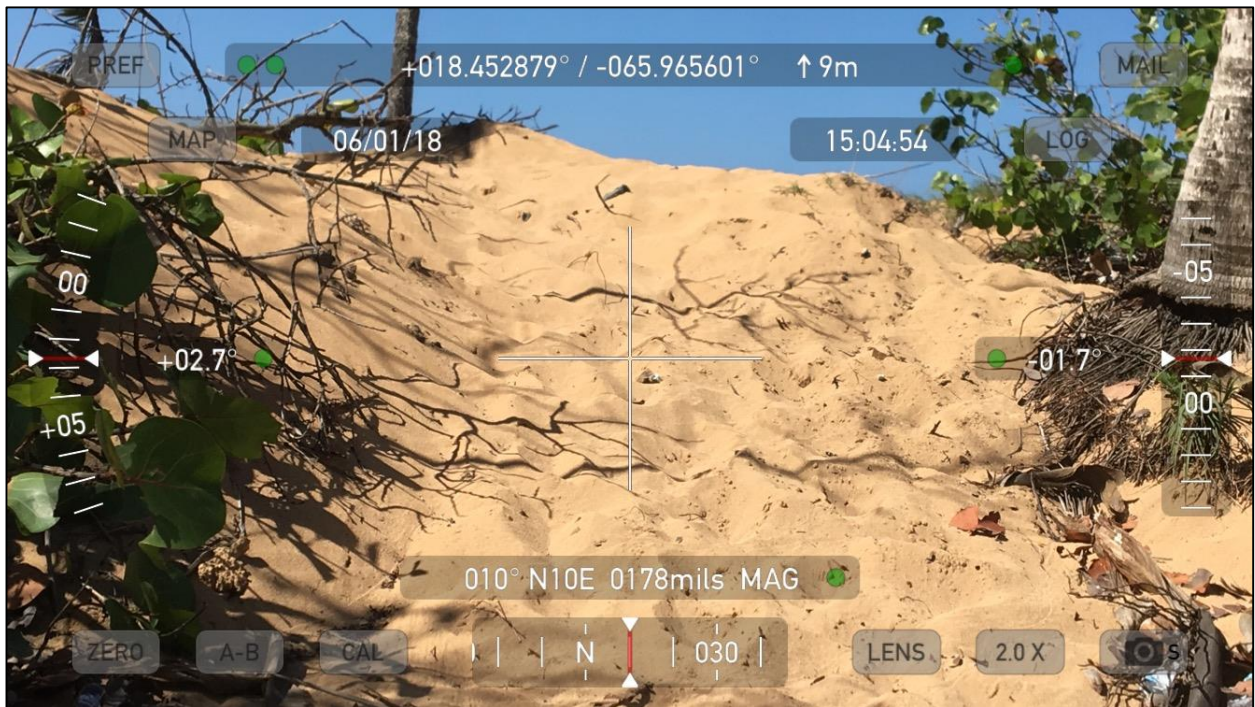
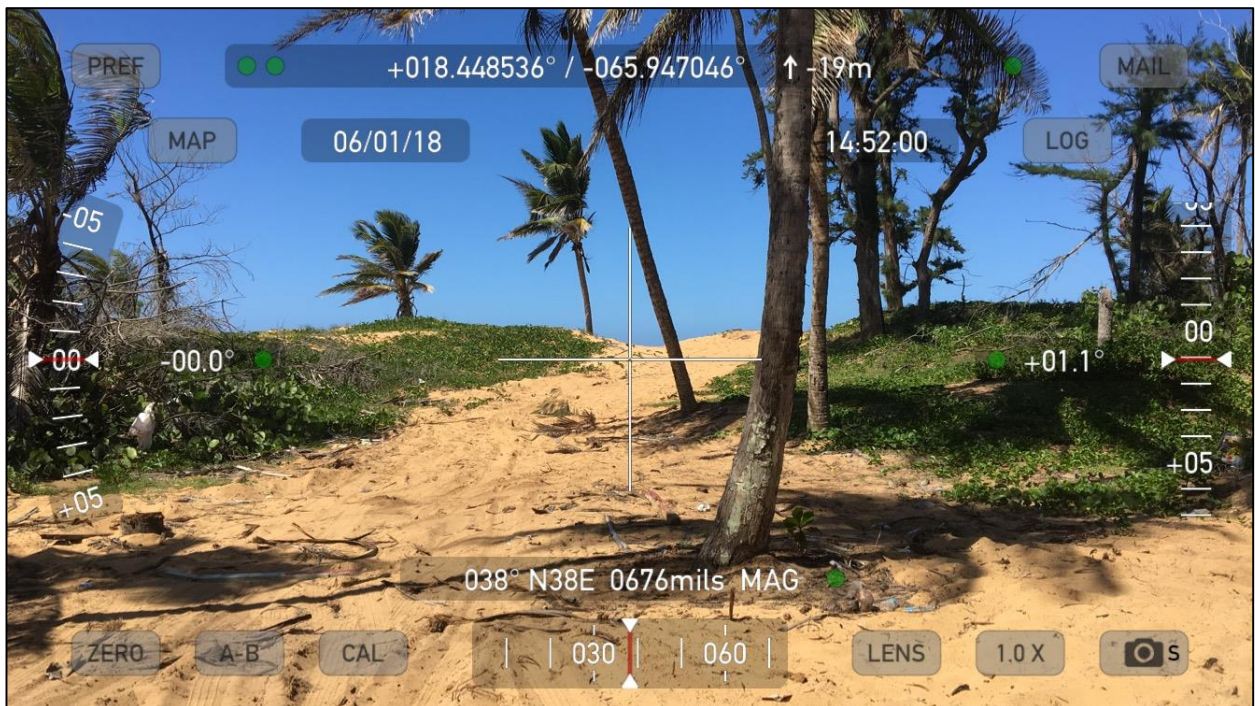
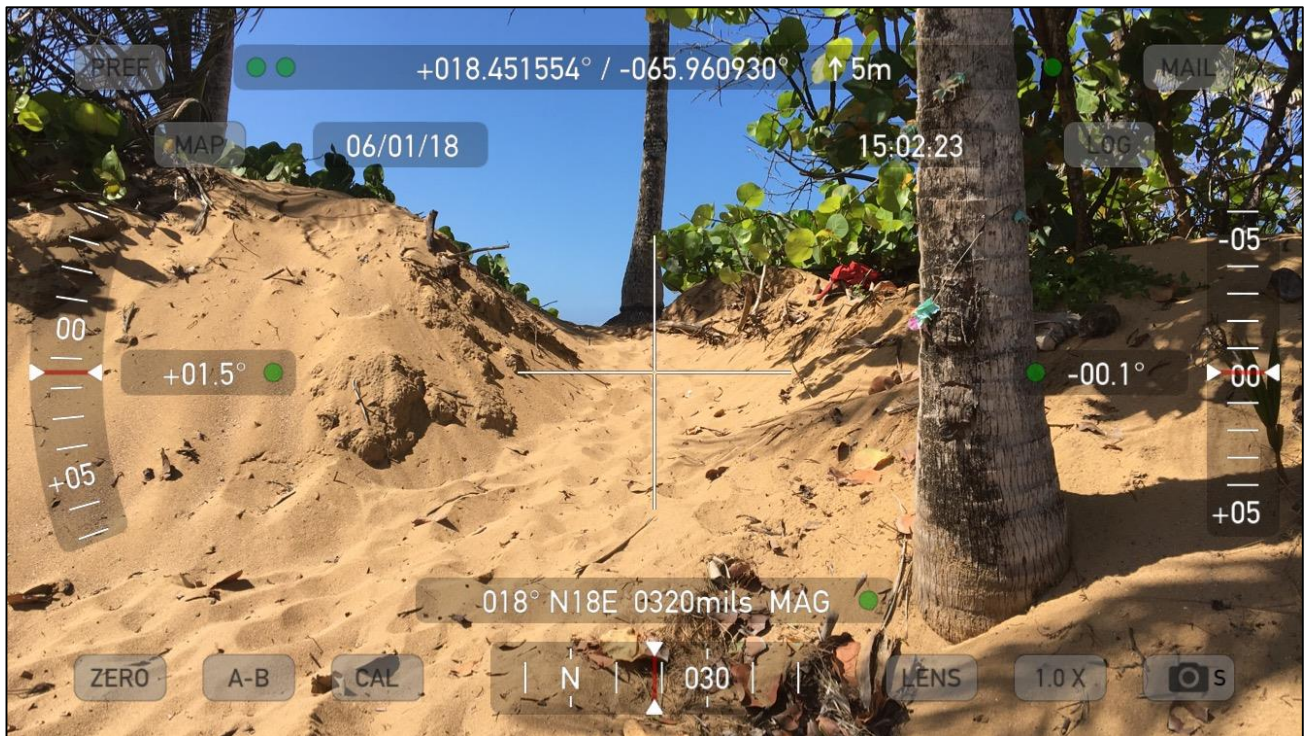
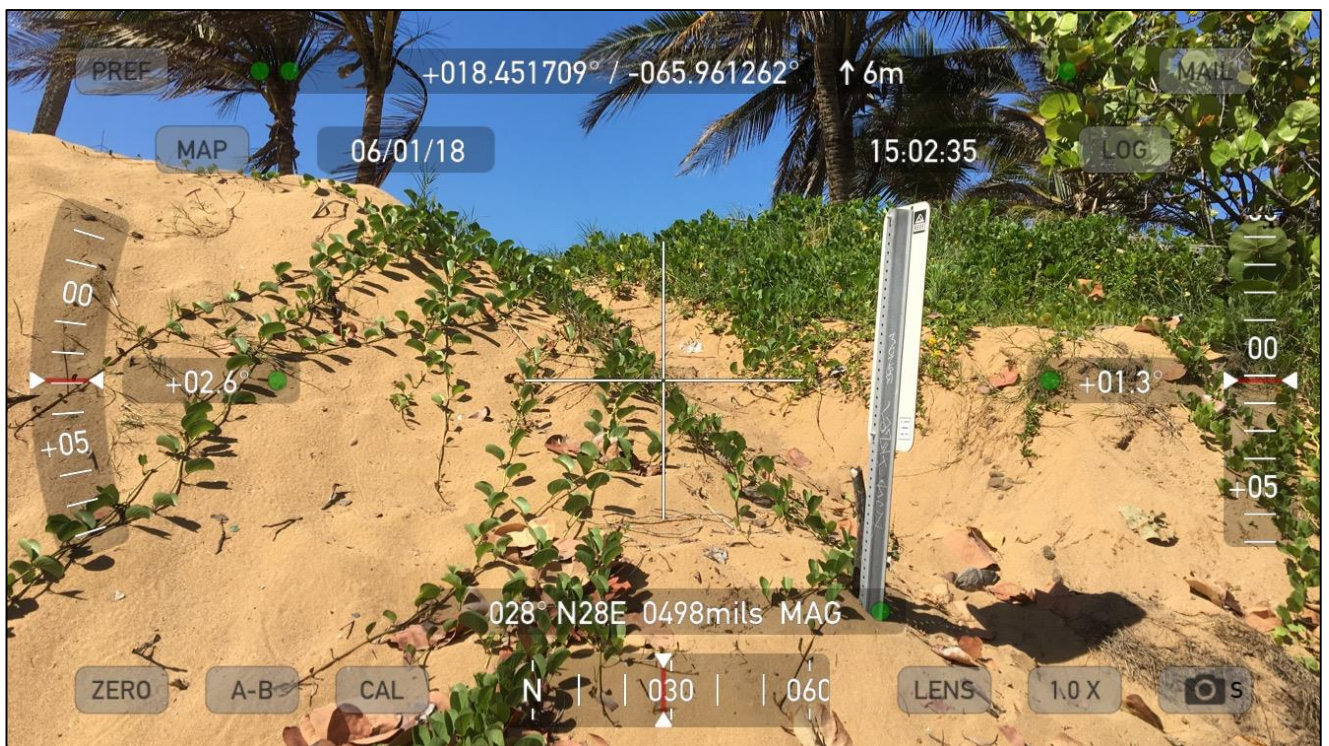
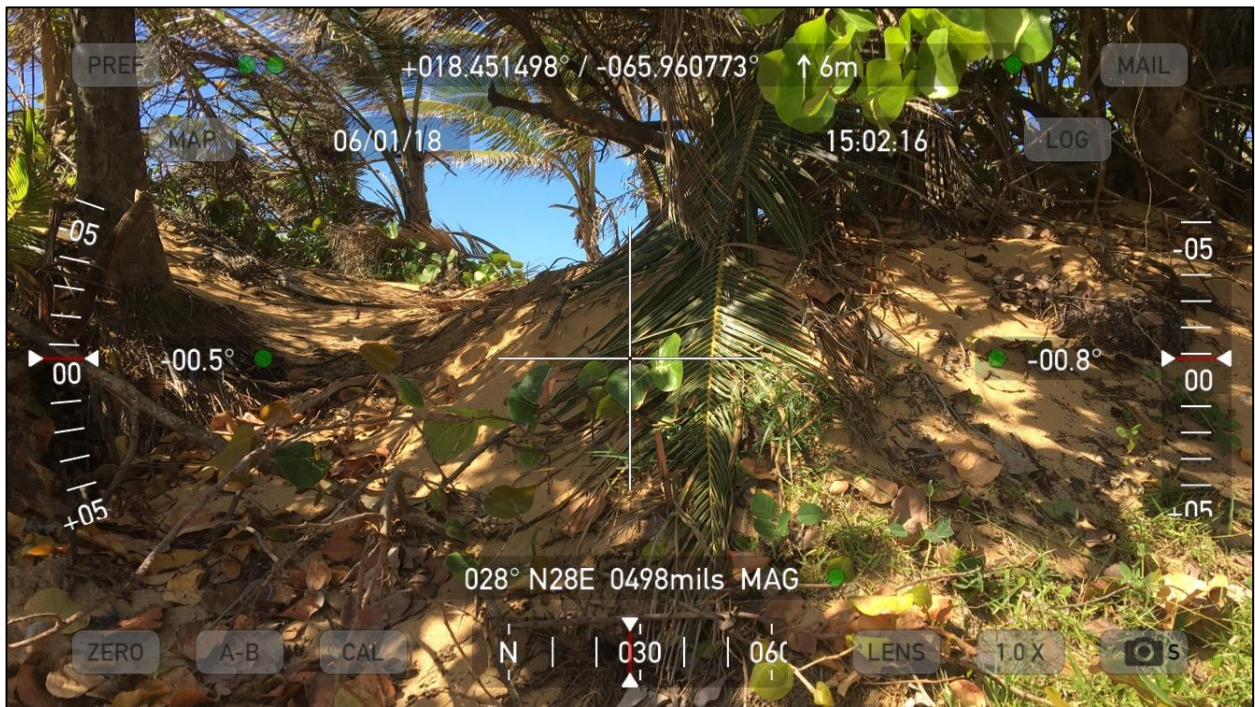
Additional breaches that should also be repaired.

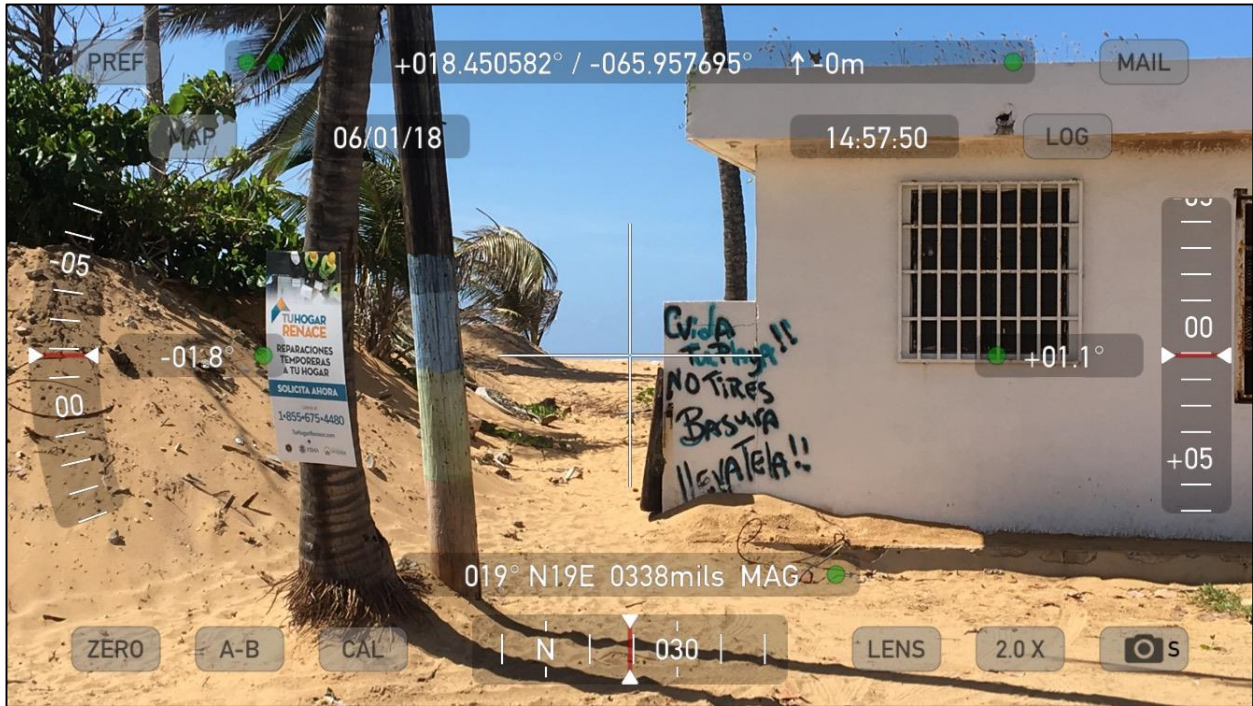
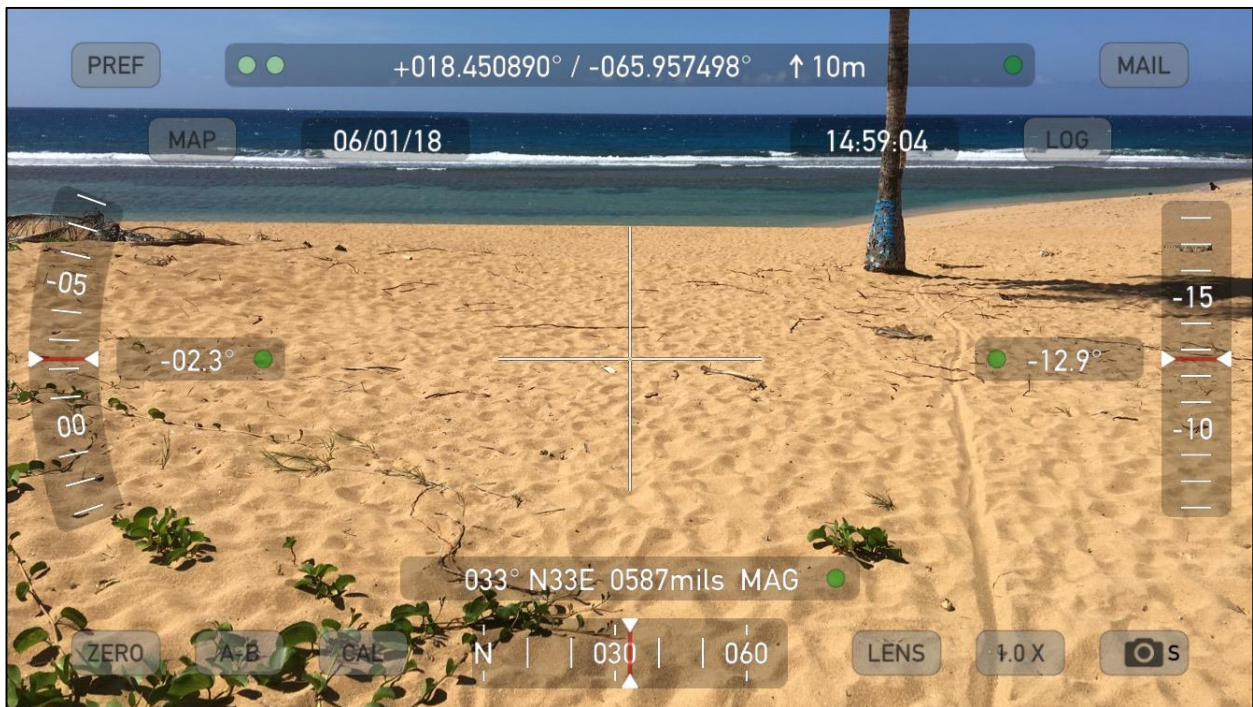
The access on the left of the building on the top picture should also be blocked. The beach area behind the buildings (bottom picture) should be restored with sand trapping devices and pioneer vegetation such as the beach bean thriving on the same picture. The growth of this plant in this area is limited by the heavy foot traffic (note footprints) and dragging of coolers.

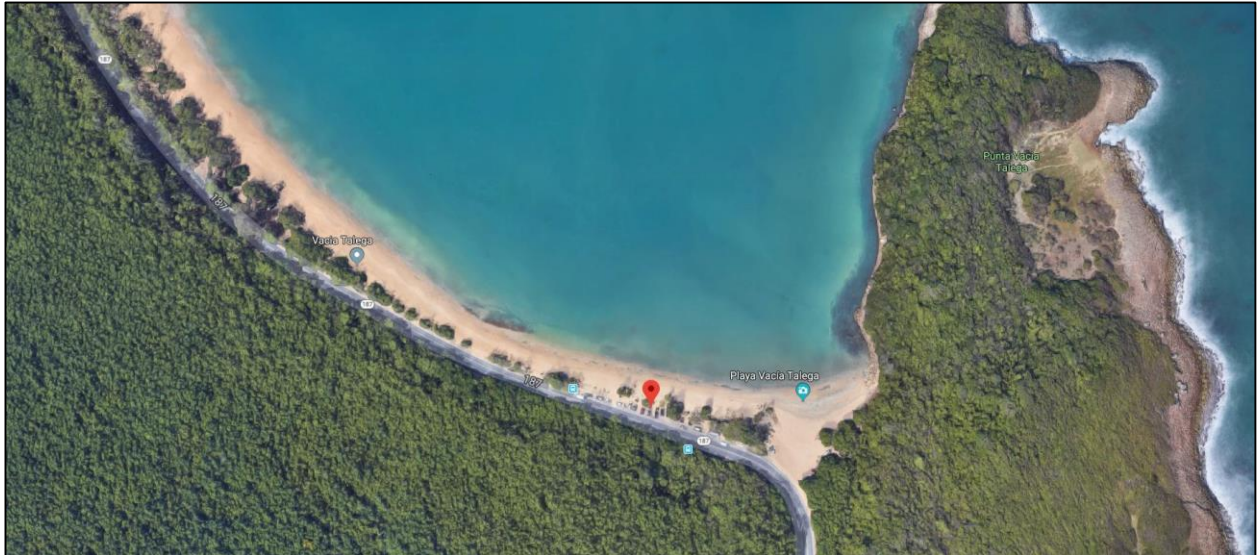
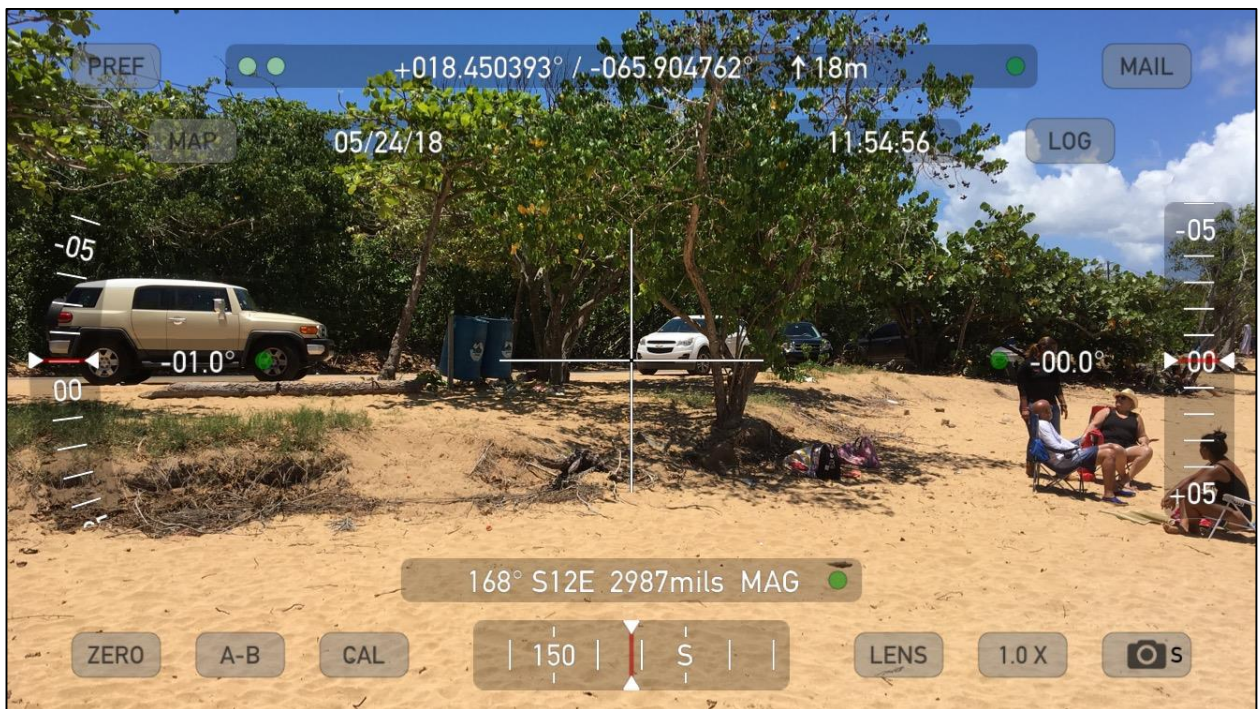
Site 6 (Vacía Talega).

This is Vacía Talega Beach is an area of heavy recreational use. This area experiences heavy foot and vehicular traffic specially during weekends and holidays. We recommend exclusion fencing in the area to reduce vehicular damage to an incipient dune and pioneer vegetation. Information signs and at least two wooden boardwalks could significantly contribute to at least some sand accumulation (the morphology of the coast does not

promote sand transport – personal communication with Dr. Rosana Grafals and Dr. Maritza Barreto from UPR) but excluding traffic from the beach could promote the growth of stabilizing plants and some sand accumulation that would make this area more resilient to extreme weather events.

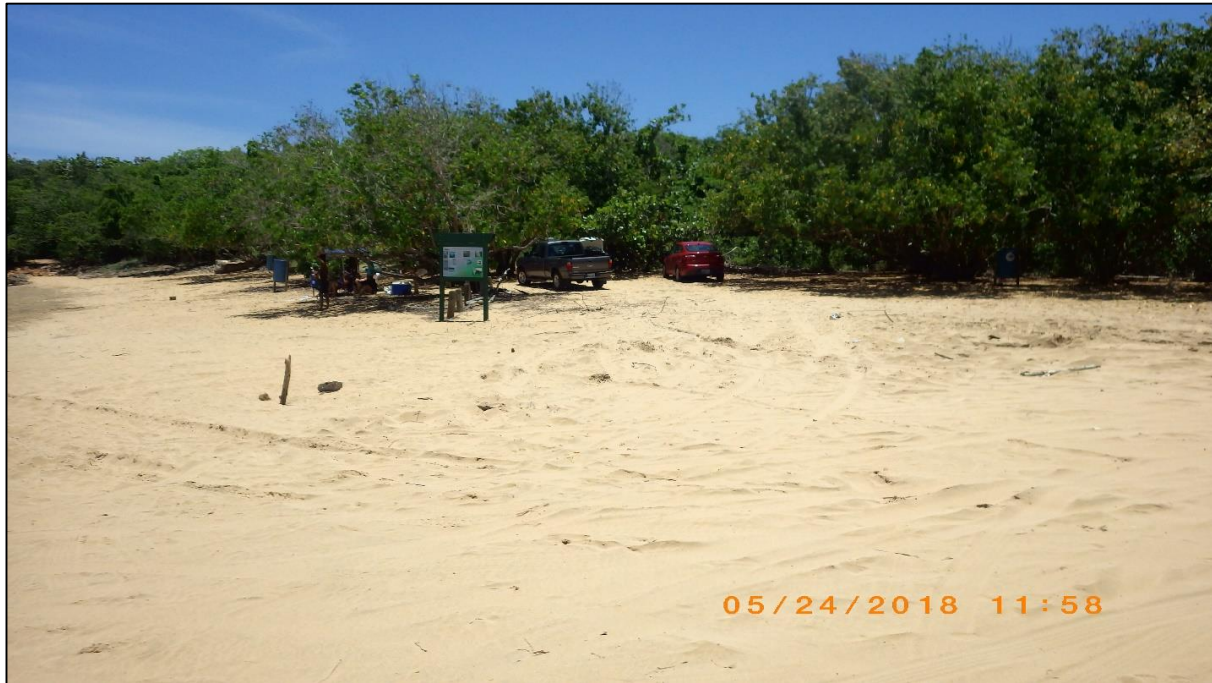
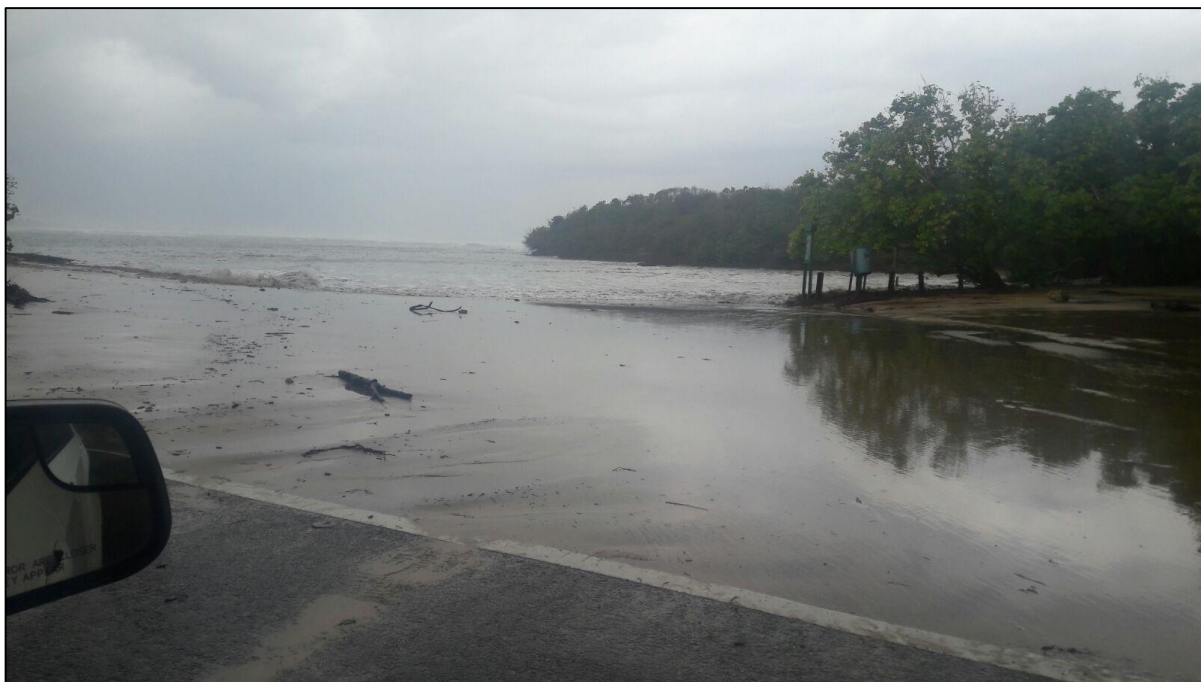
This unprotected beach leaves road PR-187 exposed to heavy wave action and flooding during strong storms. This area experienced heavy flooding during winter storm Riley (see below).

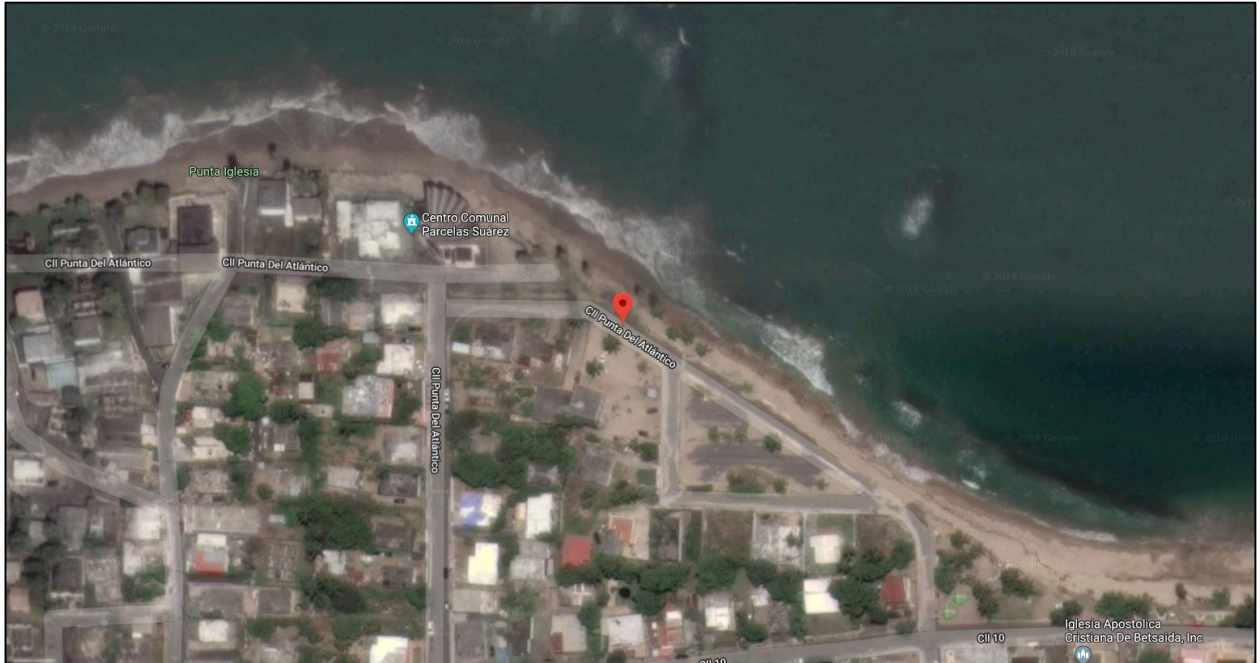
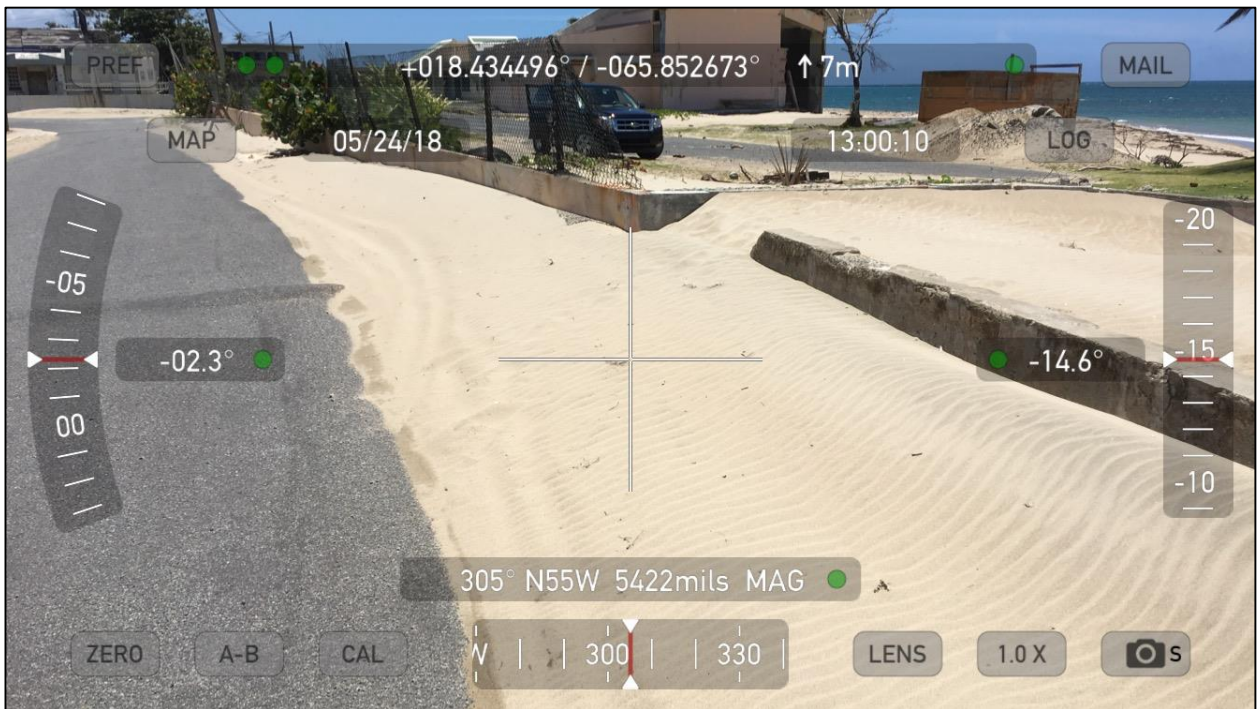
Site 8 (Parcelas Suárez).

Road Punta del Atlántico in Parcelas Suárez was severely affected by wave action during the extreme events of 2017 and early 2018. The road was closed and there are plans to install hard structures to protect the coast. Our recommendation is to immediately demolish the extremely dangerous Centro Comunal Parcelas Suárez building and install experimental sand trapping devices in the area as well as exclusion vegetation followed by the planting of pioneer vegetation. Even though Dr. Maritza Barreto thinks there is no significant landward sand transport we were able to witness a significant amount of sand (brought in from nearby areas of the coast by winter storm Riley?) being constantly blown on-shore. We also saw ripples on the sand suggesting sand accumulation and significant amounts of sand being accumulated on the yards of nearby houses. The pavement of the closed road should be removed and the area should be planted with pioneer dune vegetation combined with biomimicry matrices as a last alternative before installing hard structures on this area. We perceived more support to green infrastructure by the municipal government and community members. This is something to be seriously considered. We can monitor sand accumulation closely using our UAV system and photogrammetry software.

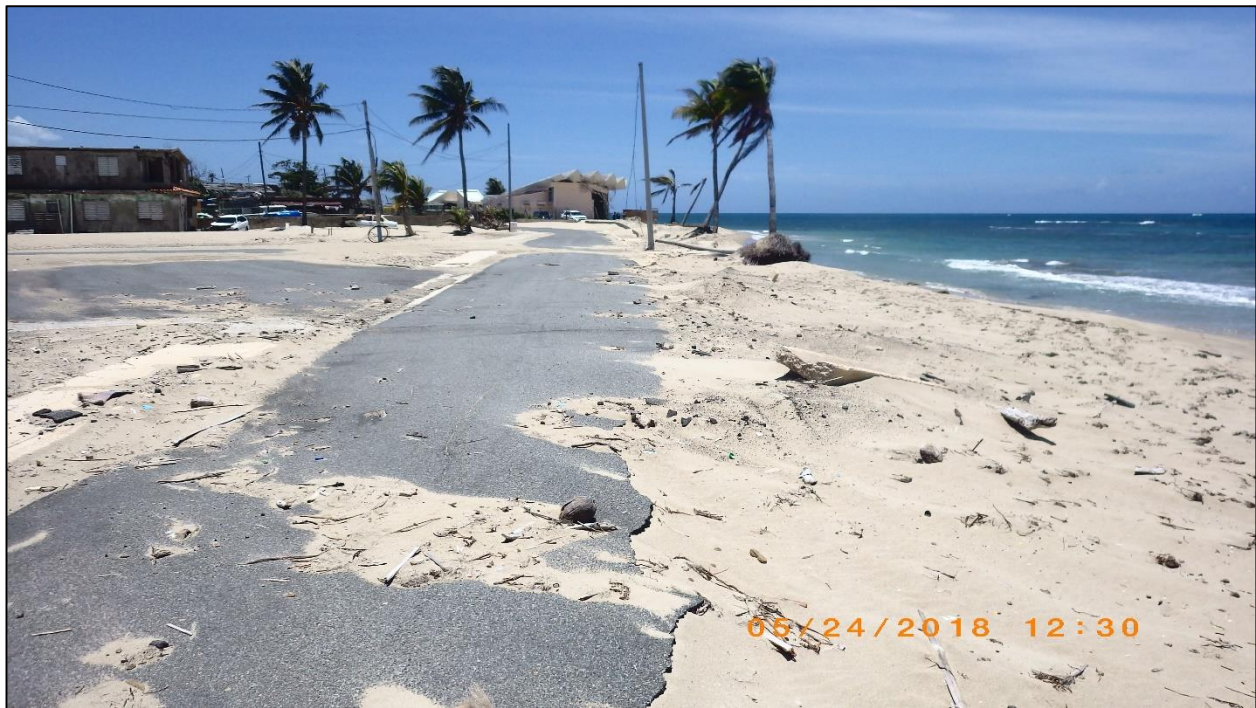
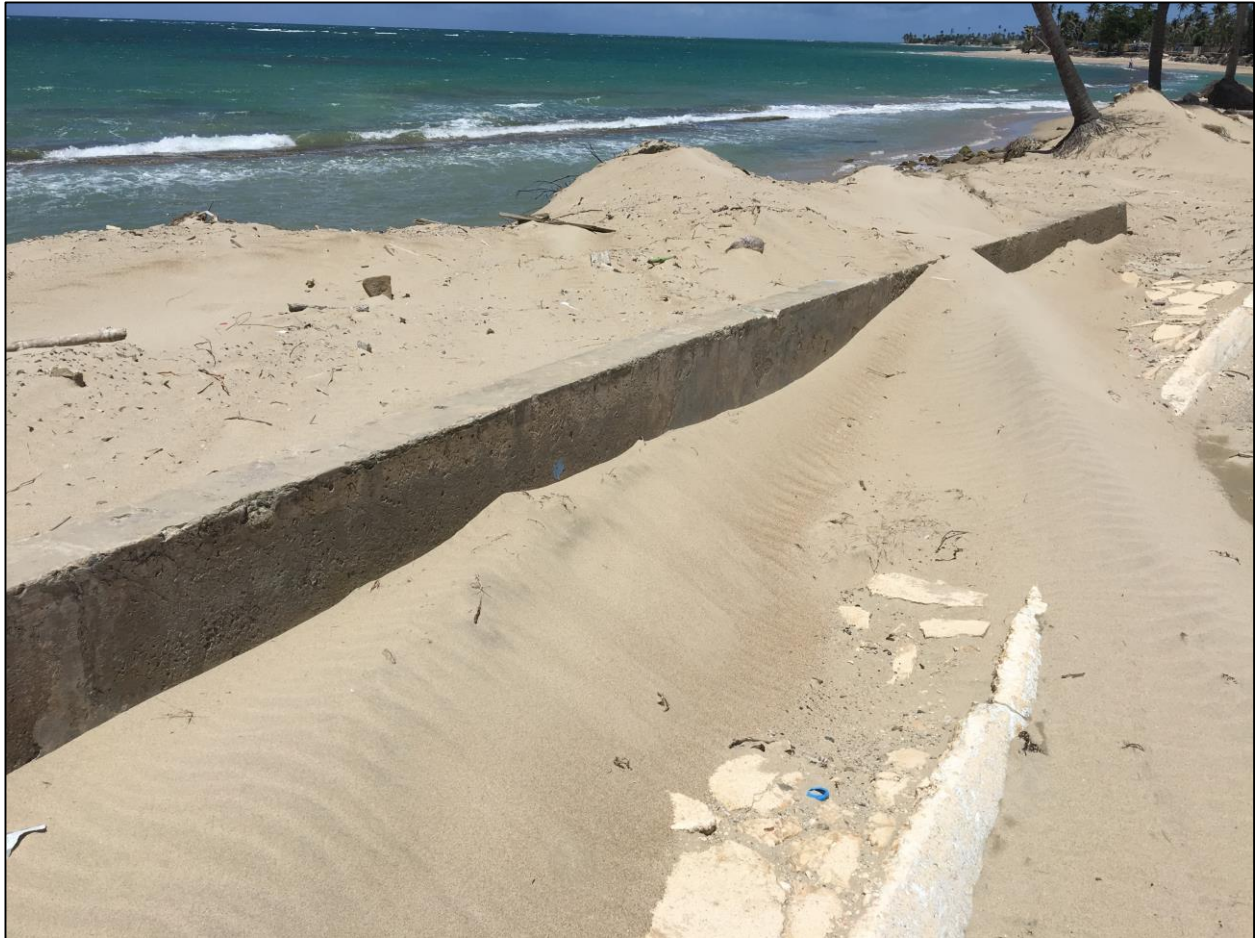
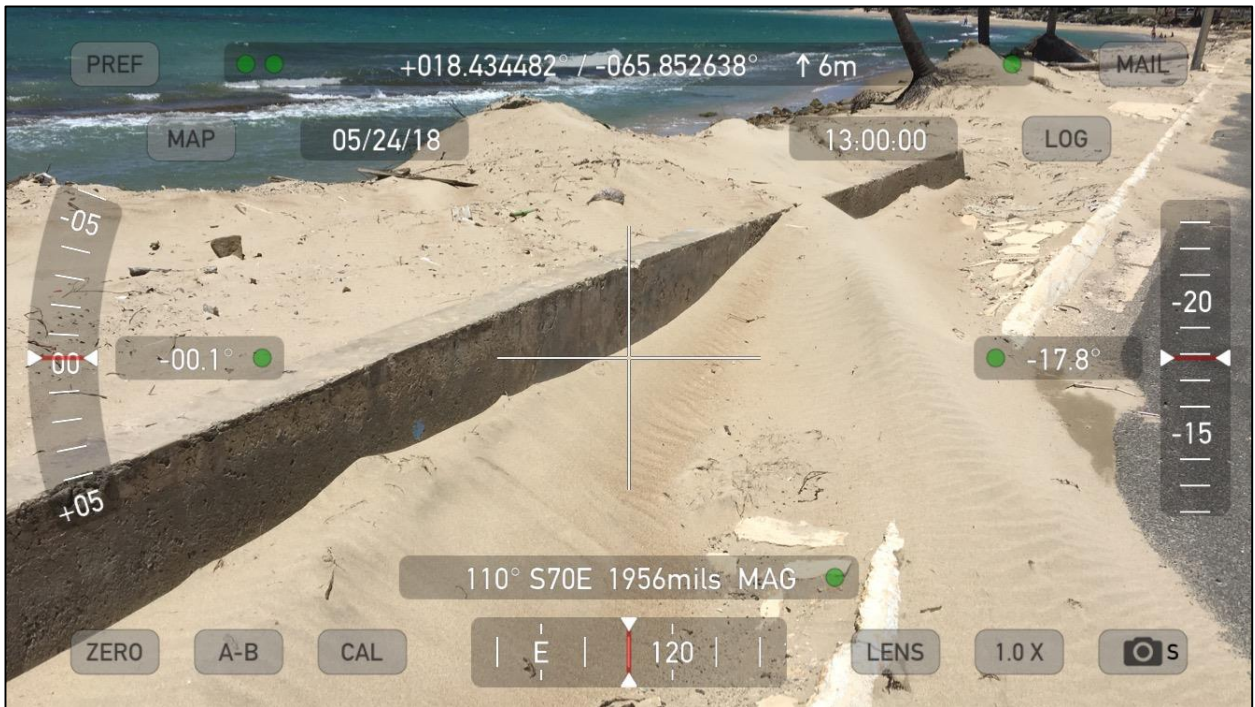
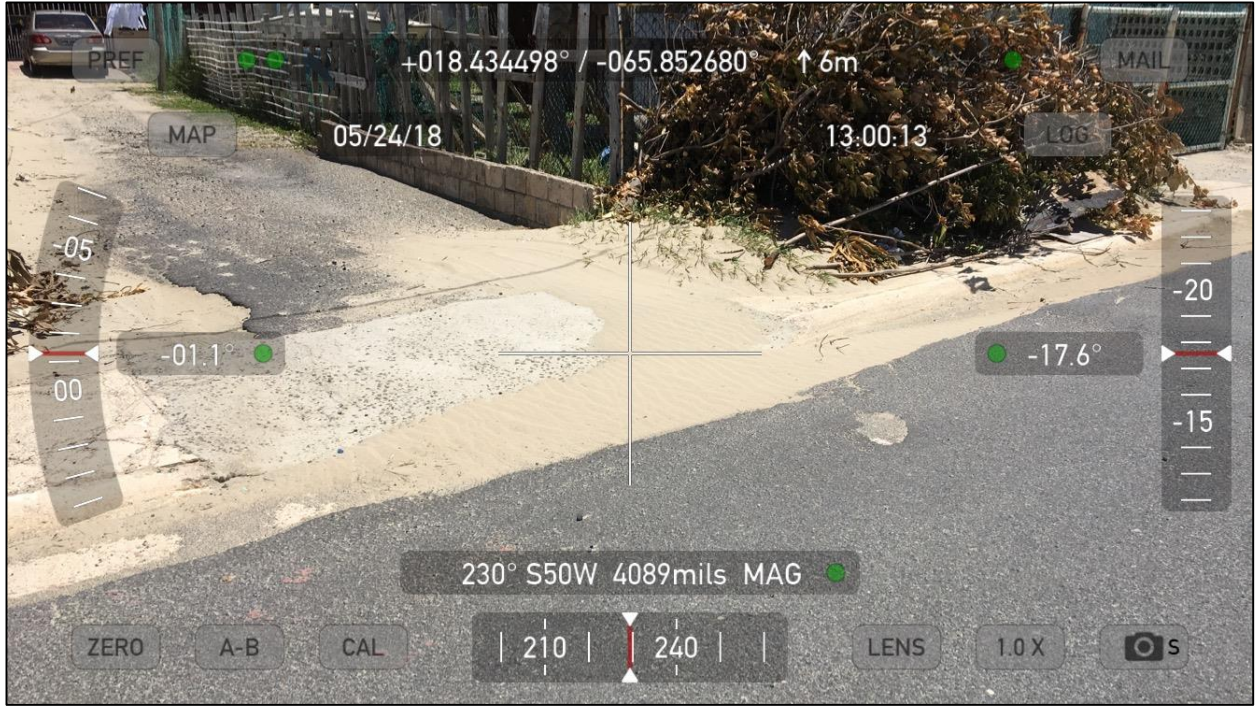
Sand being transported landward and being accumulated on the road and houses in Parcelas Suárez.
