Puerto Rico and Caribbean Beach Network  
Planning School  
University of Puerto Rico  
Rio Piedras Campus

Final Report

**Assessment of beach morphology at Puerto Rico Island**  
Contrato Núm. 2015-000101

January 31, 2017

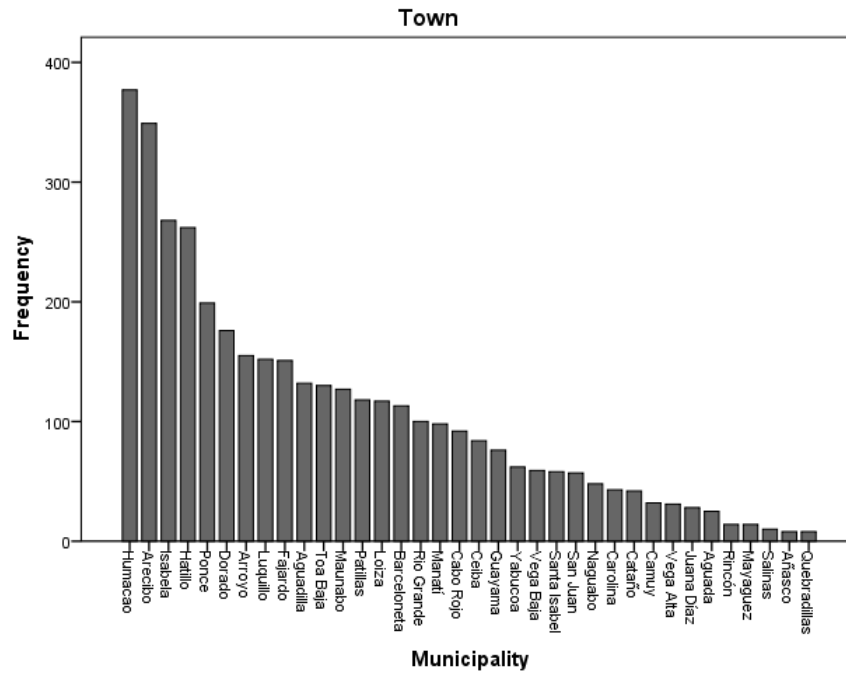
Figure 7. Frequency distribution of beach transects by municipality included in this study.

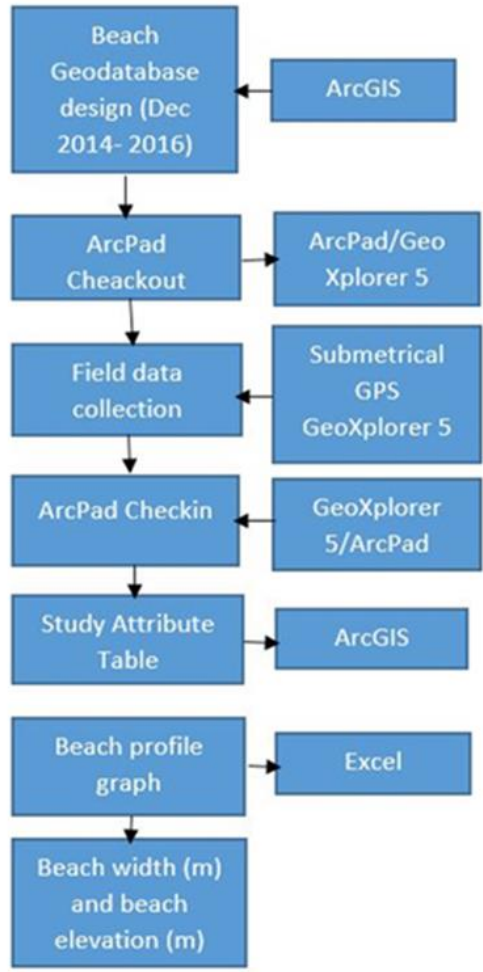
Figure 7. Conceptual Map of Beach profiling method through mapping using submetrical GPS (Prepared by Nahir Cabrera, Barreto and Cabrera, in publication process).

The beach profiles were collected using a submetric Global Positioning System (GPS Trimble GeoXplorer 5) through mapping procedure (Figure 7). ESRI ArcPad and ArcMap softwares were used to design a geodatabank (Barreto and Cabrera, in publication process), data acquisition and evaluation. The databank includes fields as latitude, longitude, elevation and comments. North American Datum 1983 (NAD 83) was used as a horizontal datum in this study. The GeoXplorer 5 is calibrated using the new absolute vertical Geographic Datum for each beach selected in this study for increase vertical measurement precision. Vertical Reference used in this study was Geoid 12A PRVD02-PR vertical datum 2002. An additional vertical calibration was performed in each site base on geographic location (Table 11).

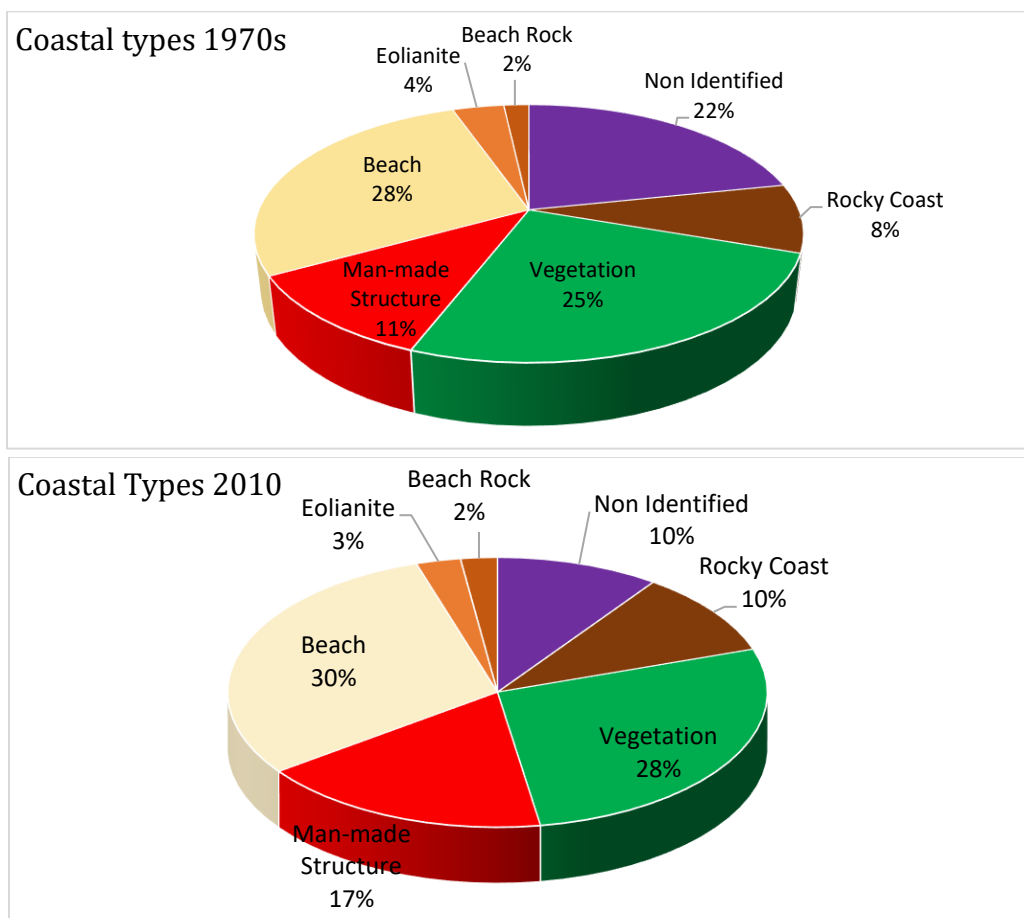
Figure 9. Coastal type distribution at Puerto Rico (1970 and 2010)

Evaluation between coastal types between 1970's and 2010 photos were execute to identify coastal types for both period (Figure 9). However, quantitative evaluation of coastal types cannot conduct due to coastal features cannot identified in all photos due to spatial resolution and quality (no-identify category). In addition, 2010 coastal types evaluation includes Vieques and Culebra Islands. Therefore, qualitatively evaluation indicated that man-made structures might increase along the shoreline for 2010 period at the Island.

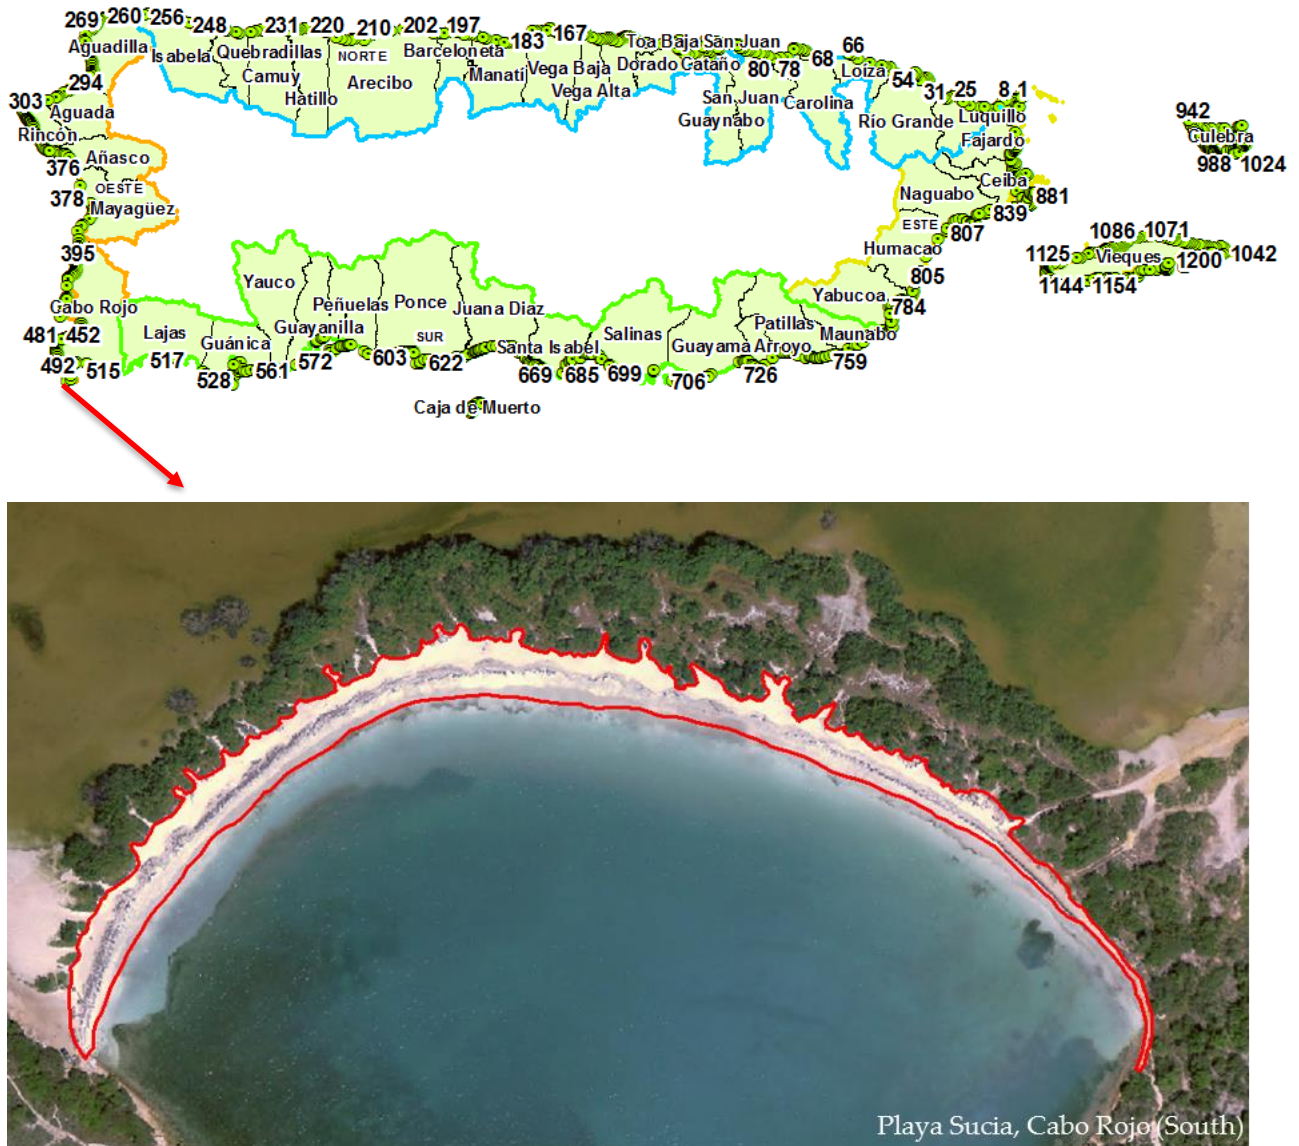
Figure 10. Puerto Rico beach inventory (2010) (Barreto and Valentín). a. Map showed all beach units identified in the inventory. b. An example of a beach unit (beach polygon), Playa Sucia, cabo Rojo.

The Island of Puerto Rico has 1225 unit of beaches for 2010 period. Beach units are identified for the main Island of Puerto Rico, Vieques, Culebra and Isla de Caja de Muertos (Figure 10). The municipalities with major amount of beach units are: Vieques (172), Cabo Rojo (127), Culebra (111), Ceiba (60) and Rincón (53) (Figure 11). These beaches are mainly short and narrower beaches, with a lunate shape located between rocky shorelines.

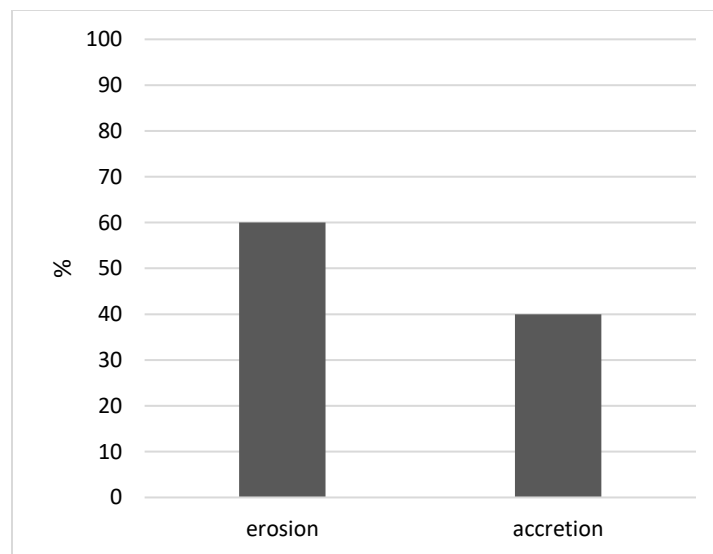
Figure 16. Distribution of accretion and erosion (%) in beaches at PR (1970's and 2010).

An overview of shoreline changes showed a variety of erosion and accretion along the Puerto Rico coastline position from 1970's to 2010. Loss of sand is the major event found in the majority of beaches from 1970's to 2010. Approximately, 60% of the beaches included in this study suffered erosion in Puerto Rico for this period. Accretion is identified in 40% of the beaches in the Island (Figure 16).

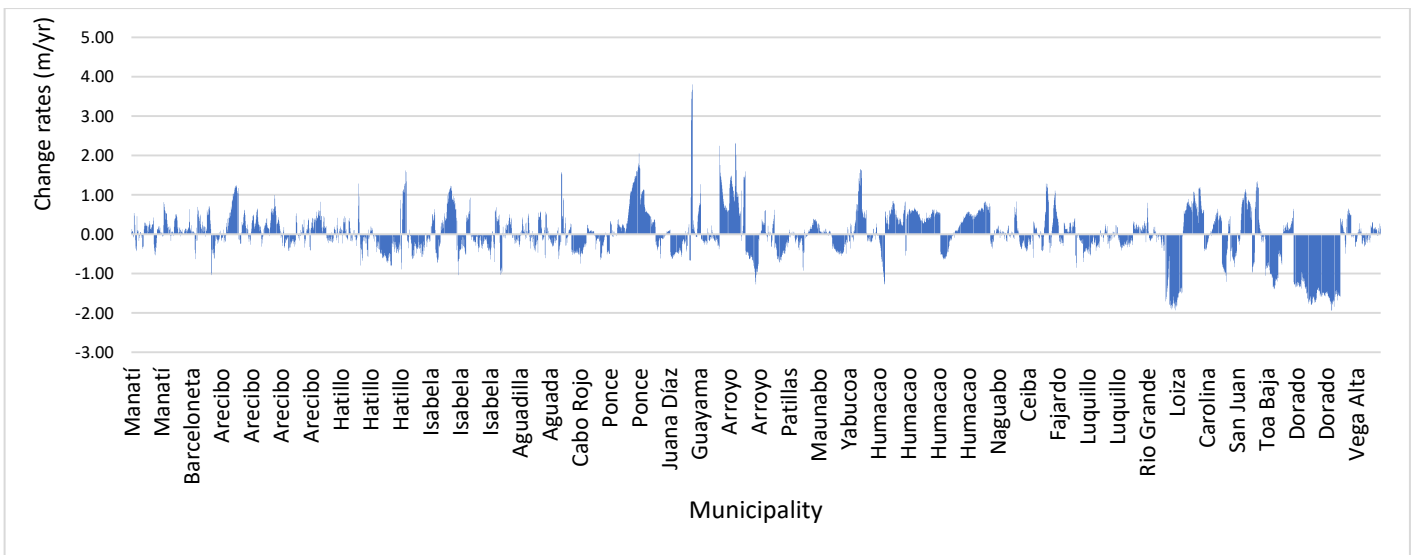
Figure 19. Shoreline Change rates (m/yr) at Puerto Rico, 1970's and 2010.

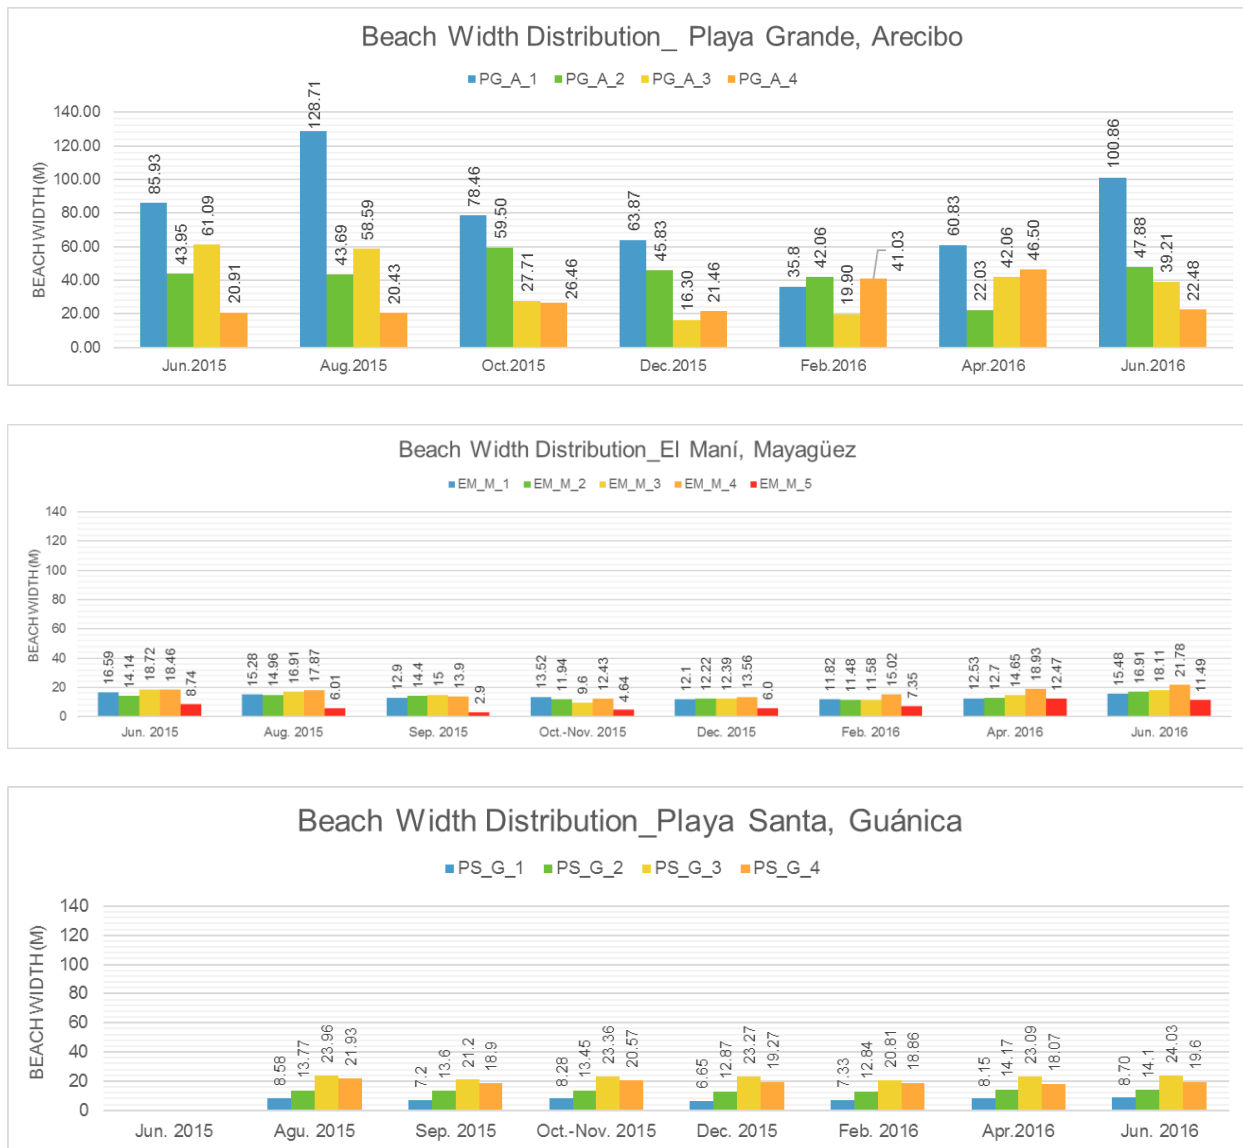
Figure 21. Beach width distribution at Playa Grande, El Maní and Playa Santa.

One hundred four (104) beach widths measurement were collected from June 2015 to August 2016 in all selected beaches. Beach width ranges from 0.1 to 128.7 meters. Major beach widths were identified at Playa Grande at Arecibo where beach widths ranges from 20 to 128.71 meters. The wider beach plain is located in station 1 at Playa Grande. Smaller beach widths were measured at Fortuna Beach, Luquillo. Severe loss of beach extension was identified in the western site where is located the residential and touristic areas. Differences in beach widths can identified by stations per beach. This can be related with with beach orientation of each segment.

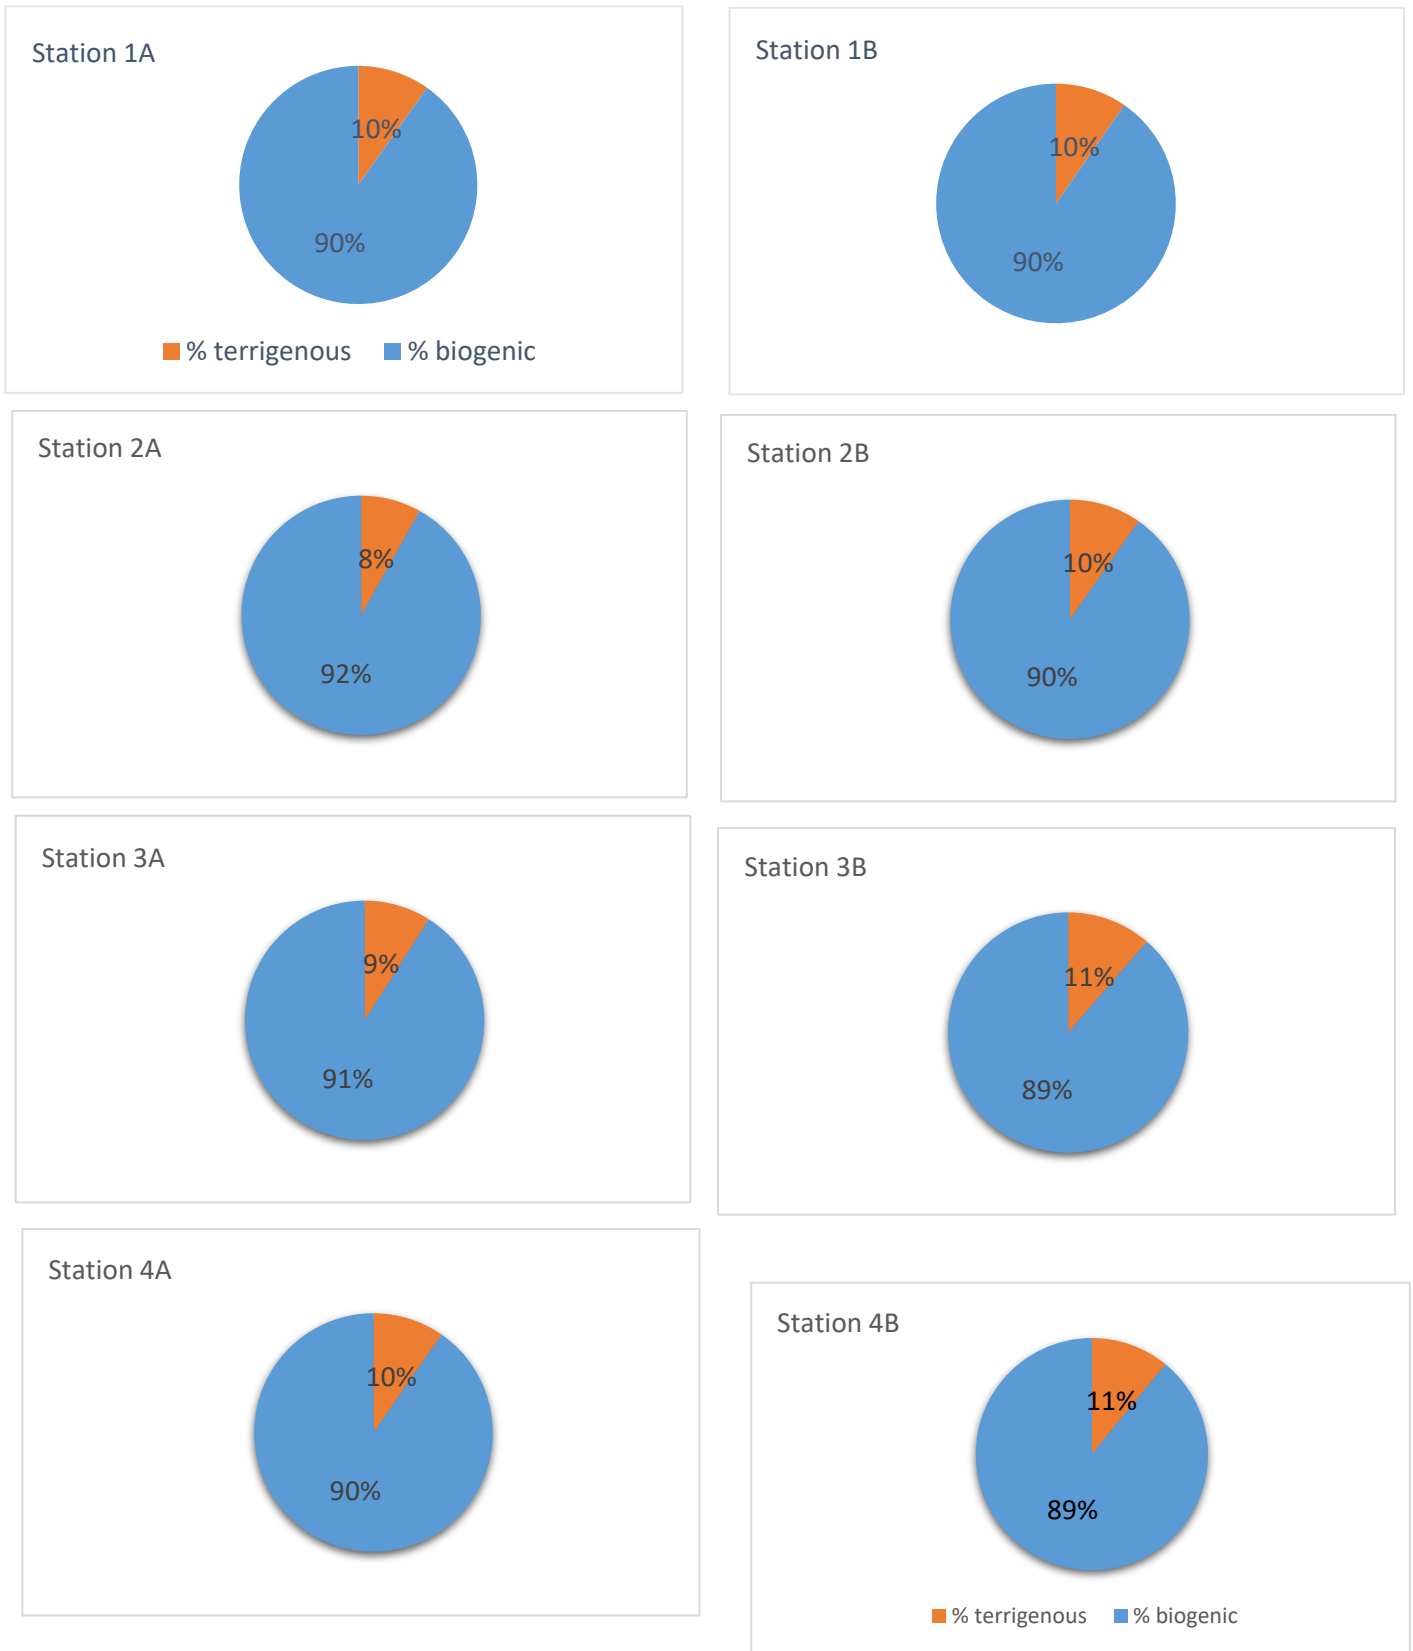
Figure 45. Beach Sediment Composition by station at Playa Fortuna, Luquillo, Puerto Rico (2015-16)

Five hundred seventeen (517) beach sediment samples were collected and analyzed to identify beach sediment composition. Three sediment components were identified in beach sites included in this study. These are biogenic ( $\geq 75\%$  calcium carbonate component), terrigenous ( $\geq$  terrigenous component as minerals/rock fragments) and mixed biogenic and terrigenous sediments (between 26 to 74 % both components). Carbonate biogenic sands came from biogenic production, including spicules, forams, coral fragment, carbonate seaweeds and molluscan shell debris. Biogenic sands were found at Playa Santa (Guánica) and Fortuna Beach (Luquillo). Terrigenous sands came from the erosion of terrestrial rock that can be transported from different source distances through river sediment transportation. Terrigenous beaches were identified at El Maní, Mayaguez and Punta Santiago (Humacao). Mixed carbonate and terrigenous sand beaches are found at Playa Grande (Arecibo) and Playa Puerto Nuevo (Vega Baja). Parcelas Suárez showed two separate beach sections based on sediment composition. These are: a mixed carbonate and terrigenous beach (station 1, 3 and 4) and terrigenous beach (stations 2, 5, 6 and 8). Differences in sediment composition were identified between backbeach and swash zone in some of the study sites.

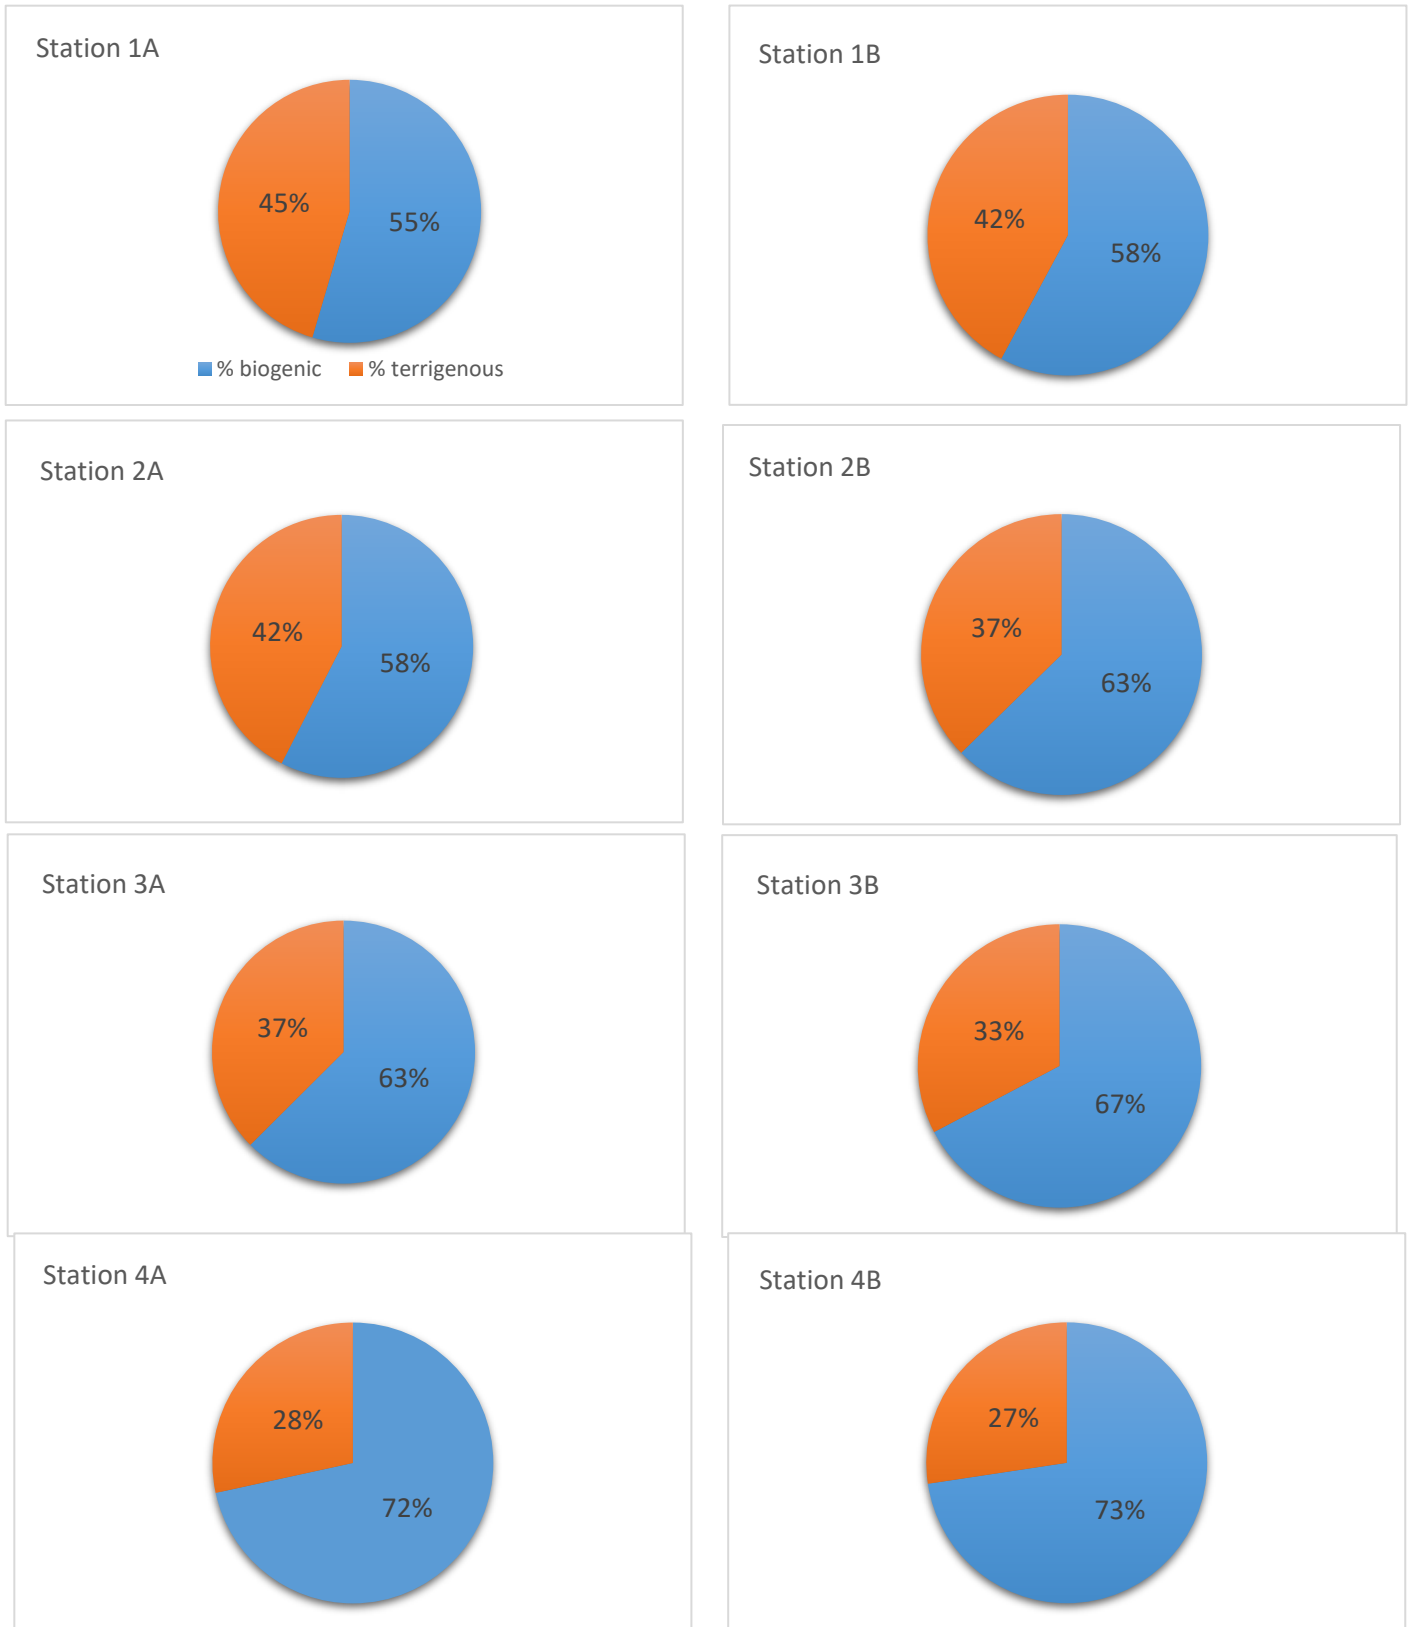
Figure 47. Beach Sediment Composition by station at Playa Puerto Nuevo, Vega Baja, Puerto Rico (2015-16)
