# *CABO ROJO*

## *COMMUNITY WATERSHED ACTION PLAN FOR*

### *WATER QUALITY AND CORAL REEFS*

PREPARED BY  
 Paul Sturm  
 Ridge to Reefs

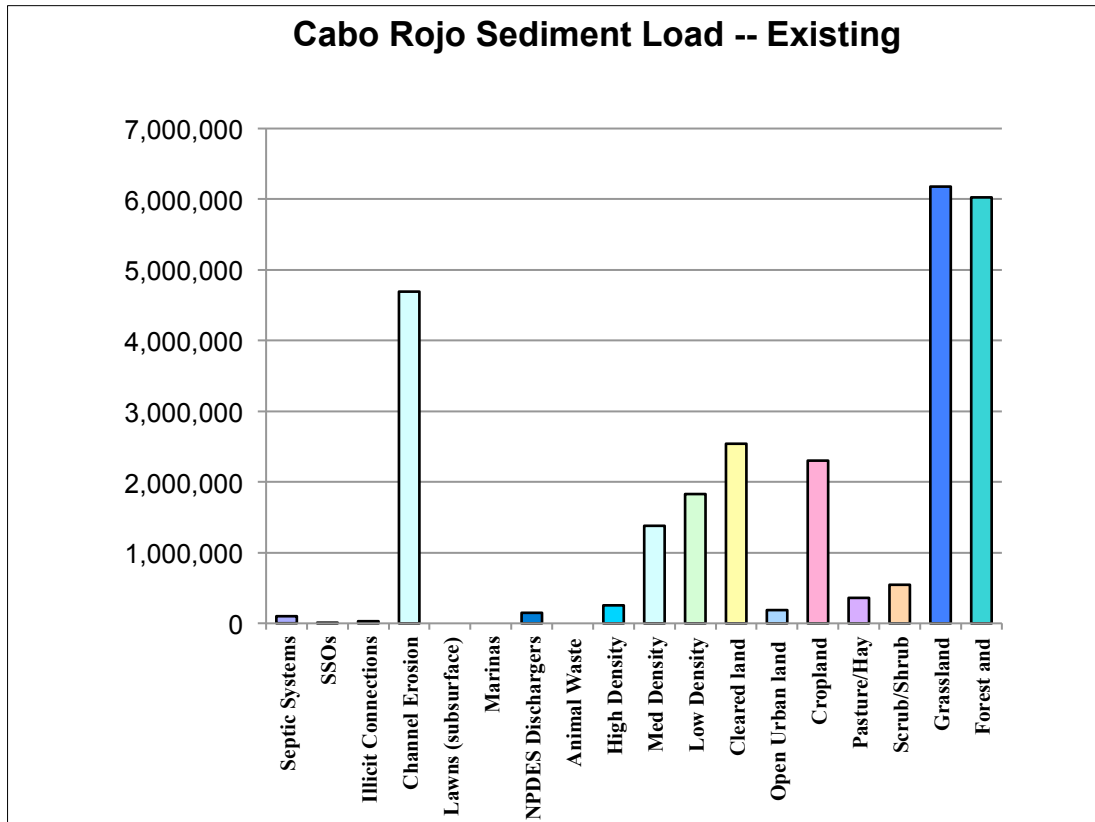
Figure 4. Sediment Source Estimates in Cabo Rojo using the WTM

Figures 3 and 4 illustrate the sources of nitrogen and sediment in the watershed based on the model output. Septic systems, particularly those close to the coastal waters, are the largest source of nitrogen in the watershed followed by grass and forestland and NPDES discharges (sewage treatment plants). For sediment the major sources include forest land and grassland as well as channel erosion, and bare soil areas. Bare soil areas include the network of unpaved roads in the area of Los Pozos near Combate. Mining and extraction operations as well as agriculture in the valley and headwater coffee farms are also significant contributors to sediment loading particularly in the Guanajibo watershed.

Sediment loads are not estimated based on individual dirt roads (where there can be a lot of variation) but rather on the sediment losses expected from bare soils, dirt roads, land uses in general – a more detailed analysis was beyond the model capability – but the impact of bare soils were evaluated in our fieldwork and we have used that information to identify areas for stabilization.

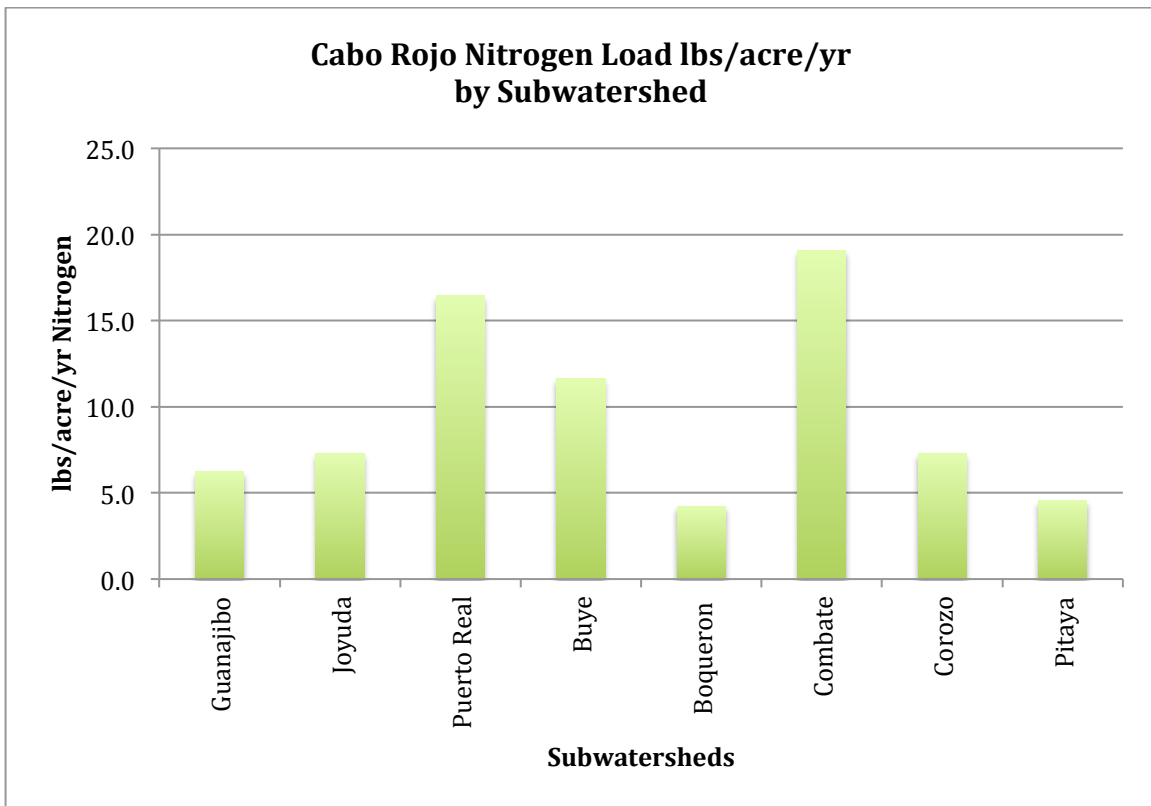
**Figure 5. Cabo Rojo Nitrogen Loading Rates by Subwatershed Based on the WTM**

- Figure 5 helps to exhibit elevated nitrogen loading estimates for some of the coastal watersheds that was also reflected in the water quality sampling data.
- Combate and Puerto Real are of significance in terms of nitrogen losses to the coastal and marine ecosystems due to the high density of septic systems. This issue is confirmed by the high levels of Chlorophyll A seen particularly along the beaches in Combate which are close to 100 times higher than targets for healthy coral reefs based on Otero and Carbury, 2005 (who estimated that healthy coral reefs need chlorophyll A levels between 0 and 0.75 ug/l). In addition, some monitoring sites sampled during dry weather both subwatersheds had very high levels of enterococci and ammonia suggesting a strong component of raw sewage.

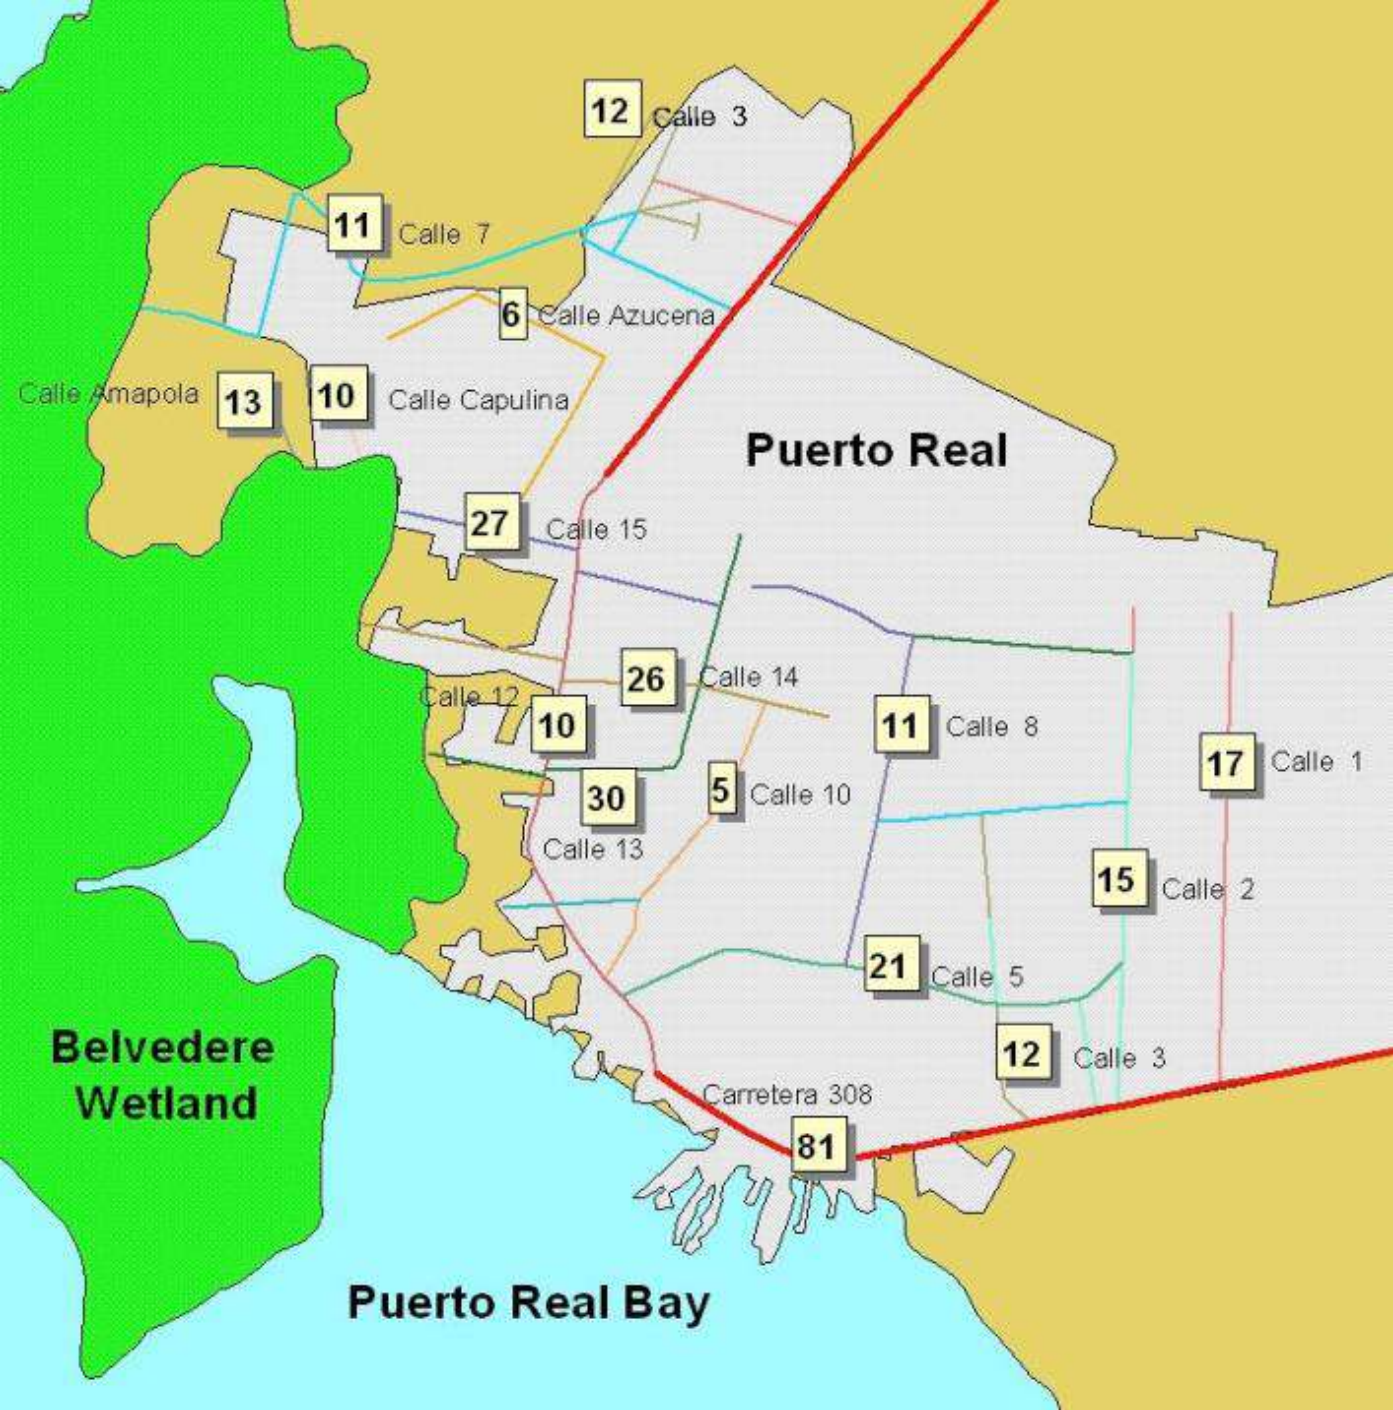
Figure 8. Puerto Real number of septic systems per street shown in the yellow box (from Norat and Mattei, 2006) – two priority areas in our analysis were the 81 along the coast on Road Pr-308 and El

## Fangito Street with no buffer and those along Calle 1 where we observed high rates of failure via water quality sewage indicators

Past coral studies have documented some troubling trends in the nearshore reefs in Cabo Rojo. In 2006, Norat and Mattei documented problematic bacteria and turbidity water quality conditions in Puerto Real and near the mouth of the Guanajibo River. They also identified over 300 of 400 septic systems

(Figure 8) that were likely experiencing failure and contributing sewage and contaminants to the Belvedere wetlands and Puerto Real Bay. In addition, for this watershed plan, baseline data was collected for nearshore coral reefs by Sociedad Ambiente Marino (SAM), UPR CATEC, and CESAM in a gradient from areas close to land and sources of pollution to areas further off the coast. Widespread degradation was identified at nearshore reefs and as well as sites just outside Boquerón Bay.

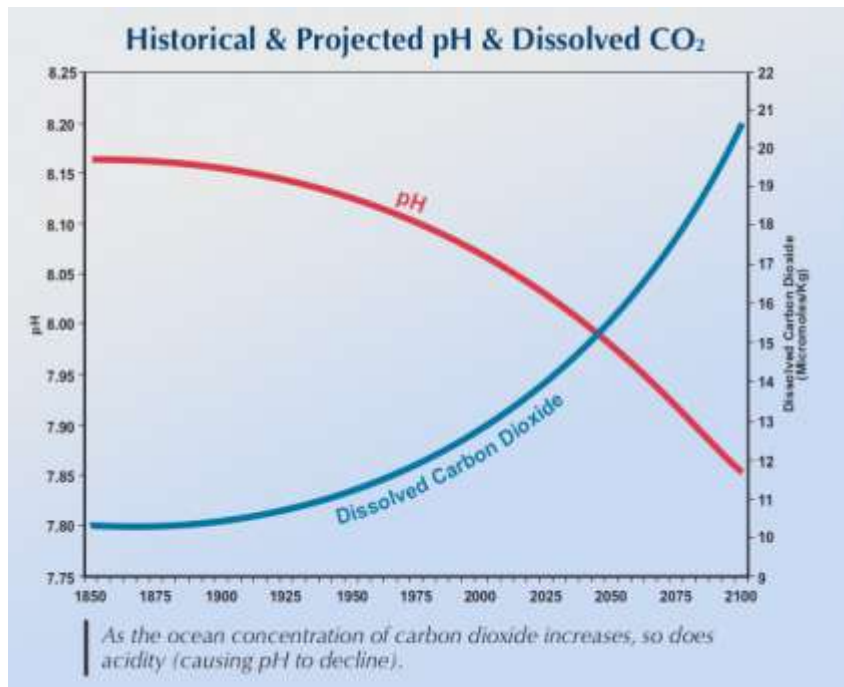
**Figure 11. Current and Future Ocean Acidification Estimates (Feeley et al. 2006)**

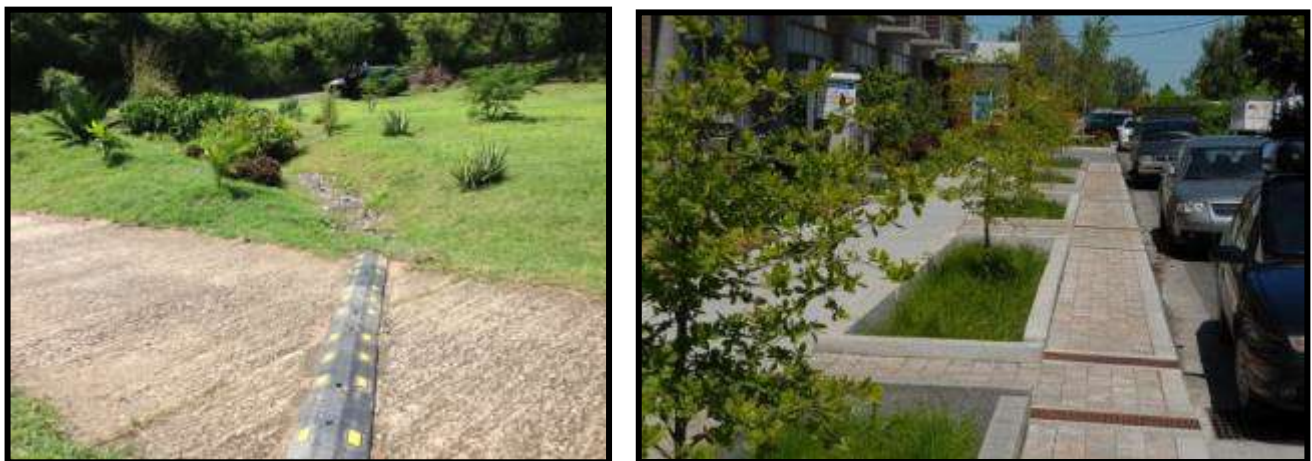
**Figure 12. Rain garden from St. Croix and streetscape biofilters from Santa Monica, CA**

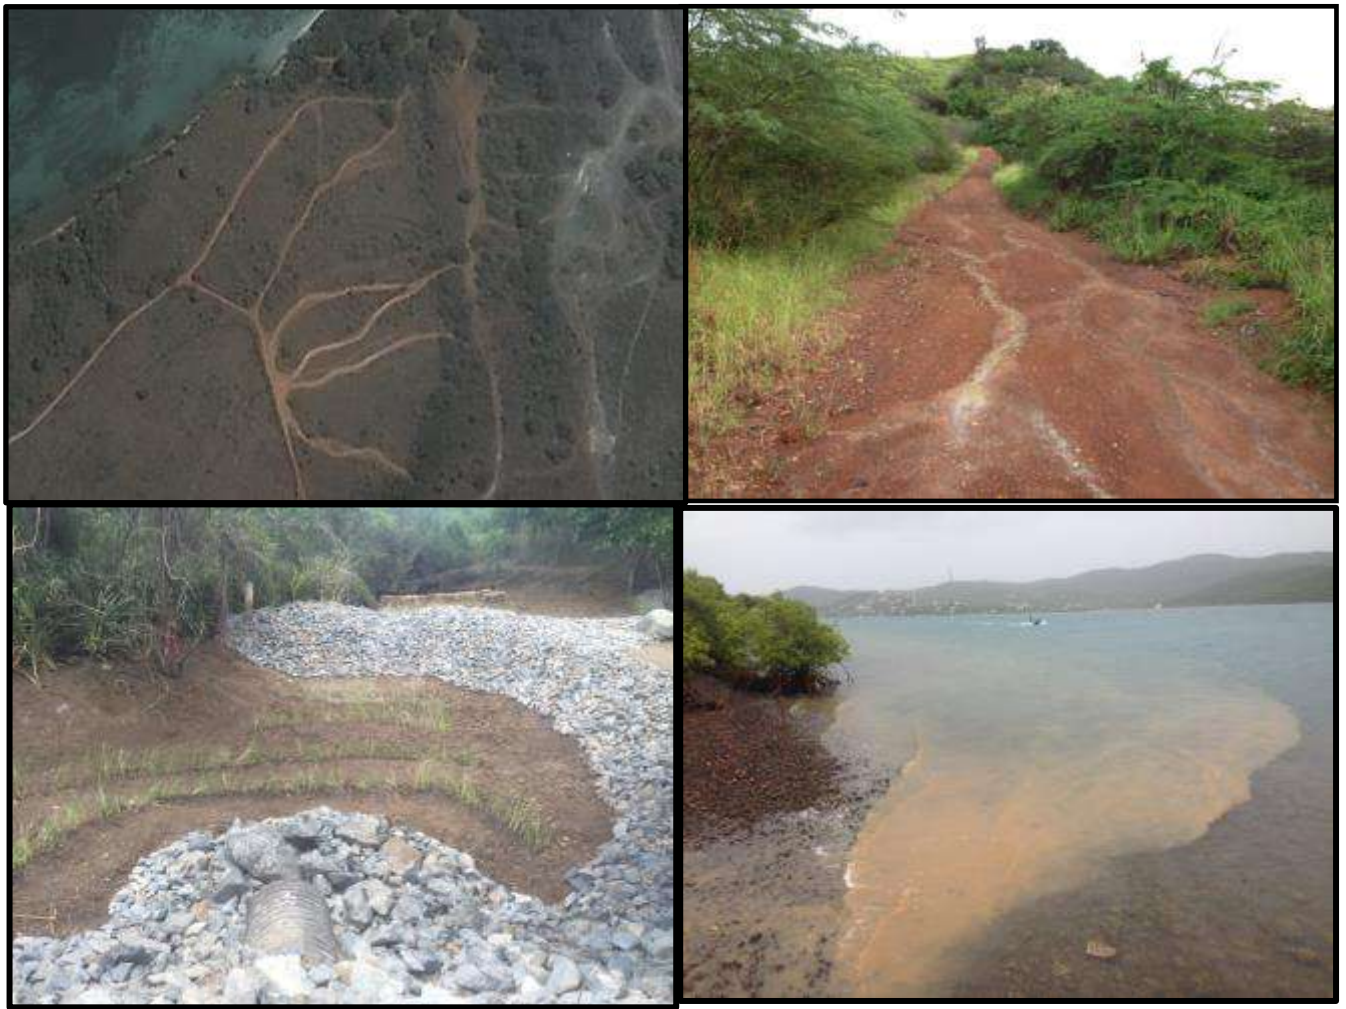
**Figure 13. Clockwise from top left: Dirt roads in Los Pozos near Combate, a significant source of sediment to coastal waters, (right) example of surface rills conveyance over the road surface creating erosion and resulting in fine sediment losses, bottom right sediment reaching coastal waters; bottom left: recently constructed sediment trap in Cabo Rojo to capture sediment before it enters Boquerón Bay**

Stabilization of bare soils (Figure 13) involves the rapid re-stabilization of vegetation and generally a transition to more native and stable forms of vegetation. One effective way to re-establish vegetation in an area is to utilize hydroseeding followed by watering to rapidly transition to a more stable vegetated system where runoff is reduced. Dirt roads are stabilized using methods to remove water from the road and reduce erosion. These include concrete or dirt cross-swales, check dams and sediment traps. The recommendations for dirt road and bare soil stabilization are found in Table 6. Maps are found toward the end of the section in Figure 16. Each of the bare soil restoration projects is important in its own right due to the high loads associated with bare soils.

It should be noted that all exposed soil and dirt roads transport sediment at a rate of 5x to 100x the natural transport rate from a forest or a field, so maximizing the amount of roads and bare soil areas treated is a critical element of the watershed plan, as is reducing the impact of future road development.

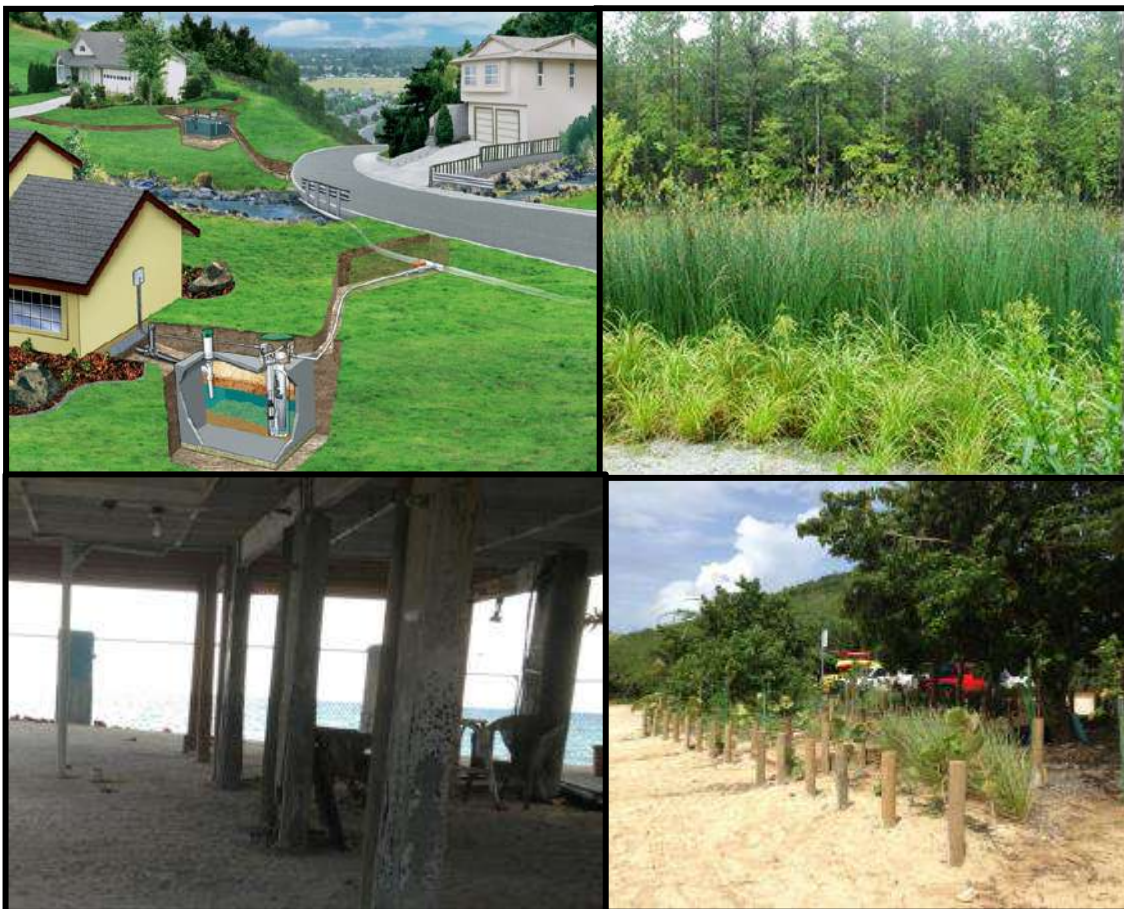
**Figure 14. Top (Pump and treat system where effluent is pumped from homes to a constructed wetland or landscaped area (right); Bottom: (left) sewage effluent enters a septic system in the beach berm in Combate, (Bottom left) a passive low cost approach to addressing this issue is to restore a vegetated beach berm to include the use of vetiver and native species such as sea grape (uva playa) as has been done in Tamarindo Beach in Culebra**

into the groundwater and maximizing nutrient removal via vegetation and uptake or by promoting denitrification. Examples of a pump and treat system are found in Figure 14 - the effluent can be pumped to a constructed wetland such as is shown in the top right of Figure 14. These efforts should be focused in areas where space is limited between the septic system and the coast and where septic failures are occurring and connecting to the PRASA sewer system is not an option. Examples would be to use these practices at small hotels and restaurants in places like Joyuda and Combate. Other more passive systems are also possible particularly where space is limited such as structures located on the beach itself – in this example from Combate septic systems are located in the beach berm. Restoring the beach buffer with native plants and vetiver (which can grow its roots to 3-4 meters deep) to attempt to intercept contaminated groundwater before it enters the nearshore waters with a dual benefit of also helping protect the shoreline from erosion by allowing the beach berm to aggregate sediment.

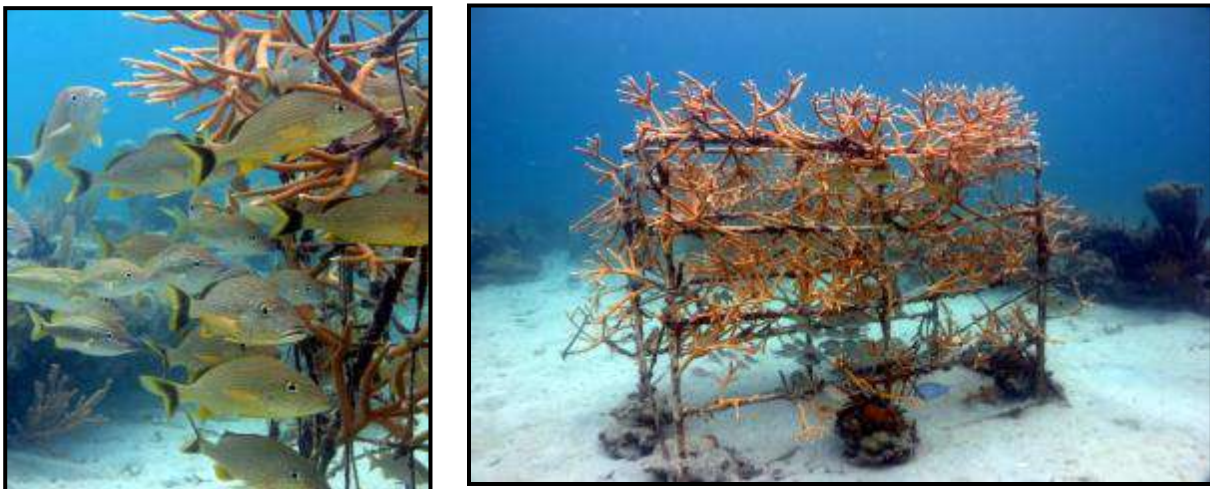
Figure 15. Coral restoration efforts in Tamarindo (Photo credit: CESAM)

Coral restoration involves the propagation of corals, in this case Staghorn coral (*Acropora cervicornis*) (Figure 15), and to a lesser extent other species including Elkhorn coral (*Acropora palmata*). These species have been decimated in the Caribbean - over the last 30 years there has been an 80 – 90% decline. Coral Restoration could be pursued in the greater Cabo Rojo area particularly in combination with implementation to control land based sources of pollution. Similar efforts have taken place in other reef areas in Puerto Rico including the first nursery site in Culebra. The goal of coral restoration efforts and out planting of corals has been to re-establish *Acropora* populations. The community project of Coral Reef Rehabilitation and Aquaculture in Culebra began in 2003 and has been led by the Society of Marine Environment (SAM) and Coralations in collaboration with the University of Puerto Rico Center for Applied Tropical Ecology and Conservation (CATEC). Locations that could be evaluated for nurseries include the areas that have the best existing conditions within the nearshore areas, mid-shore and offshore areas.

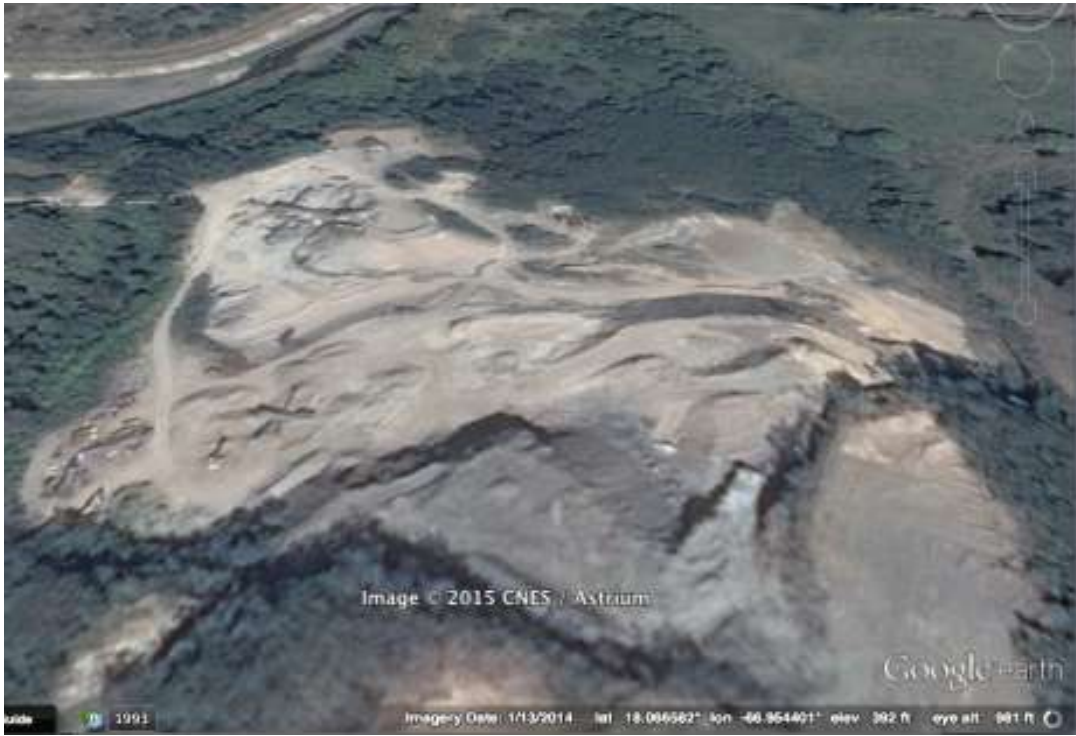
Figure 16. Typical quarry occurring on slopes with no visible sediment control basins or ponds.

At least 9 quarries and extraction operations (Table 6 and Figure 18)) are present in the Guanajibo watershed of Cabo Rojo – most of these operations have limited best management practices based on field visits to sites as well as local testimonials (Figure 16 shows a typical quarry in the subwatershed). Proposed is a project that would work with quarry owner/operators to minimize runoff and impacts to downstream waters including sediment and stormwater controls, pollution prevention plans and outreach and education. EPA, EQB should be involved in providing oversight and regulatory encouragement of quarry owner/operators to minimize their impact as well as funding to help initiate the program and support for helping them achieve higher levels of treatment and pollution prevention. A similar program in American Samoa has created a large sediment basin for a quarry that was impacting downstream coral reefs (Figure 17).

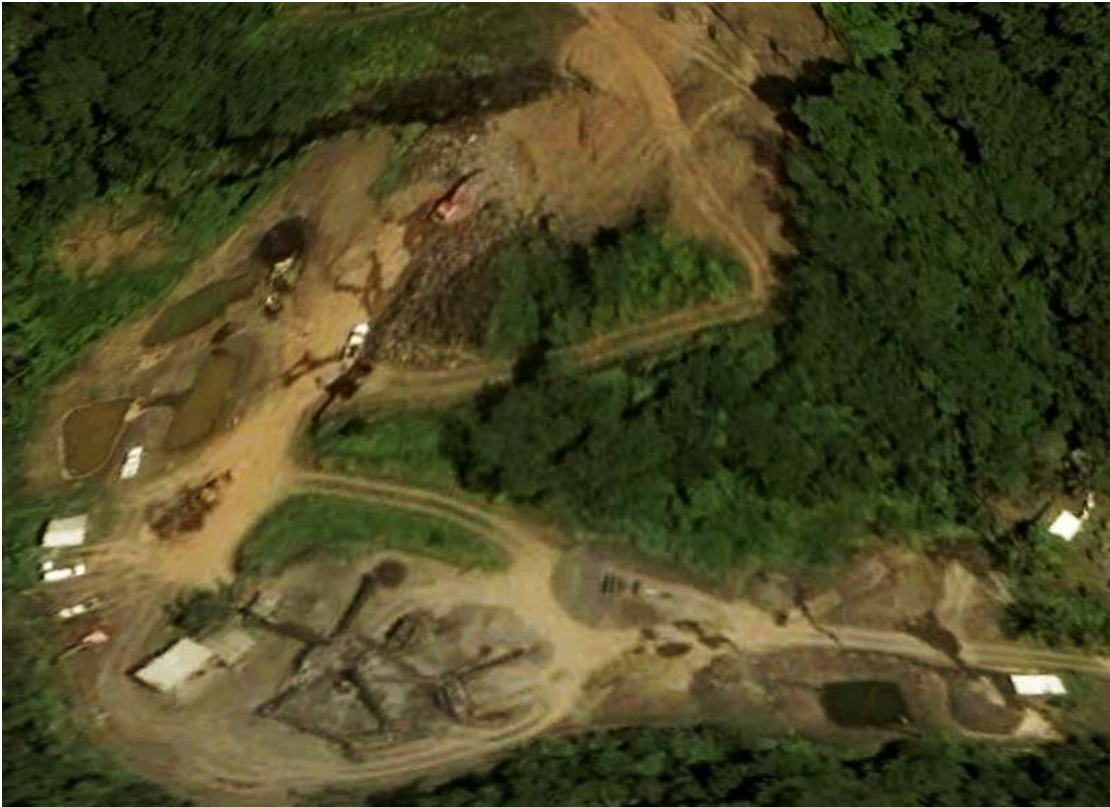
Figure 17. Quarry sediment basin (in lower right of photo) for a project in Faga'alu, American Samoa

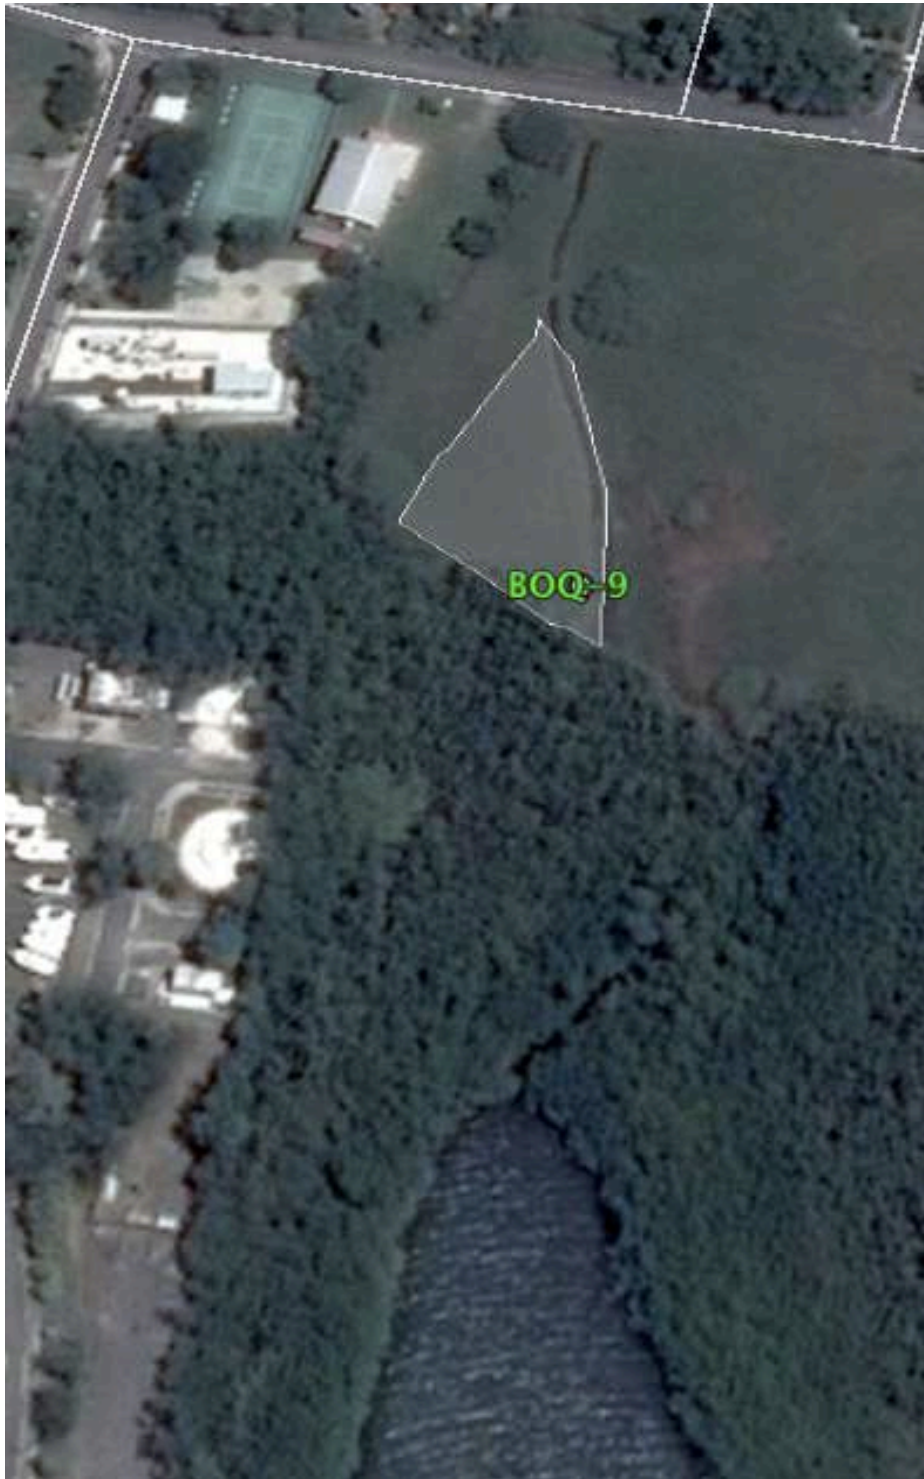
Location for a treatment wetland to address uncontrolled stormwater and elevated nutrients and bacteria

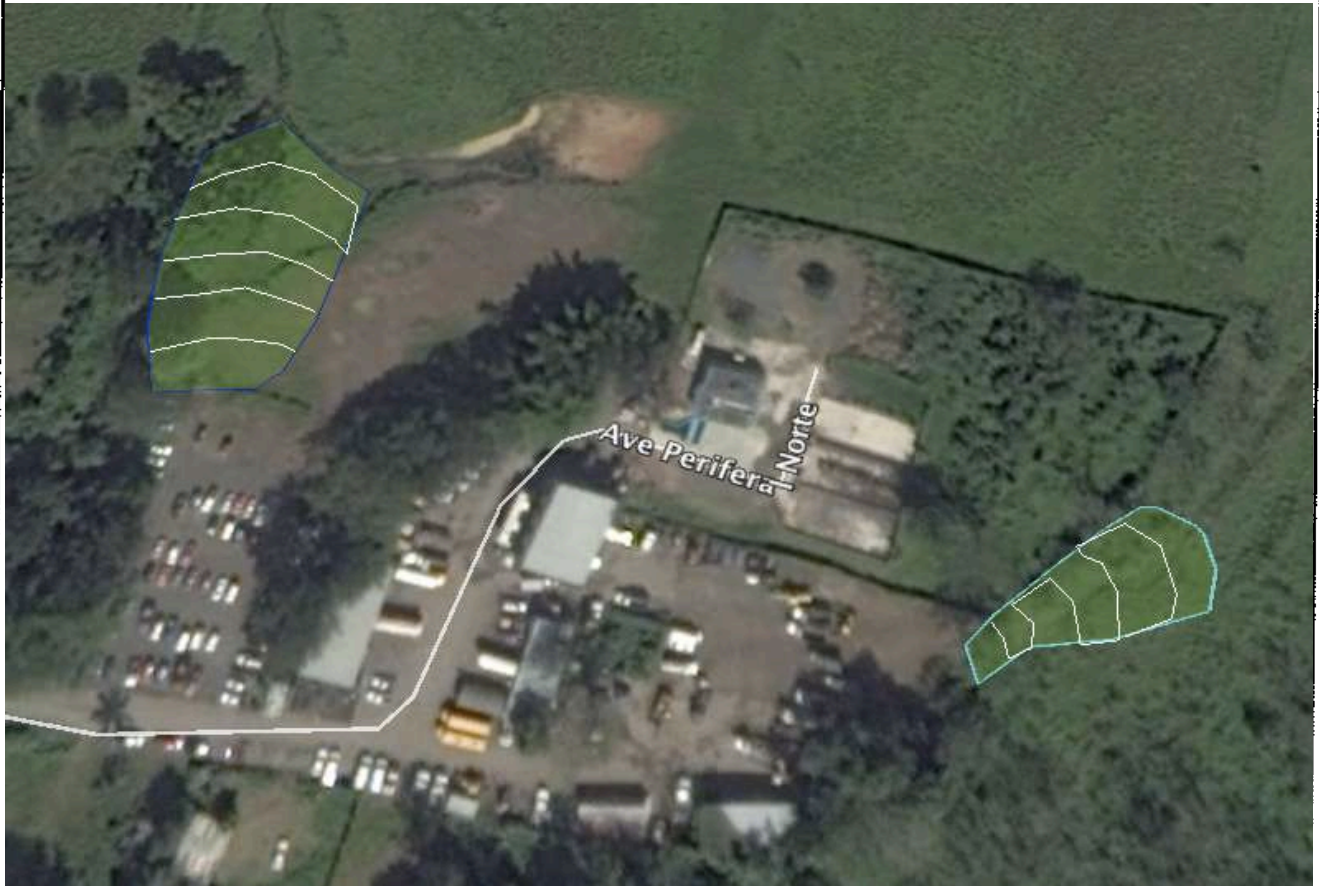
Two potential locations for stormwater wetlands at the existng public works facility in Cabo Rojo

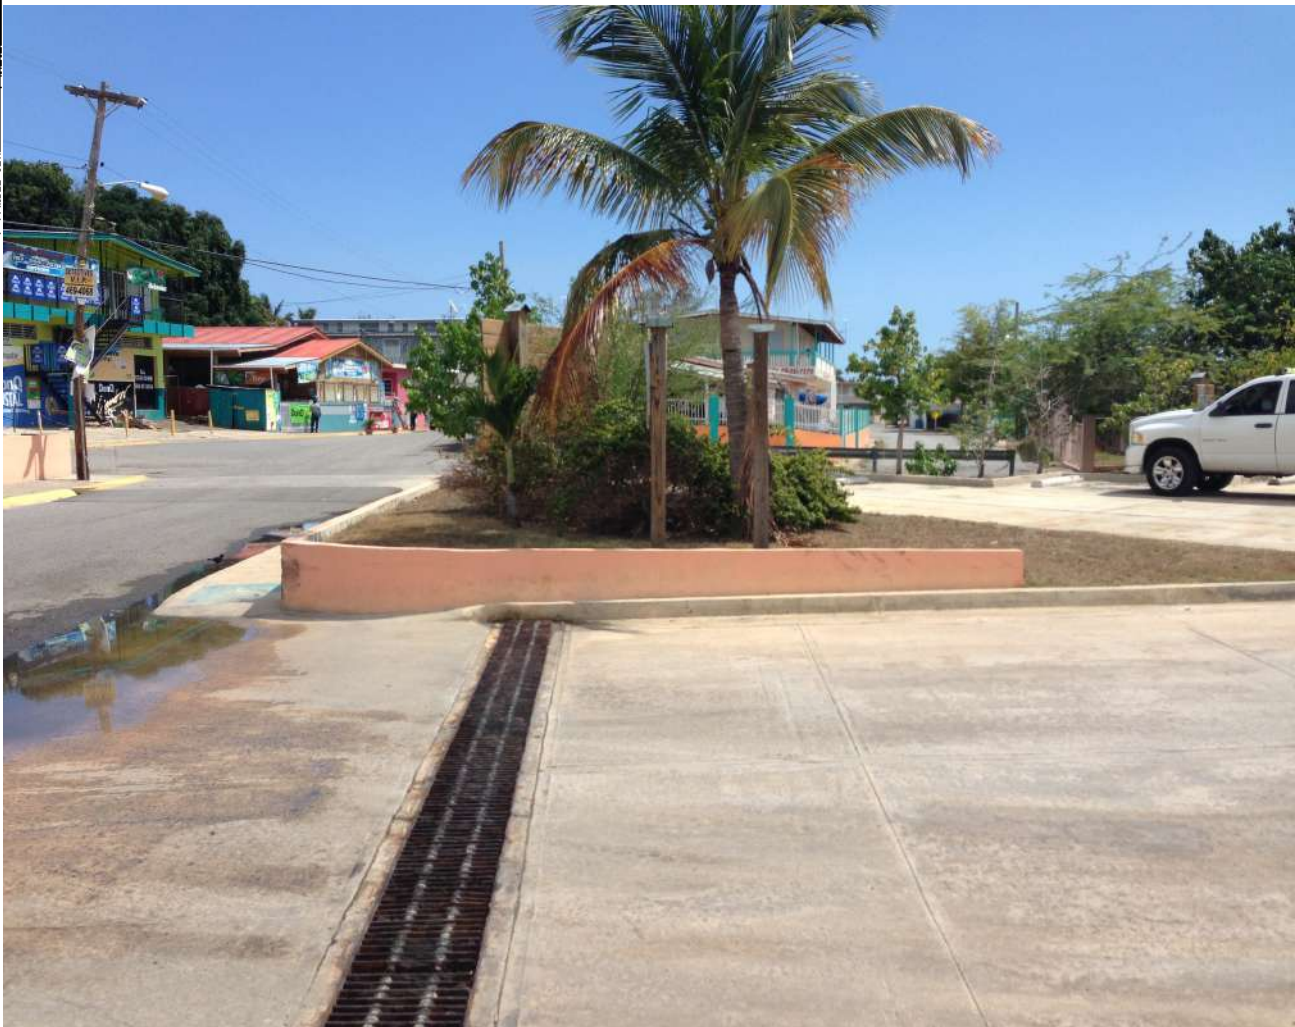
Convert clogged stormwater practice to surface sand filter within the existing vegetated island -- see overview of both practices on next sheet
