Natural and Cultural Resources Recovery Document

Environmental Resources: Coastal Wetlands

COURSE OF ACTION PROPOSED FOR COASTAL WETLAND RECOVERY

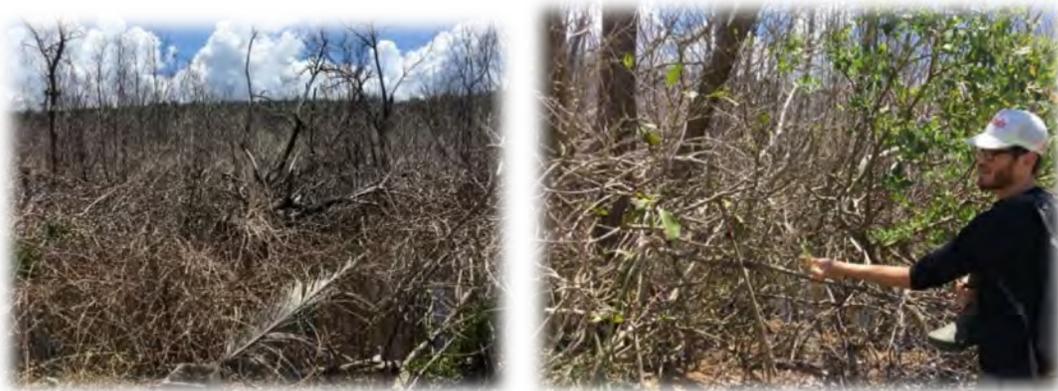
On site assessments at Isabela confirmed almost complete mortality, with the only surviving individuals present along higher grounds along the shore of the wetland (Figure 2). When measuring water depth just inside the wetland, it was discovered that numerous black mangrove pneumatophores (aerial roots) were submerged. These roots are extremely important for mangrove survival, serving as a conduit for air to reach often flooded root zones and thus allowing for normal plant metabolism. These roots will grow to a height just above normal flood depth, allowing for gas exchange with the air even when flooded. The fact that these roots were flooded and that the only surviving trees were found along higher shorelines, provides strong evidence that extremely high and prolonged flooding as a result of the hurricanes effectively drowned the trees and resulted in their death. Water depth recordings at the site (Figure 3), further confirm this in that they show no tidal connectivity and very slow drainage or evaporation. The hydrological and geomorphological assessment (Appendix D) suggests the bike path constructed along the wetland perimeter may be impeding normal tidal connectivity and this may have worsened as a result of the deposition of sand during the storm. Water chemistry measurements were normal for mangrove wetlands and are not thought to be the cause for mortality.

Figure 3 While most of the mangroves at Isabela are dead (left), there are some live trees and seedlings along the higher grounds on wetland shore

Given that abnormally high and prolonged flooding as a primary cause of wetland mortality, and in accordance with the NRCS hydrology assessment, we recommend:

- 1) Reestablish wetland connectivity with the ocean for 2019. This includes the construction of a tidal channel as well as improvements and maintenance to existing infrastructure (bike path and flow channels under the bike path).
- 2) Perform consistent hydrologic monitoring to ensure the establishment of sustainable hydrology in parallel with vegetation rehabilitation.

- 3) Restore the vegetation by planting mangrove saplings of *Rhizophora mangle*, *Laguncularia racemosa* and *Avicennia germinans* in 2018-2019, so that a full forest can develop within the next ten years. Without planting, natural regeneration to a full forest will occur from existing reproductive trees, although this is likely to take twenty to thirty years. However, with or without planting, any regeneration will be impeded and vulnerable if the geomorphological and hydrological conditions are not improved.
- 4) Re-assessment of vegetation structure and cover every year by on the ground measurements of seedling and tree density and canopy cover and at the landscape level utilizing un-manned aerial vehicles.

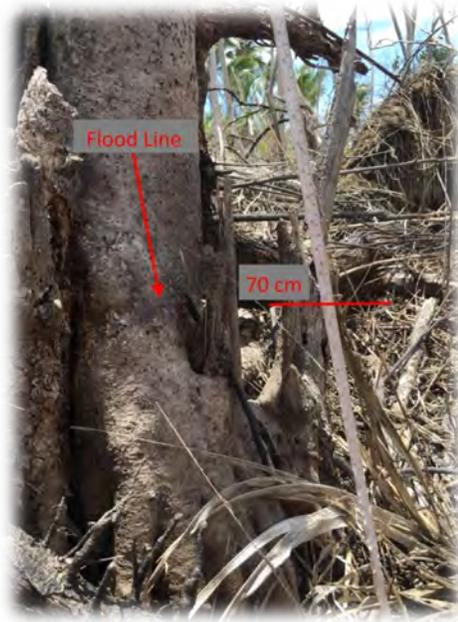
Unlike the primarily wind damage at the other sites, the mangroves of Punta Tuna and Isabela were likely affected by drastic changes in hydrology. At Punta Tuna, the closing of the wetland channel by sand deposition during the storm, followed by the flooding from precipitation and storm surge, resulted in extremely high-water levels and no drainage channel. As a result, the wetland was flooded with abnormally high water (1 meter) for an abnormally long time (4 months). Plant roots were thus drowned with no oxygen source and consequently died. This hypothesis is strengthened by the survival

Figure 6 Flood lines on trees at Punta Tuna suggest a sustained water level of 70 cm above the forest floor and locals suggest the wetland was flooded for up to four months (top). These flood waters did not allow for proper oxygen levels in mangrove roots, and effectively drowned them. Water levels recorded at the site show minimal tidal signals and no drainage, with a strong connection to rainfall (bottom). This leaves the wetland vulnerable to flooding from extreme events like hurricanes.

Hydrology was the primary cause of mortality at Punta Tuna and should thus be the focus of any rehabilitation program. Maintaining a consistent and sustainable connection with the ocean will allow for proper drainage in the case of extreme flooding as well as provide the tidal connectivity necessary for long term mangrove health.

- 1) The NRCS assessment (Appendix D) recommends ensuring proper communication with USACE and the establishment of a memorandum of understanding (MOU) allowing for channel maintenance to be carried out as needed and deemed necessary by local managers. Only by first ensuring stable and proper hydrology, can vegetative rehabilitation be successful.
- 2) Perform consistent hydrologic monitoring to ensure the establishment of sustainable hydrology in parallel with vegetative rehabilitation.
- 3) Implementation of an active management plan that includes planting of mangrove saplings to restore 100% mangrove cover and structure.
- 4) Re-assessment of vegetation structure and cover every year by on the ground measurements of seedling and tree density and canopy cover and at the landscape level utilizing un-manned aerial vehicles.

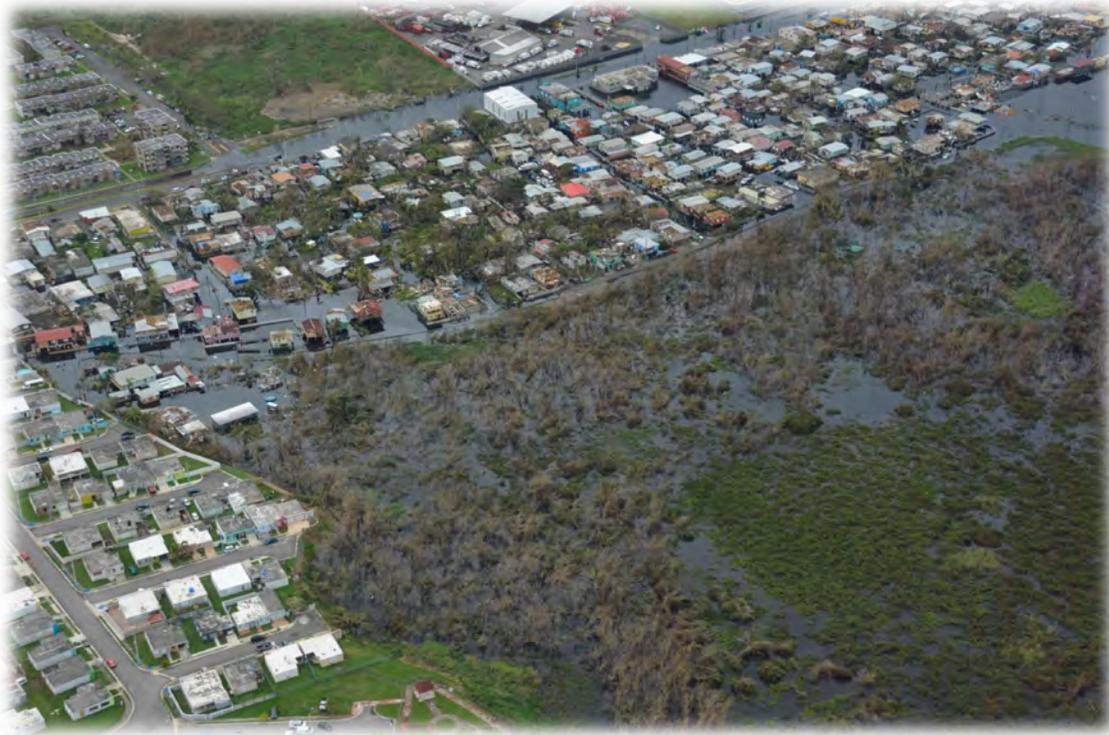
Initial damage and flooding in Ciénaga las Cucharillas was extensive (Figure 7). Ciénaga las Cucharillas contains the highest diversity of wetland habitats relative to the other sites, all of which suffered some mortality as well as significant shifts towards other habitats (Figure 8, Table 3).

Figure 7 Aerial view of Ciénaga Las Cucharillas and surrounding urban and industrial infrastructure immediately after hurricane Maria. Photo Date: 9/23/2017 8:42:33 AM <http://imageryuploader.geoplatform.gov/imageeventspublic/map.html#>

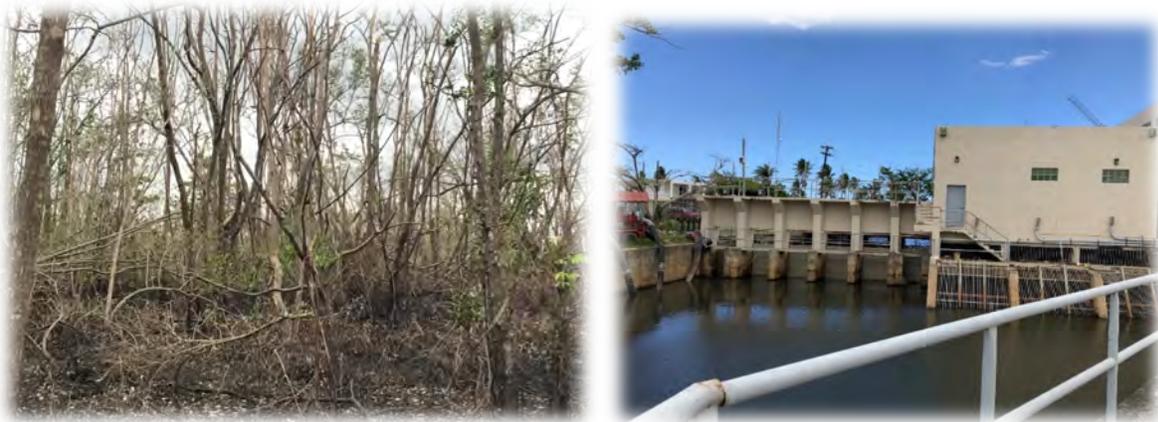
- d) There are shifts in vegetation types in the Ciénaga Las Cucharillas due to the excess and continuous freshwater flooding as a result of management of flood gates and water pumps at the mouth of the Malaria Channel, where the flood gates have remained closed during the last six years. Failure of the water pumps occurred during and after the hurricane and currently only one is active for half an hour three-times daily.

Figure 9a. Some of the mortality at Ciénaga Cucharillas (left) is likely a result of shifting hydrology due to the pump/gate station at the mouth of the Malaria canal (right). A freshwater hydrology regime is promoted by the operation of the tidal gate at the mouth of the Malaria Channel managed by the Department of Natural Resources and Environment (DRNA), where for the past six years the flood gates have not been opened, restraining the marine-terrestrial connectivity through the channel and favoring freshwater conditions in the area.

Parallel to establishing a favorable hydrological, vegetative rehabilitation with mangrove plantings need to be carried out for optimal success.

- 1) Funding /Repair/ Management improvements at pump station/ tide gates to be carried out by 2019 for reestablishing marine -terrestrial connectivity and prevention of flooding episodes.
- 2) Planting of ten ha with Black mangrove and White mangrove saplings by 2020 to cover and structure.
- 3) Monitoring of water depth, salinity and flooding.
- 4) Re-assessment of vegetation structure and cover every year by on the ground measurements of seedling and tree density and canopy cover and at the landscape level utilizing un-manned aerial vehicles.

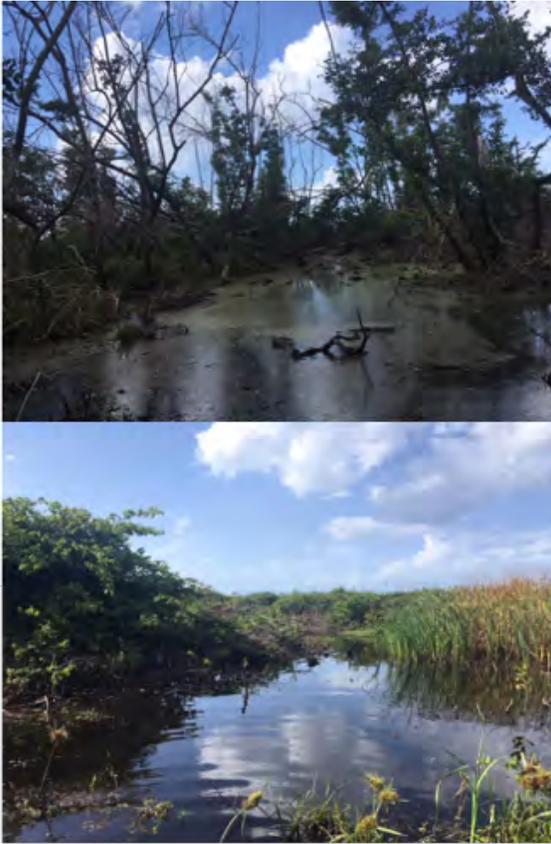
Figure 9b. Flooding conditions (0.5m above ground surface) of the Cucharillas Natural Reserve wetland, 20 meters from the nearby populated area, photographed on May12, 2018, as a consequence of Hurricane María's effects and present non-functioning pumps and permanent locked gate conditions at the station.

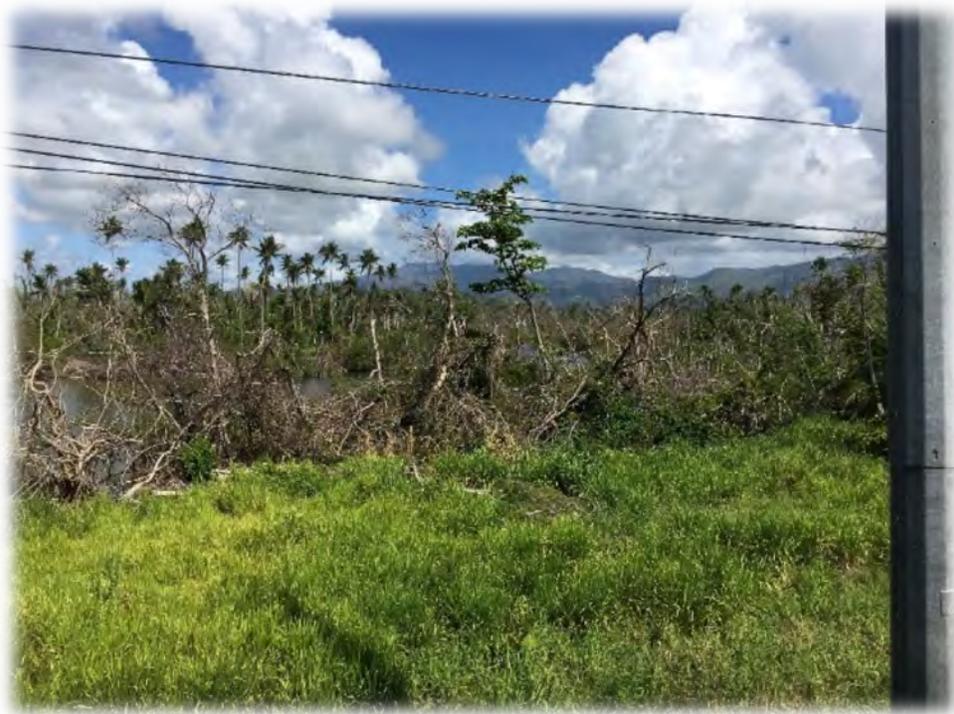
The mangroves at Punta Santiago suffered primarily wind damage, with little evidence for drastically altered hydrology. Overall mortality at Punta Santiago was 34%, with most of the loss occurring in upland forests, not wetlands (Figure 11, Table 4). Wetlands experienced a loss of 34%, corresponding to a loss of around 1.6 hectares. Viable seeds were observed at the sites, suggesting natural regeneration will occur, and no abnormalities in water chemistry were measured. Further, the NRCS hydrology/geomorphology report found no significant alterations to site hydrology. This suggests the primary damage to the vegetation at Punta Santiago was due to wind and that no active management is necessary for rehabilitation. We therefore recommend a passive monitoring program with no active management unless significant changes in recovery are detected.

Figure 10 The mangroves at Punta Santiago suffered a mortality rate of 34%, although natural regeneration, including seed germination and tree re-sprouting has already begun. Recommendations are to passively monitor and allow for natural regeneration.

- 1) Passive monitoring program with no active management unless significant changes in recovery are detected.
- 2) Re-assessment of vegetation structure and cover every year by on the ground measurements of seedling and tree density and canopy cover and at the landscape level utilizing un-manned aerial vehicles.

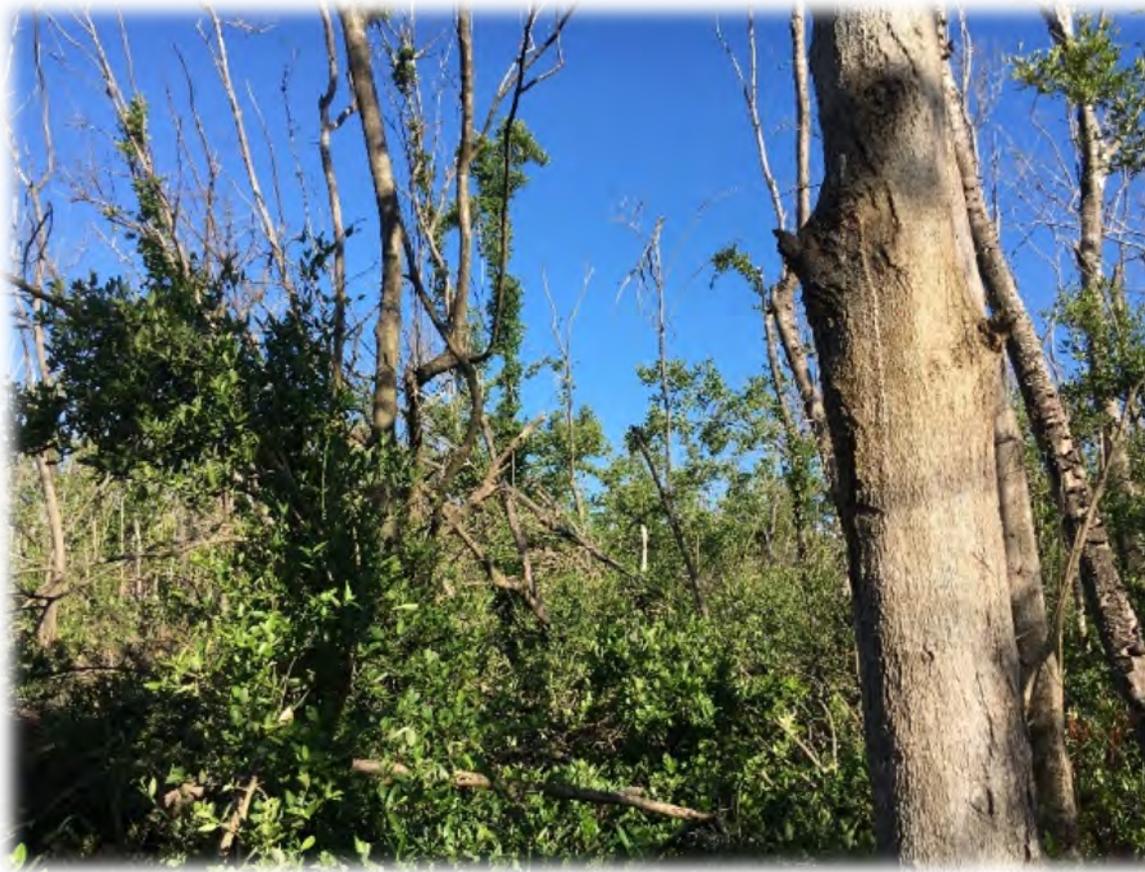
Although no aerial surveys were possible at Piñones due to restrictions from the nearby international airport, we were able to assess the site on the ground (Appendix B). This assessment found 30% mortality in the mangroves, with sufficient live mangrove seedlings and hydrological and water chemistry conditions that did not suggest any imminent threats to ecosystem vitality (Figure 12). We expect natural regeneration and canopy closure to occur over the next five years. Therefore, we recommend only passive monitoring to ensure natural rehabilitation occurs unimpeded and no active vegetation rehabilitation unless significant changes are detected.

Figure 12 The mangroves at Piñones suffered a mortality rate of 30%, although natural regeneration, including seed germination and tree re-sprouting has already begun. Recommendations are to passively monitor and allow for natural regeneration.
