CULEBRA

COMMUNITY WATERSHED ACTION PLAN FOR WATER QUALITY AND CORAL REEFS

PREPARED FOR
NOAA CORAL REEF CONSERVATION PROGRAM
PUERTO RICO DRNA
CULEBRA OFFICE OF THE MAYOR

March 2014

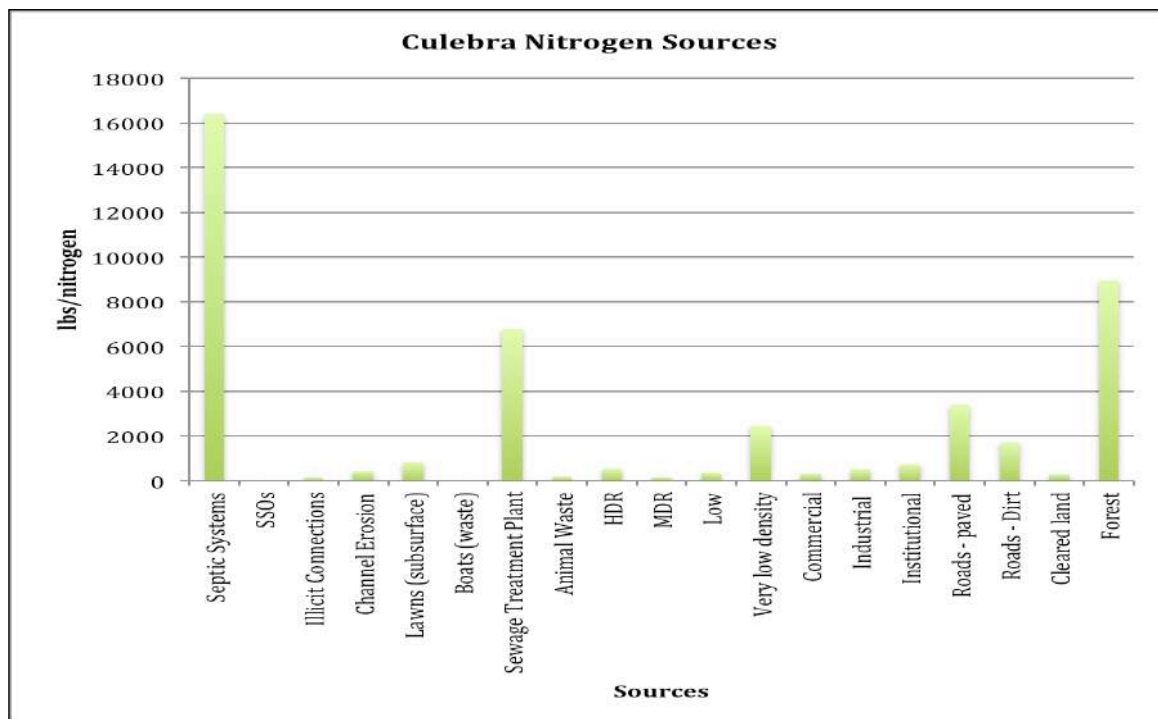
Figure 4. Nitrogen Source Estimates in Culebra using the WTM (HDR and MDR refer to High and Medium Density development) (Sturm et. al, 2014)

Figures 4 and 5 illustrate the sources of nitrogen and sediment in the watershed based on the model output. Septic systems (including direct sewage discharges to Ensenada Honda and the Lobina channel) are the largest source of nitrogen in the watershed, followed by forested areas and the sewage treatment plant. Other sources of note are paved roads, dirt roads and very low-density development. For sediment the major sources include dirt roads, forested areas, channel erosion, paved roads and cleared roads. It is important to note that on a per acre basis forest/fields (63% of the land use of Culebra) produces the least pollution of any land use, so few strategies are available to achieve further reduction – though where coastal lagoons are located they often intercept water from diverse land uses and improve water quality.

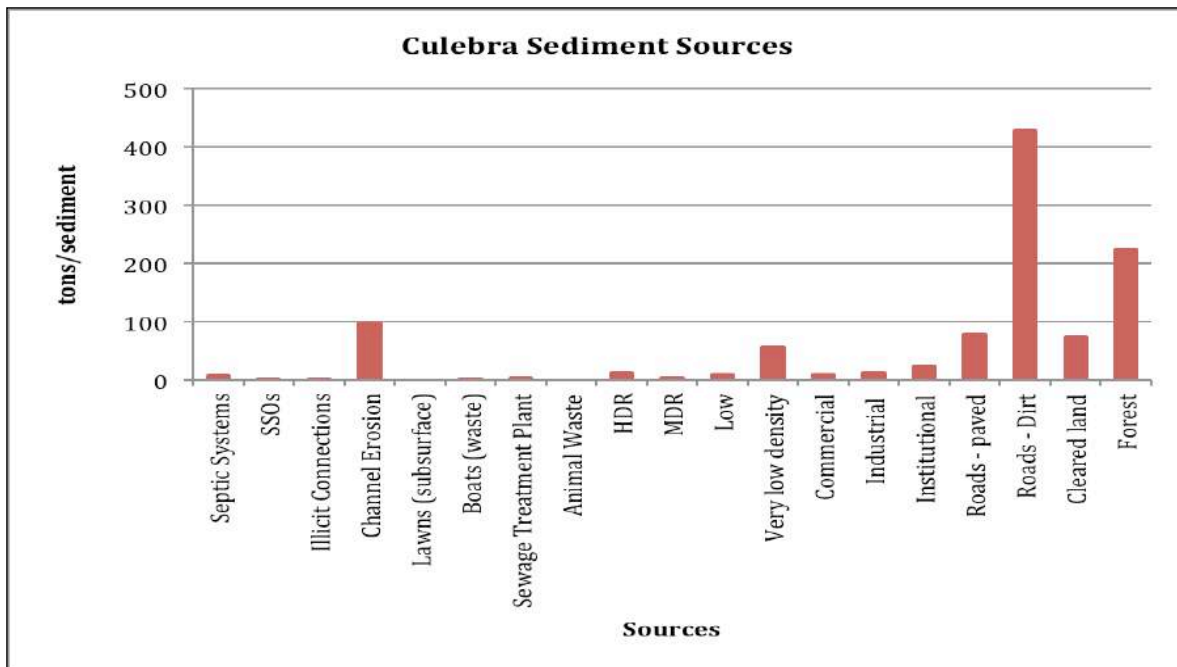
Figure 5. Sediment Source Estimates in Culebra using the Watershed Treatment Model (Sturm et. al, 2014)

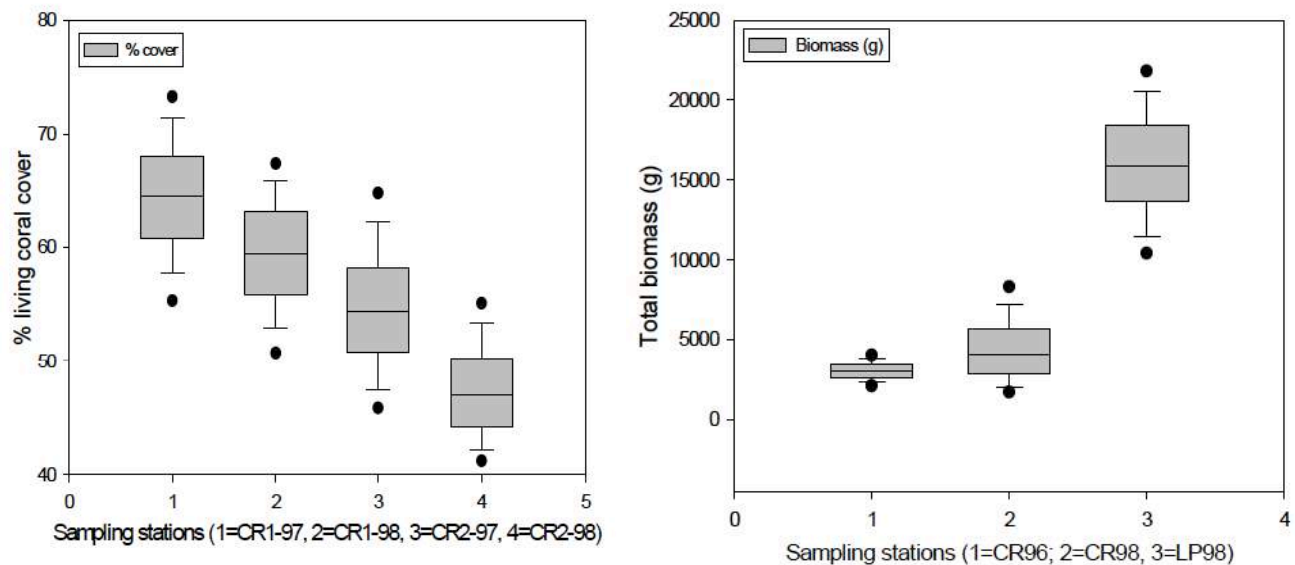
Figure 8. (Left) Shows % of living coral cover (45 - 65%) in 1997 and 1998 at two stations CR1 and CR2; (Right) show fish biomass at Carlos Rosario (CR) vs. a Luis Peña (LP) station (Hernández-Delgado 2000).

Past coral studies have documented a declining trend in coral reef health in Culebra. In 1998, Hernández-Delgado reported that live coral cover at several sites in Tamarindo and Carlos Rosario was greater than 60% (Figure 8) even though at that time relatively high amounts of algae were present. Since that time, additional impacts have been documented and coral bleaching events have occurred to further degrade coral reefs in Culebra. For example, estimates of live coral cover in 2008 (just 10 years later in some of the same areas), ranged from 20-40% live coral cover (Figure 9 (left)). The best reef sites in Carlos Rosario in 1997 had 65% live coral cover but in 2008 had dropped to 30% coral cover – a decrease by 50% in just 10 years. At other sites, including Flamenco beach, there has been a catastrophic decline, particularly within the reefs close to shore and the beach area (Hernandez-Delgado pers. Comm). These declines are generally associated with mass bleaching events due to temporary conditions with high sea surface temperatures likely combined with chronic elevated nutrient levels. Recovery has been very slow in many areas, likely due to on-going anthropogenic impacts, lack of grazing fish and diadema, and elevated nutrients. High levels of algal cover are present on the reefs. Algae acts to stifle recovery from bleaching events, which can cause a phase shift from a coral-dominated to an algal-dominated system (Hernández-Delgado, 2010).

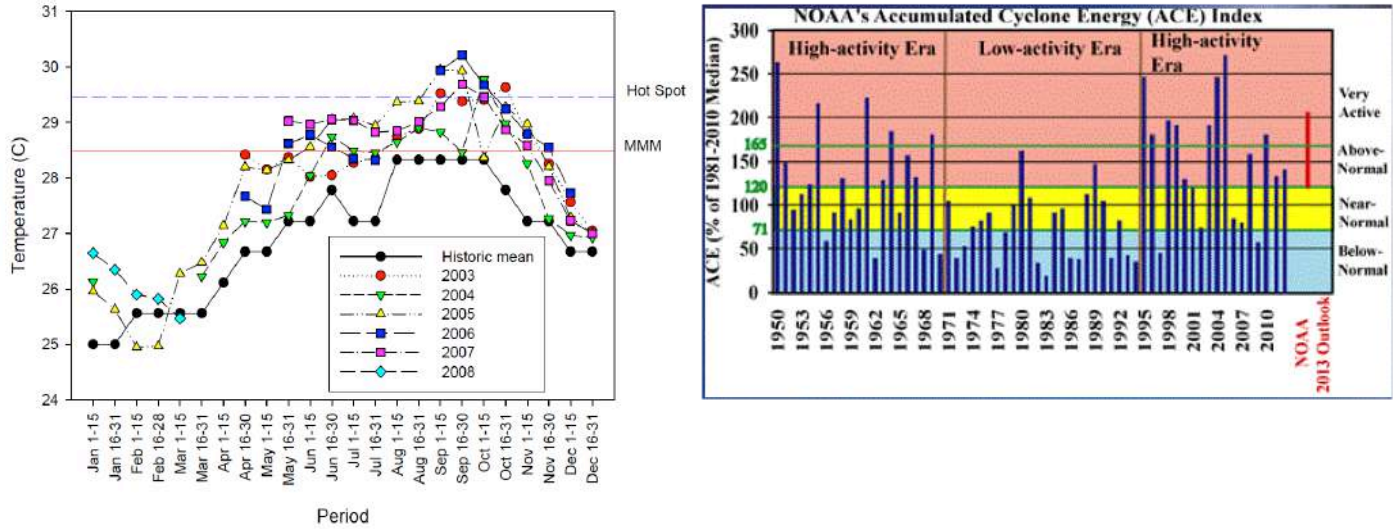
Figure 11. (left) SSTs at Bahia Tamarindo (2003-2008) vs. historic mean (Hernández-Delgado, 2009); (right) Atlantic NOAA Hurricane/Cyclone Intensity Index from 1950-2012 with 2013 predictions (NOAA, 2013)

Climate change poses an additional risk to island communities due to exacerbating existing challenges related to storms and hurricanes, food insecurity and coastal inundation. More frequent hurricanes cause physical damage to coral reefs, and increases in high sea surface temperature events (SSTs) are responsible for coral bleaching (Hernández-Delgado, 2009). Figure 11 (left) illustrates the above-normal SSTs at Bahia Tamarindo in Culebra from 2003-2008 where each of the years had periods when temperature levels exceeded those that threaten coral reefs. Figure 11 (right) shows recent high energy

activity associated with hurricanes in the Atlantic/Caribbean (NOAA, 2013). Figure 12 shows the potential threat of ocean acidification as a result of CO₂ loading into the world's oceans and them becoming increasingly acidic and less hospitable for coral reefs (Feeley et al. 2006). The impacts of high SST events can be mitigated by addressing the local sources of pollution in Culebra. However, increasing acidity of the oceans is an issue that can only be dealt with by reducing CO₂ emissions globally.

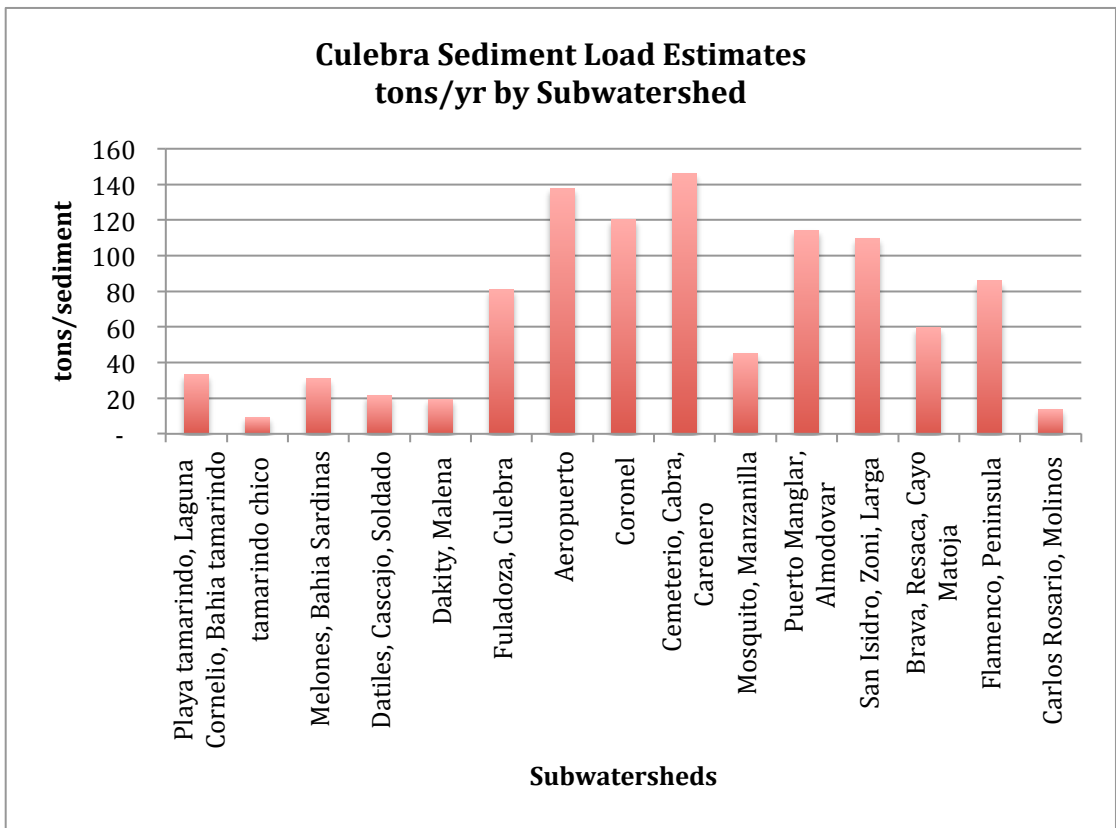
Figure 14. Sediment loadings by grouped (adjacent) subwatersheds

Figures 14 and 15 show the relative contribution of various watersheds to nitrogen and sediment pollution. Appendices A-3 and A-4 show the land use breakdown analysis that was to be performed based on zoning and existing land use in order to create an accurate land use layer for Culebra. That layer and additional assumptions in Appendix A-3 served as the basis for our model.

1. The WTM produces relative (expected) loading estimates based on land use, impervious cover and point sources (assumptions can be found in Appendix A-4).

6. The amount of channel erosion was estimated in the model based on observed field conditions and high, medium or low coefficients were applied.
7. Subwatersheds were grouped to reflect similar land uses and drainage to particular areas of interest such as important coral reef areas.

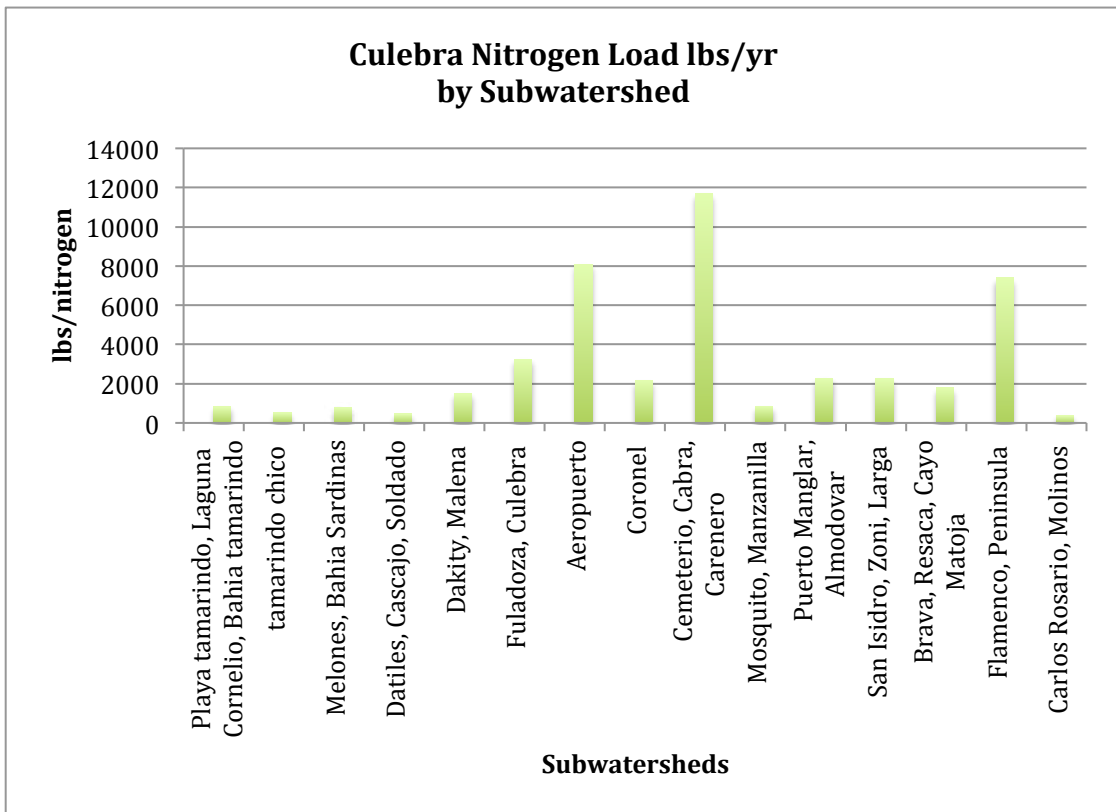
Figure 15. Nitrogen loading by Subwatershed groupings

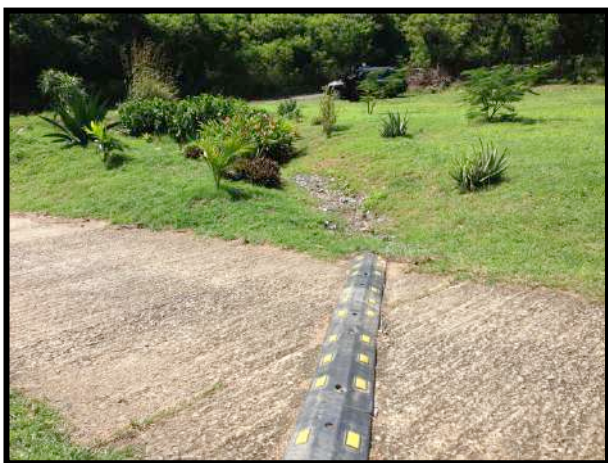
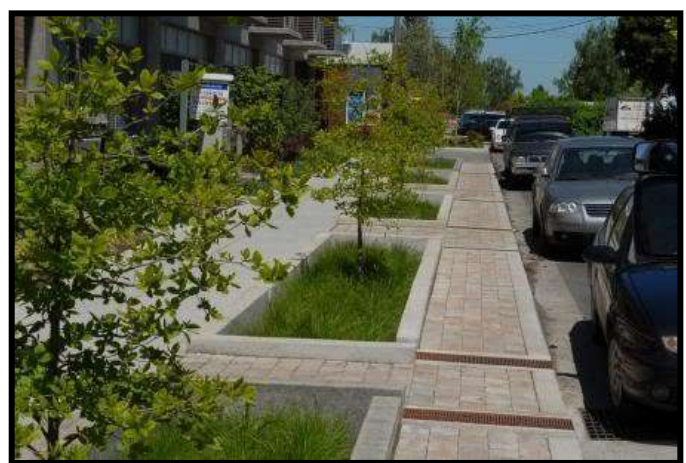
Figure 16. Rain garden from St. Croix and streetscape biofilters from Santa Monica, CA

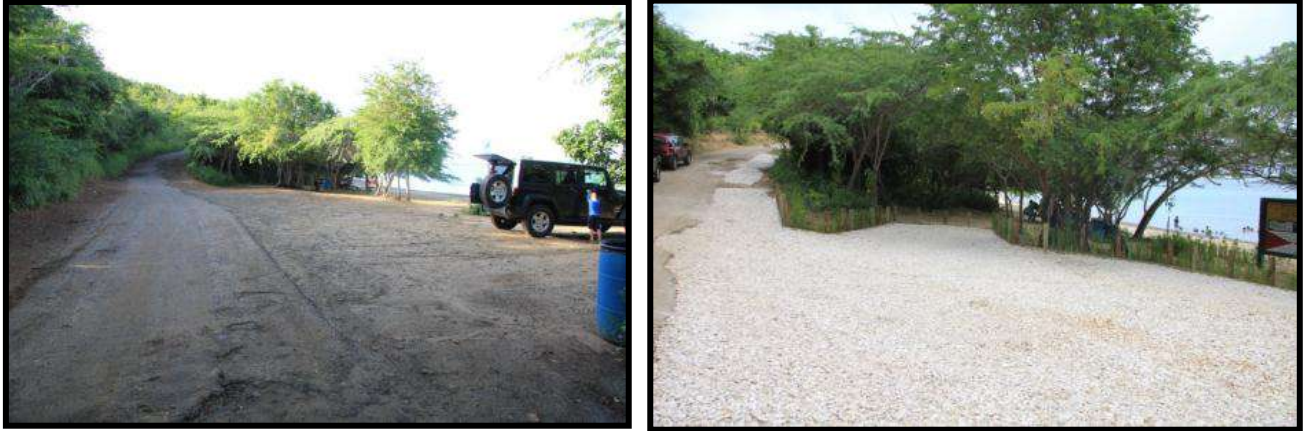
Figure 17. Before and after stabilization at Tamarindo Beach in Culebra

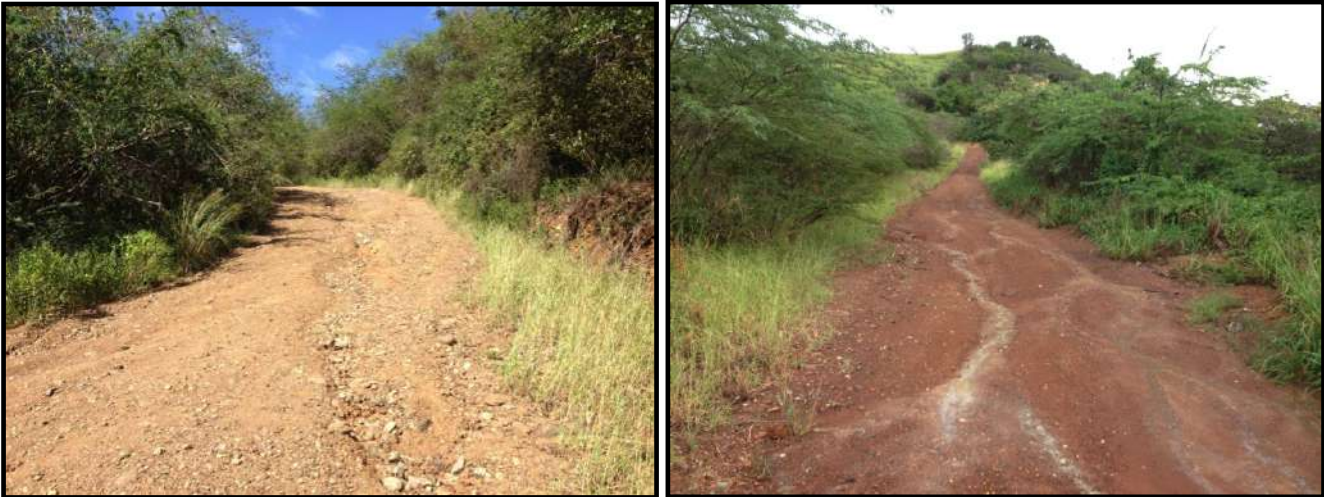
Figure 18. Dirt roads as a source of sediment (note the surface runoff over the roads creating erosion and resulting in fine sediment losses)

Stabilization of bare soils (Figure 18) involves the rapid re-stabilization of vegetation and generally a transition to more native and stable forms of vegetation. One effective way to re-establish vegetation in an area is to utilize hydroseeding followed by watering to rapidly transition to a more stable vegetated system where runoff is reduced. Dirt roads are stabilized using methods to remove water from the road and reduce erosion. These include concrete or dirt cross-swales, check dams and sediment traps. The recommendations for dirt road and bare soil stabilization are found in Table 5, maps are found toward the end of the section in Figures 23 and 24, and a dirt road layer created for the island is shown in Appendix A-5.

It should be noted that all exposed soil and dirt roads transport sediment at a rate of 5x to 100x the natural transport rate from a forest or a field, so maximizing the amount of roads treated is a critical element of the watershed plan, as is reducing the impact of future road development.

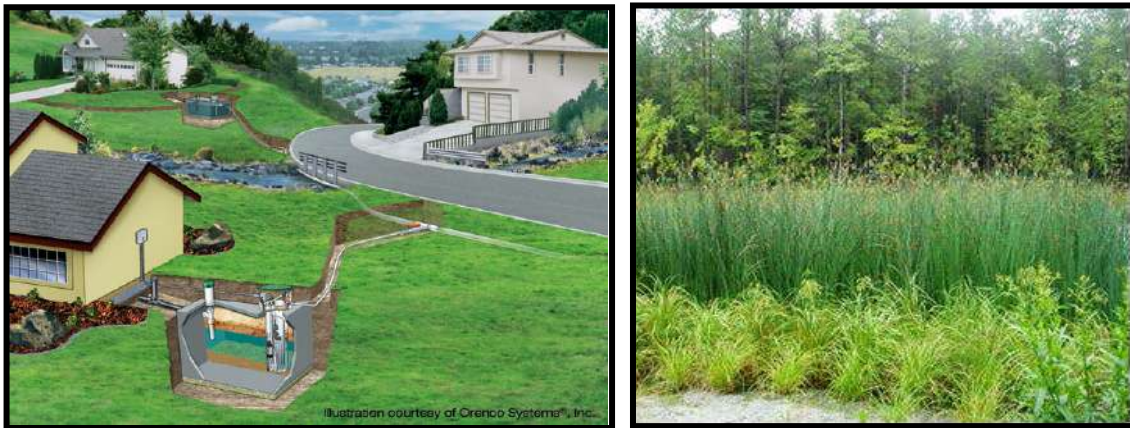
Figure 19. Pump and treat system effluent is pumped from homes to a constructed wetland or landscaped area

wetland such as is shown in the figure. These efforts should be focused at the WWTP (that historically used wetlands to treat the effluent) and at hotels and small communities on septic systems that cannot be easily connected to the WWTP.

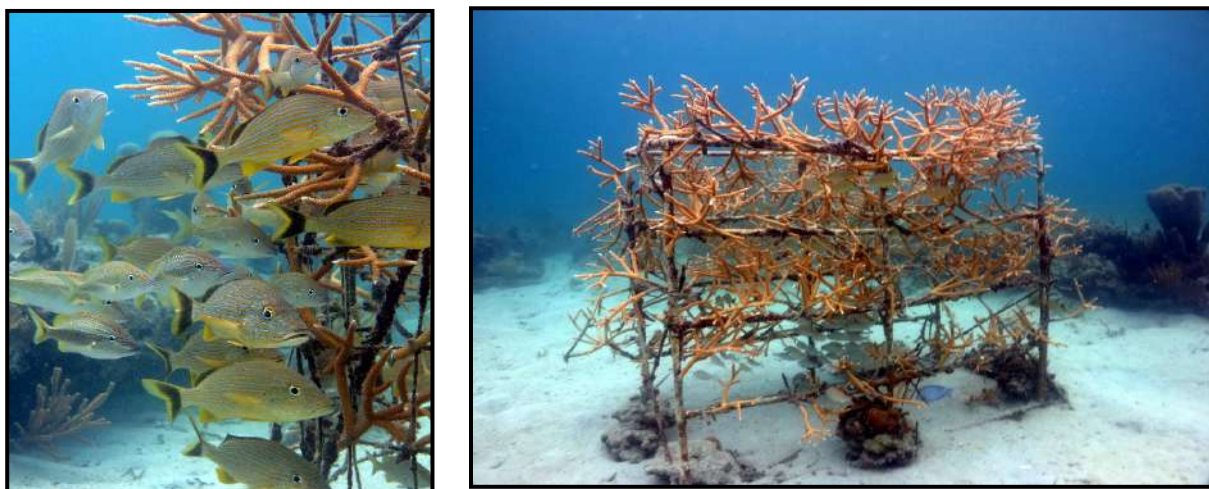
Figure 20. Coral restoration efforts in Tamarindo (Photo credit: CESAM)

Coral restoration involves the propagation of corals, in this case Staghorn coral (*Acropora cervicornis*) (Figure 20), and to a lesser extent other species including Elkhorn coral (*Acropora palmata*). These species have been decimated in the Caribbean - over the last 30 years there has been an 80 – 90% decline. Tamarindo Beach and Punto Soldado are two areas in Culebra where there have been restoration efforts. The goal of coral restoration efforts and out planting of corals has been to re-establish *Acropora* populations in the area. The community project of Coral Reef Rehabilitation and Aquaculture began in 2003 and has been led by the Society of Marine Environment (SAM) and Coralatons in collaboration with the University of Puerto Rico Center for Applied Tropical Ecology and Conservation (CATEC). Subwatershed restoration efforts should also be implemented to protect these important coral propagation areas that also contain coral reefs that are being restored and that are in relatively good condition.

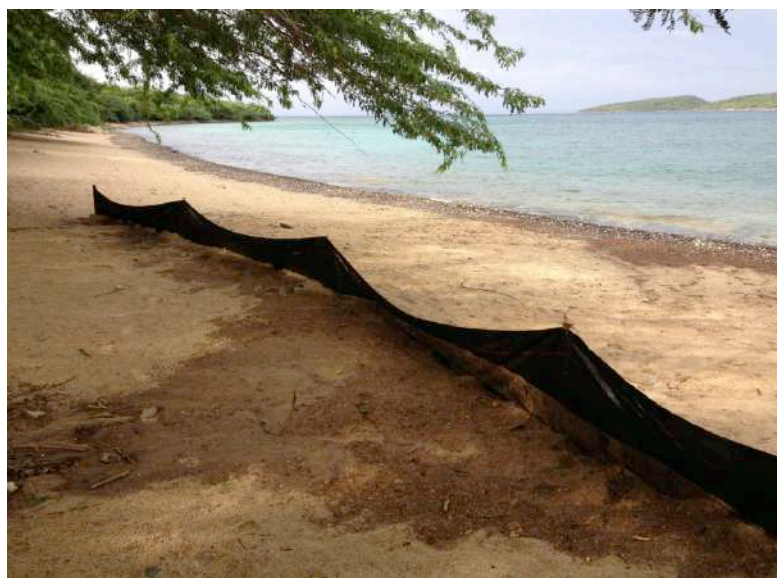
Figure 21. Silt fence at the Tamarindo restoration holding back sediment from nearshore waters from an upland dirt parking lot and restoration project

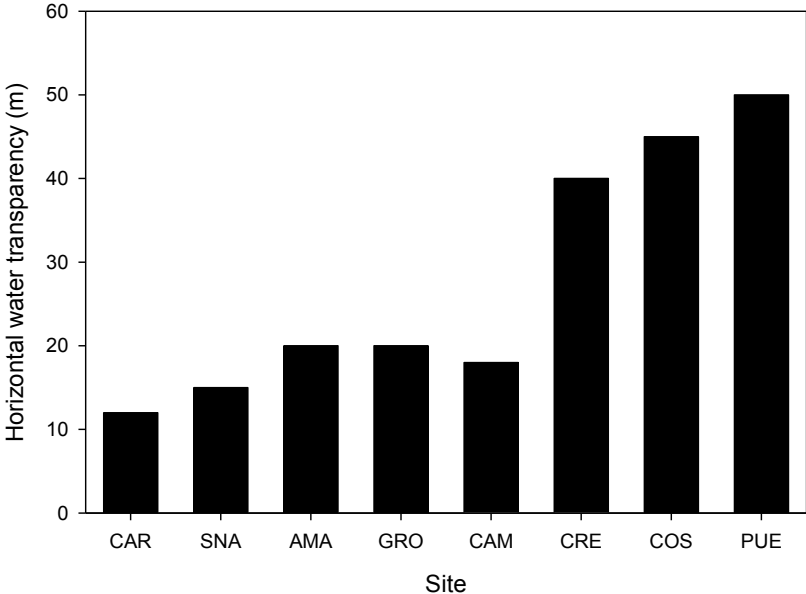
Figure 29. Secchi horizontal water transparency

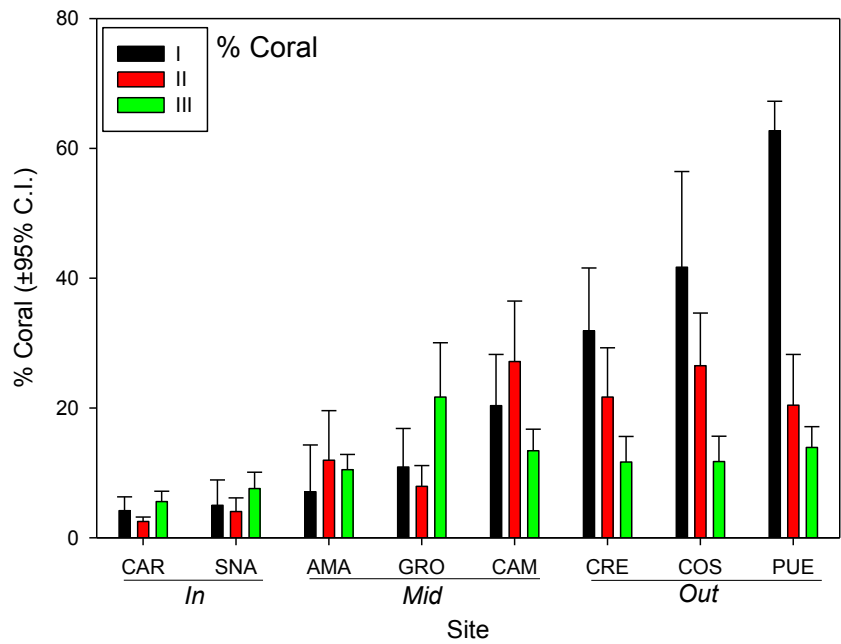
Figure 31. Mean percent live coral tissue cover (±95% confidence intervals)

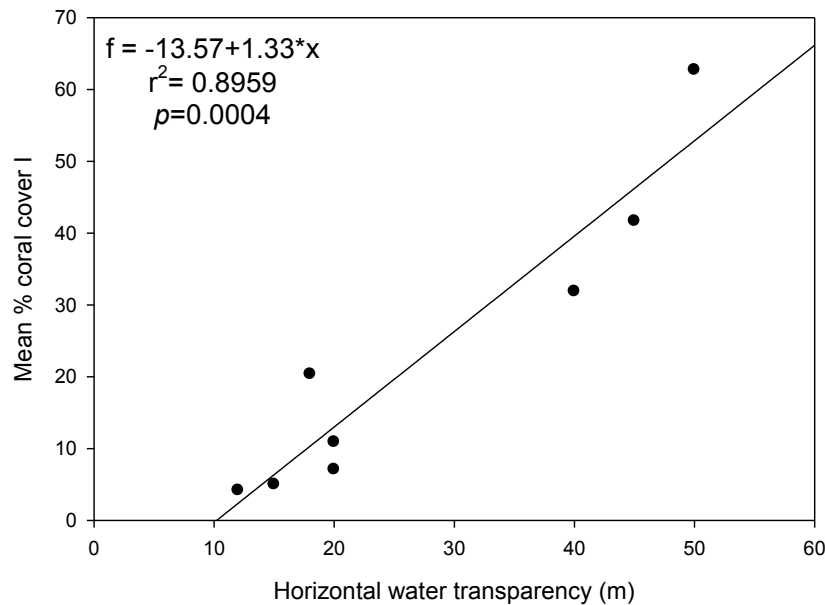
Figure 32. Linear regression between mean % coral cover from shallow reef zone and horizontal water transparency.

Corals showed a highly significant linear increase in percent live colony tissue cover with increasing water transparency (Figure 32). However, corals showed a rapid decline in percent live coral tissue cover with increasing chlorophyll *a* concentration (Figure 33), suggesting that coral reefs adjacent to Ensenada Honda Bay outlet are significantly degraded by chronic LBSP.

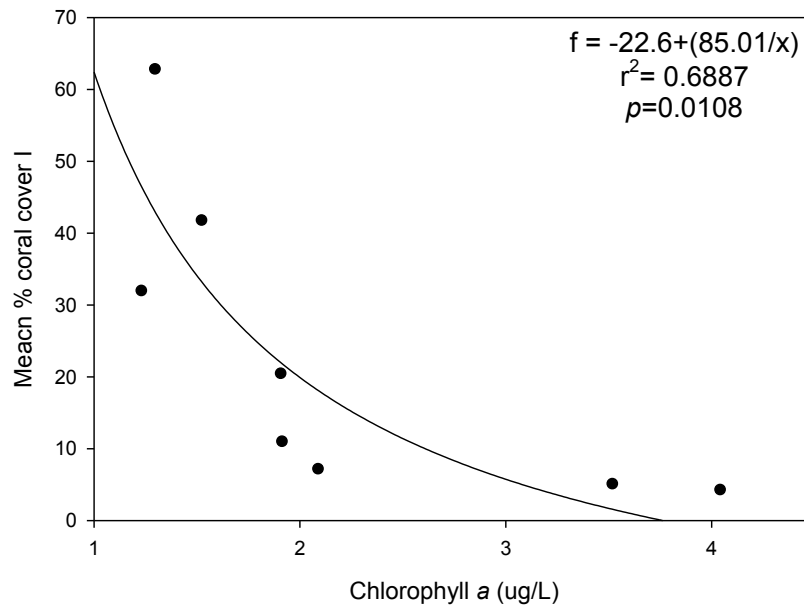
Figure 33. Exponential decay regression between mean % coral cover from shallow reef zone I and chlorophyll *a* concentration.

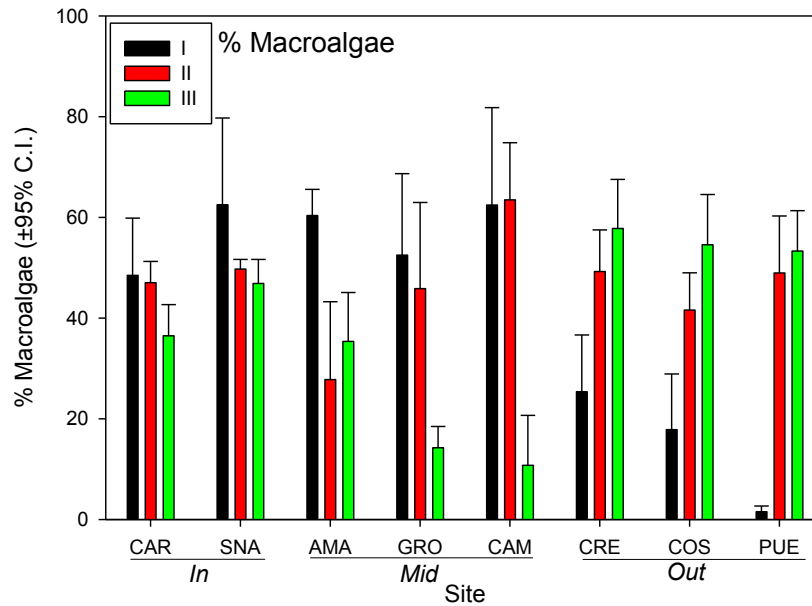
Figure 34. Mean percent macroalgal cover (±95% confidence intervals).

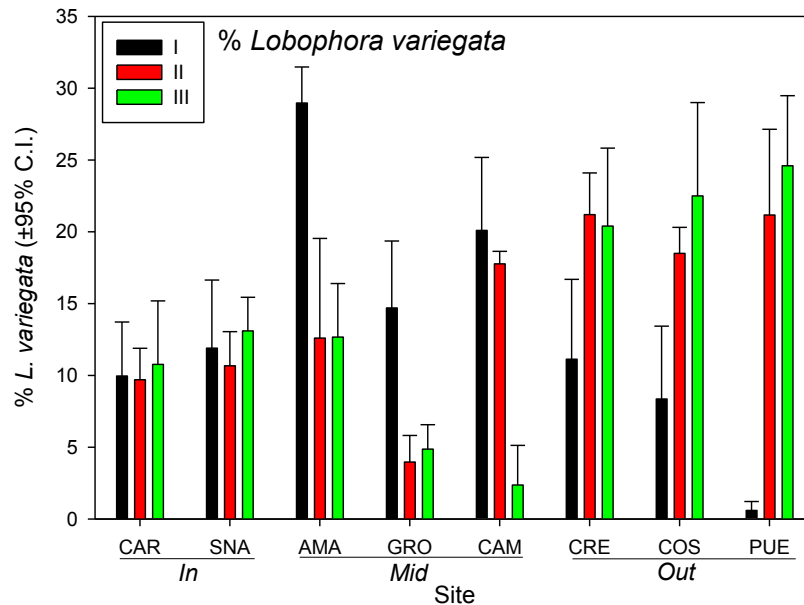
Figure 35. Mean percent *Lobophora variegata* relative cover ($\pm 95\%$ confidence intervals).

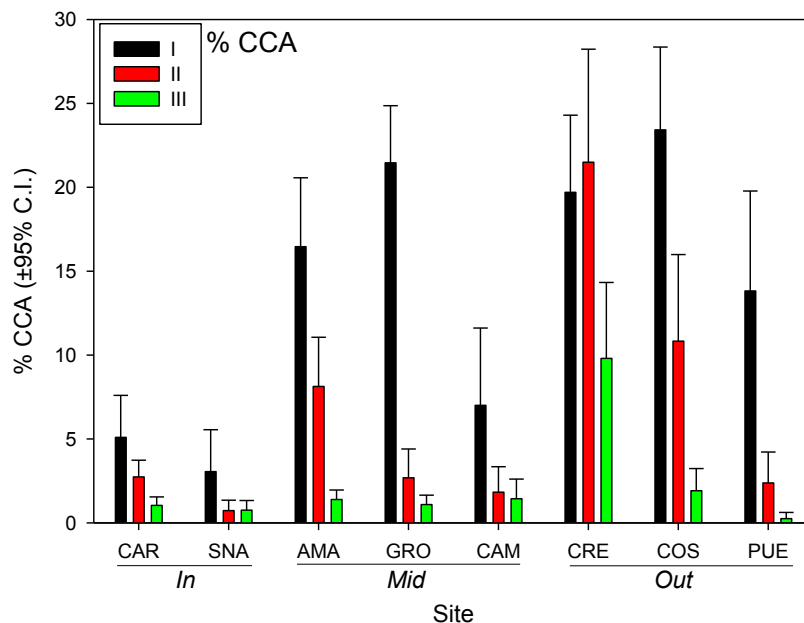
Figure 36. Mean percent crustose coralline algae (CCA) cover ($\pm 95\%$ confidence intervals).

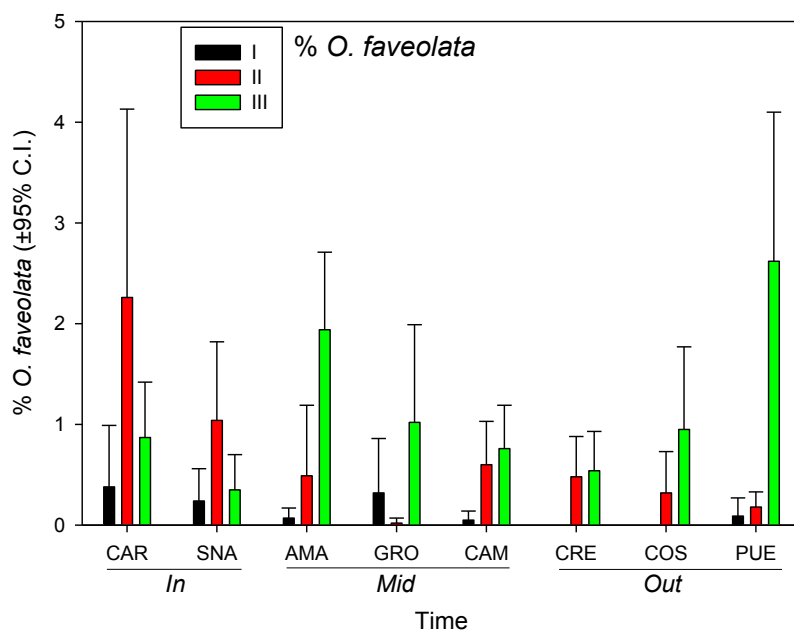
Figure 40. Mean percent *Orbicella faveolata* relative cover (±95% confidence intervals).

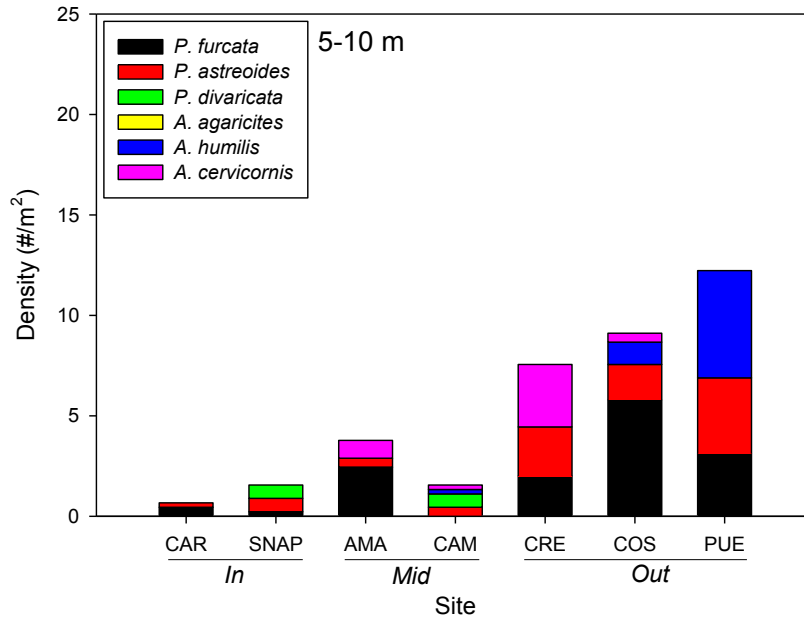
Figure 43. Coral recruit species dominance at shallow depth zone II (5-10 m).
